Abbreviated Preliminary Assessment for Revenue Prospect (aka California, Scott Mine)

Idaho County

**State of Idaho
Department of Environmental Quality**

December 2012

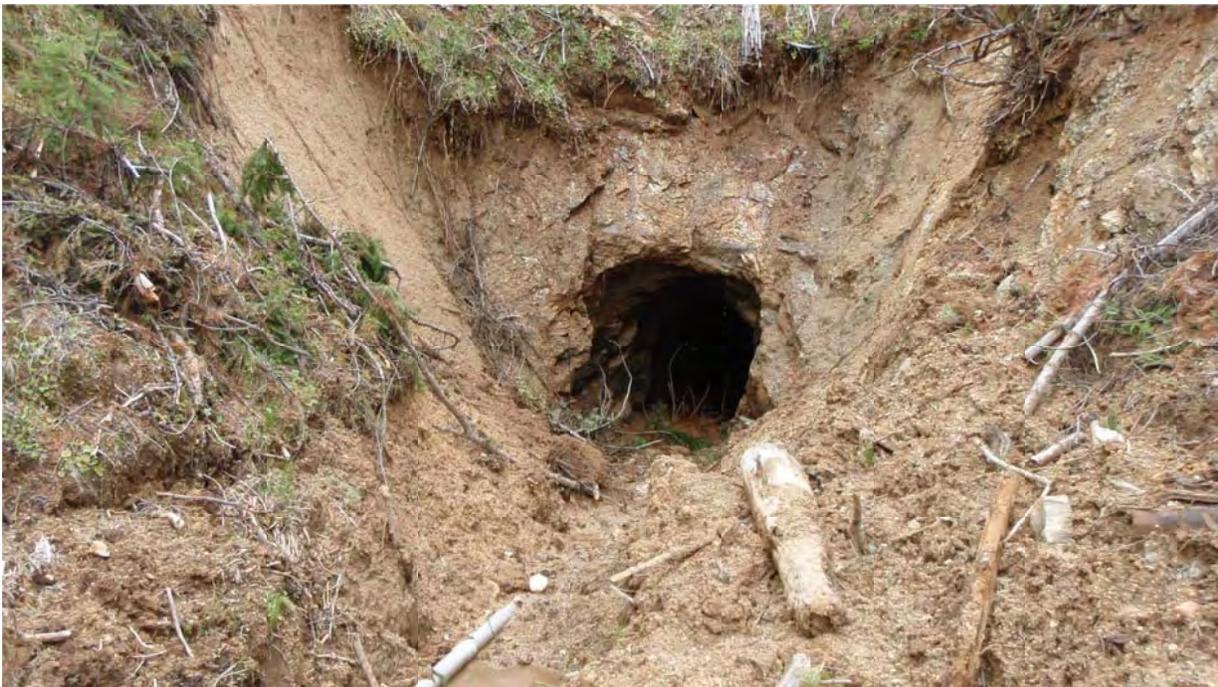
Photo 1. Revenue Prospect open adit.

No equipment, mining related material, hazardous materials, or petroleum based products are at the mine site. During the visit the adit was open. This was discussed with Mr. Scott and he intends to restrict access to the mine tunnel.

Photo 1 shows the open adit on the Revenue Prospect. During the site visit approximately 1 to 2 gallons of water was discharging from the adit mouth. The water is diverted southeast and goes subsurface into a heavily vegetated area.

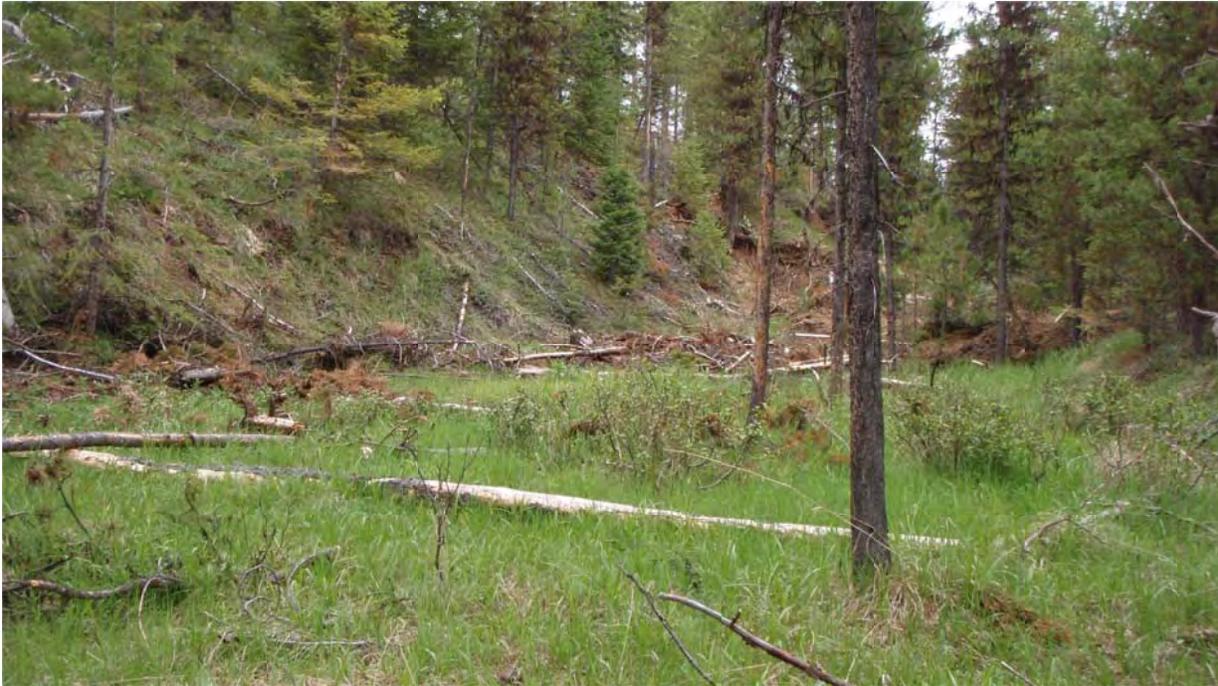
Photo 2. Revenue Prospect adit drainage area.

Photo 2 shows the well vegetated adit drainage area. The adit water only flows in the wet spring time and the drainage goes subsurface in this area. It is dry during the summer.

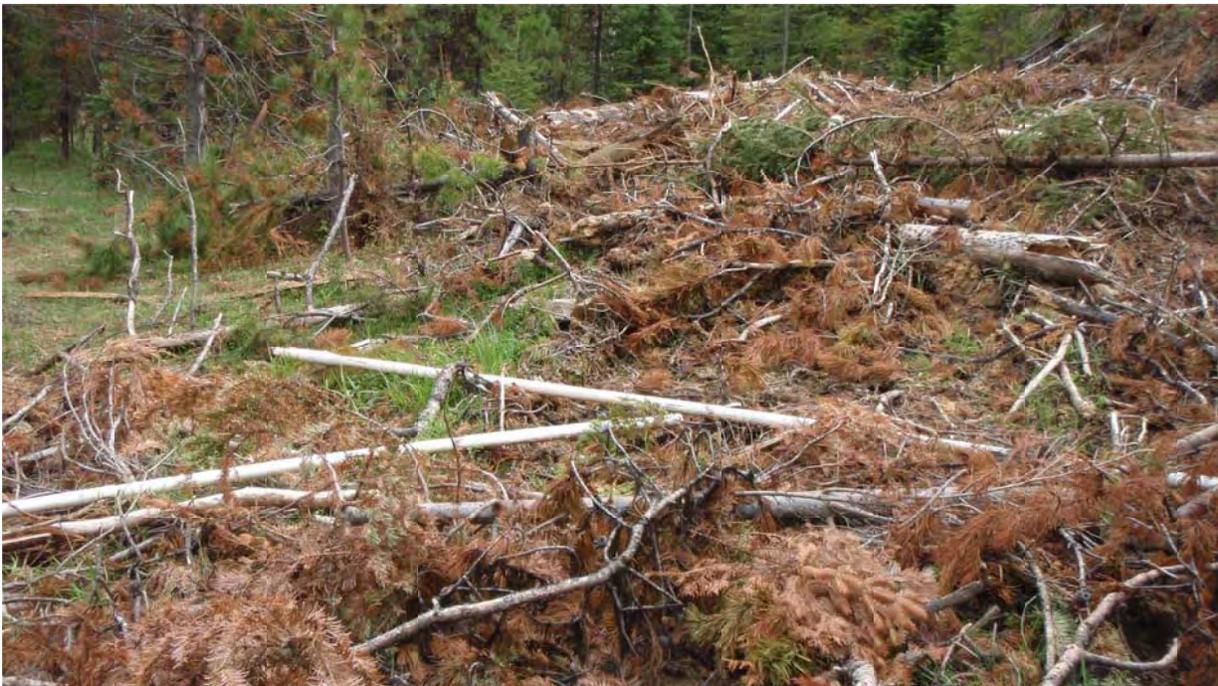
Photo 3. Woody debris covering and stabilizing the disturbed area near the Revenue Prospect adit.

The sediment sample had elevated metals where the adit opening had been cleaned out. The area where the drainage was discharging appeared to be stable and well vegetated at the time of the assessment. At the time of the assessment no pathways were observed for soil transport from the site.

Photo 3 shows the disturbed area and woody debris placed to cover and stabilize the area. The mouth of the adit area was cleaned out for better access. Note the apparently healthy grass and vegetation growing amongst the woody debris.

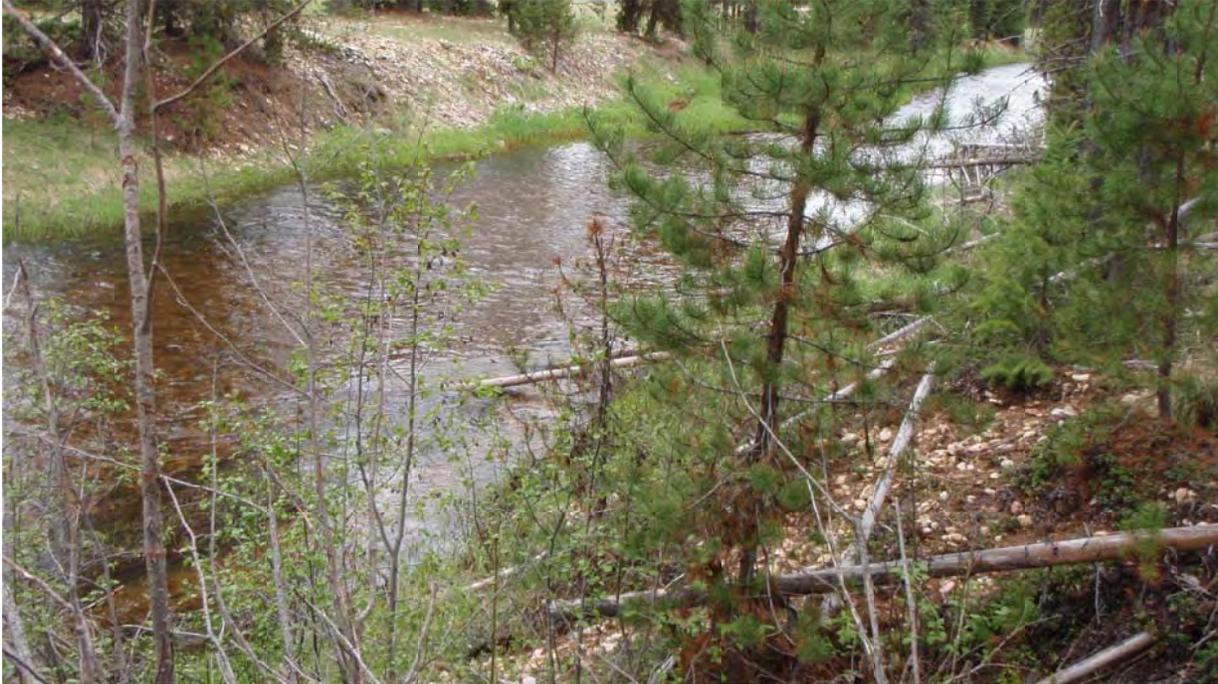
Photo 4. American River near the Revenue Prospect.

Photo 4 is looking across the American River from the Revenue Prospect side of the river. The river is 30 meters from the adit.

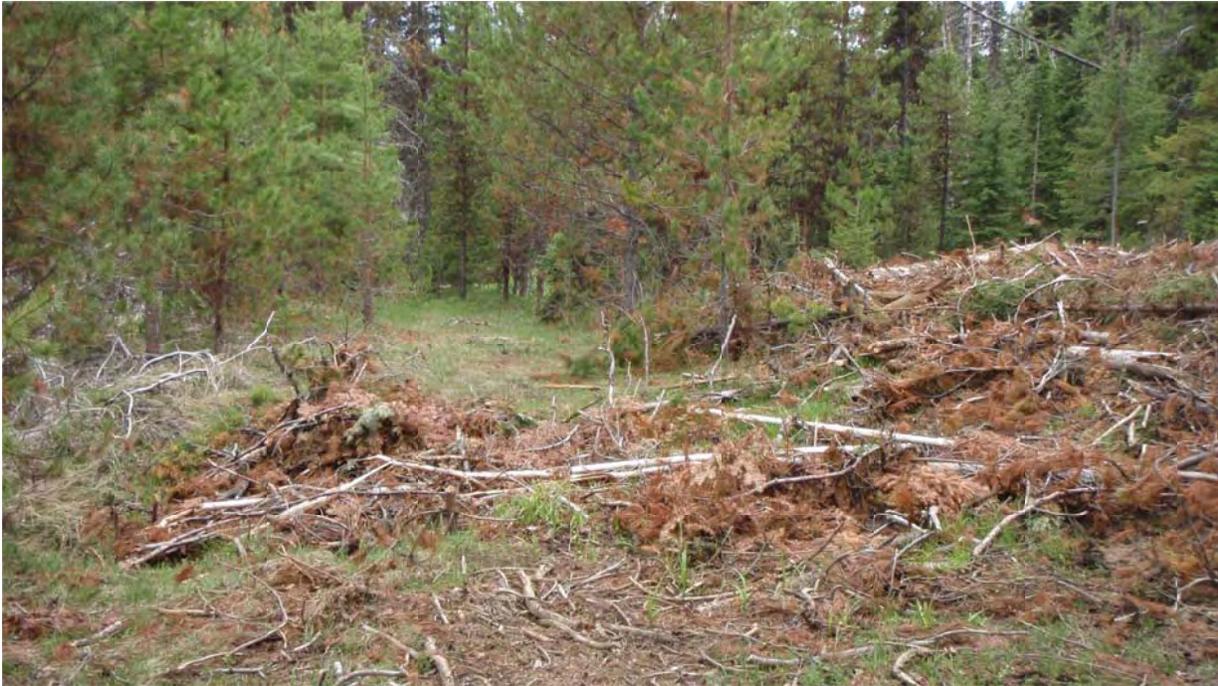
Photo 5. Logging slash piles near the Revenue Prospect.

Photo 5 shows logging slash piles in the immediate vicinity of the Revenue Prospect. At the time of DEQ's assessment the vegetation in this area was being thinned and logged to provide wild-fire control for the City of Elk City. The city is approximately one mile northeast of the mine site.

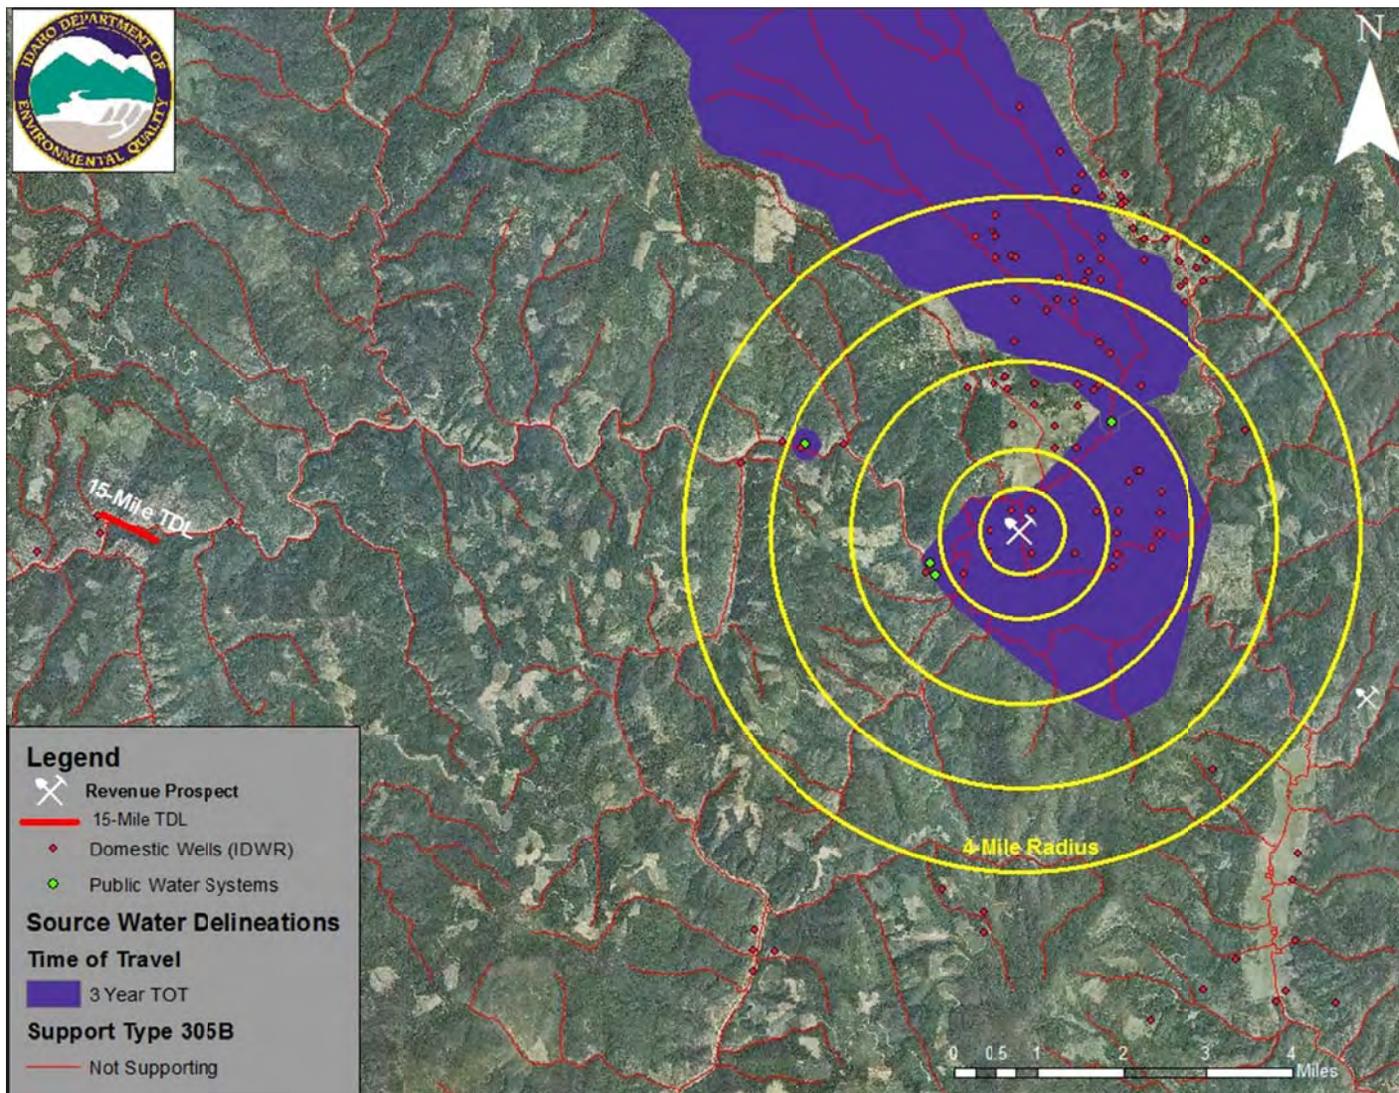
Figure 3. Domestic well and public water system locations.

There are approximately 72 domestic well locations and four public water systems within the 4-mile radius, 15-mile TDL. There are not significant wetlands within a 2-mile radius or in the general area. Sensitive streams located in the vicinity of the Revenue Prospect are also shown (indicated as “not supporting”).
