Preliminary Assessment and Site Inspection Report for Travers Park Landfill

Bonner County

**State of Idaho
Department of Environmental Quality**

January 2013

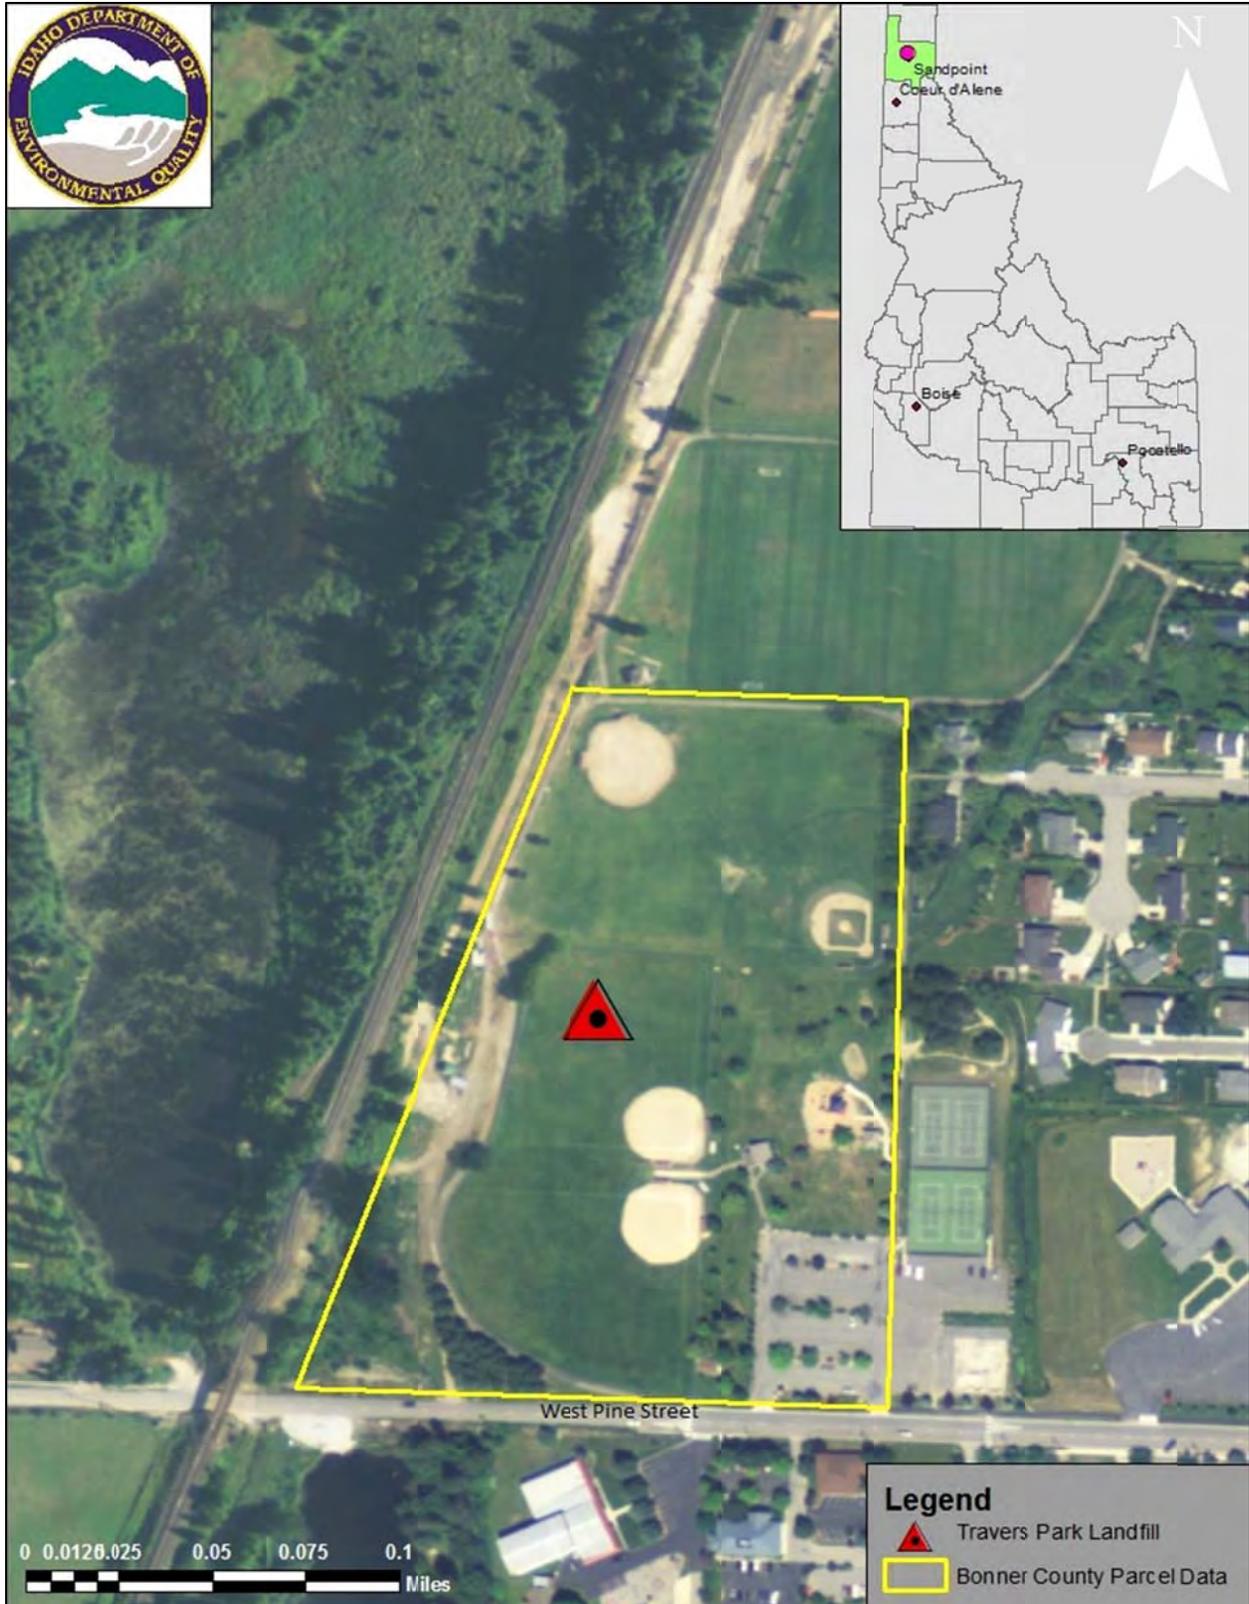
Figure 2. Aerial photograph overlain by Bonner County parcel data for the City of Sandpoint.
(Source: 2009 Natural Color 1-meter National Agriculture Imagery Program [NAIP] Idaho)

Travers Park and its underlying landfill are located near the western edge of Sandpoint along Chuck Slough, a broad slow moving waterway conveying a few ephemeral streams to the Pend Oreille River and likely a local expression of the ground water surface. Access to the park is from west Pine Street (Figure 2).

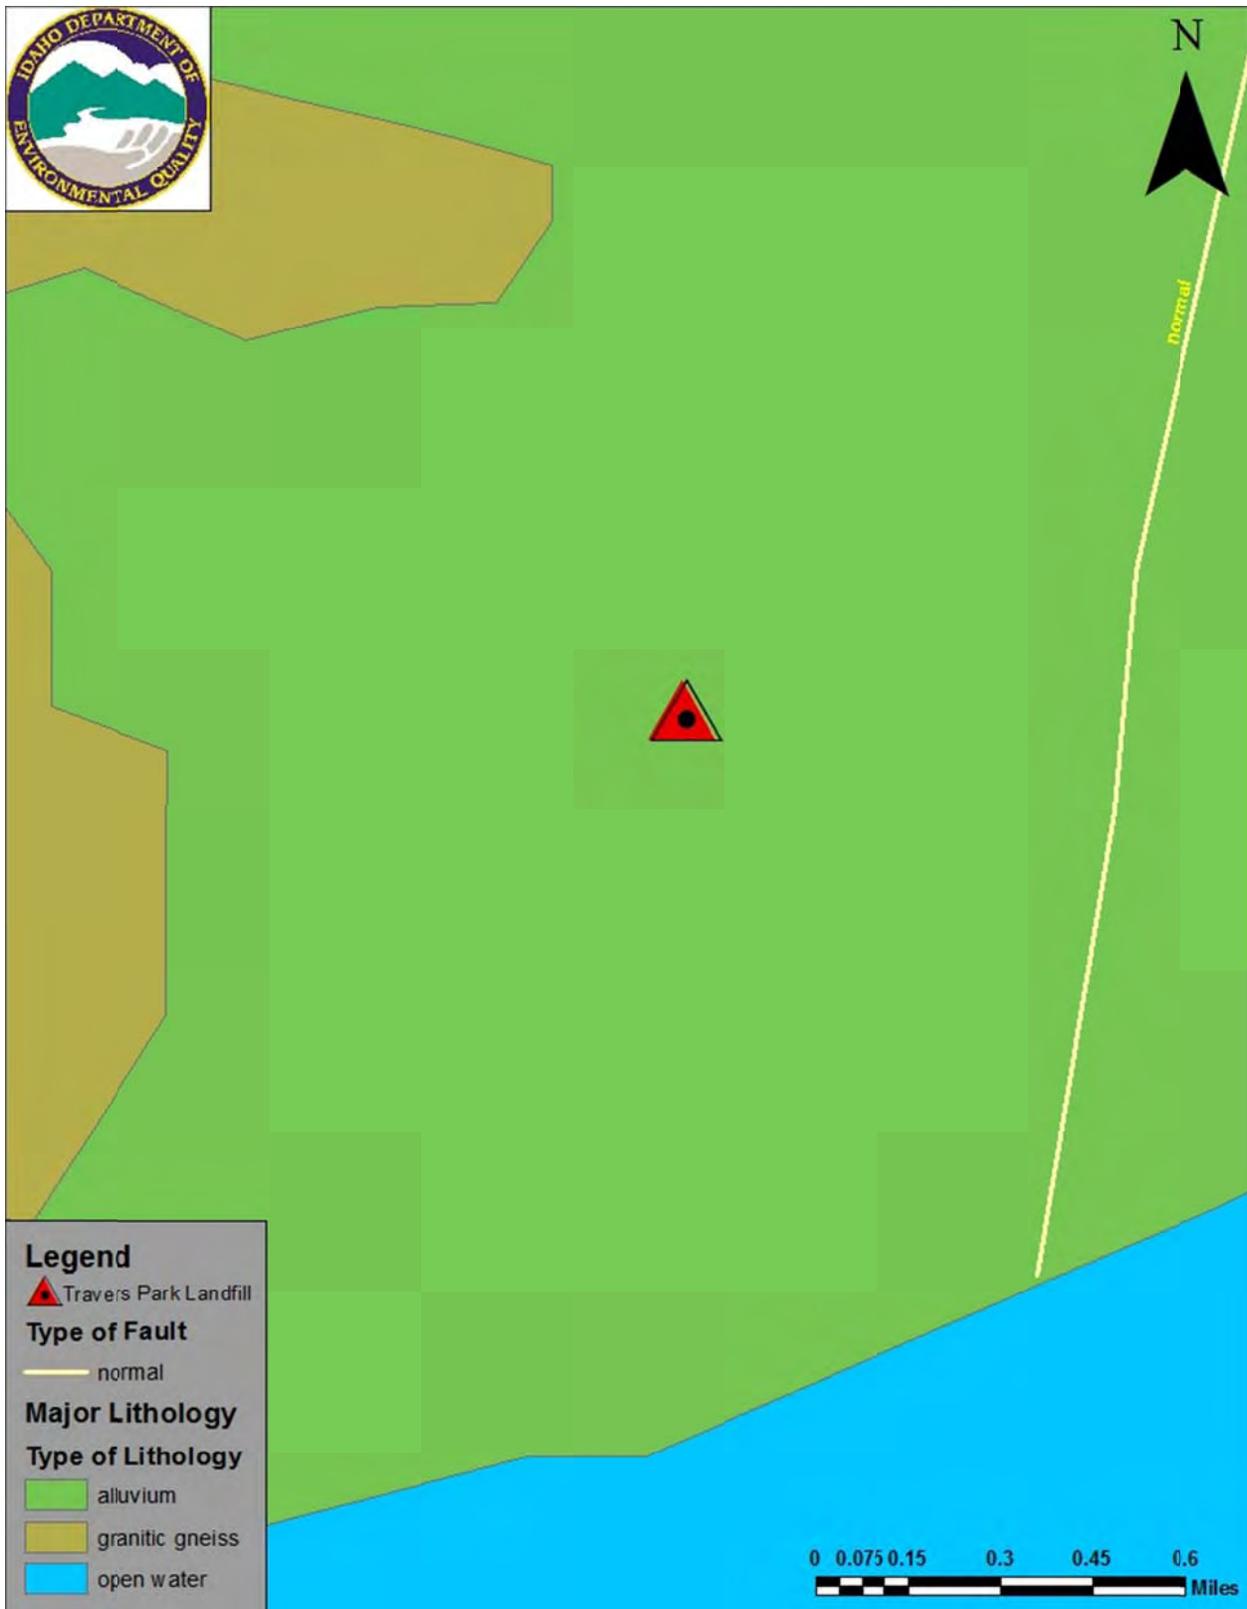
Figure 4. Map of major lithology in the vicinity of the Travers Park Landfill.

The vertical lithology of the area is confirmed by the well logs of the closest ground water well to Travers Park (Figure 3). The wells indicate fine clay surface soils with interspersed soft granitic lenses to a depth of 300 feet where solid granitic bedrock is contacted. The clay lenses at five feet depth or one quite similar retards ground water penetration over a wide area of north and western Sandpoint. The ground water flows along this southwest boundary into Chuck Slough. Part of this discharge passes through the landfill beneath Travers Park. Figure 4 is a map of the major lithology in the vicinity of the Travers Park Landfill.

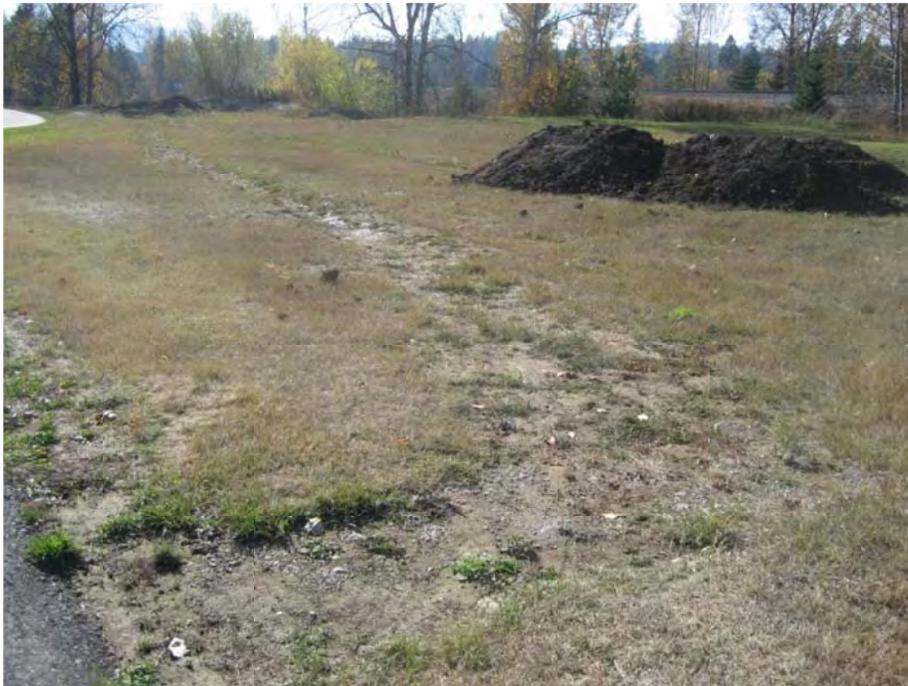
Photo 1. Looking south-southwest from the western perimeter of Travers Park.

The park surface is relatively flat likely from filling, capping, and grading the surface of the former landfill. Photo 1 illustrates the typical cap and finish grade covering the old landfill. The cap extends to the tree line and then drops steeply 30 to 35 feet to native topography and remnants of Chuck Slough. The pond is at the base of this fill.

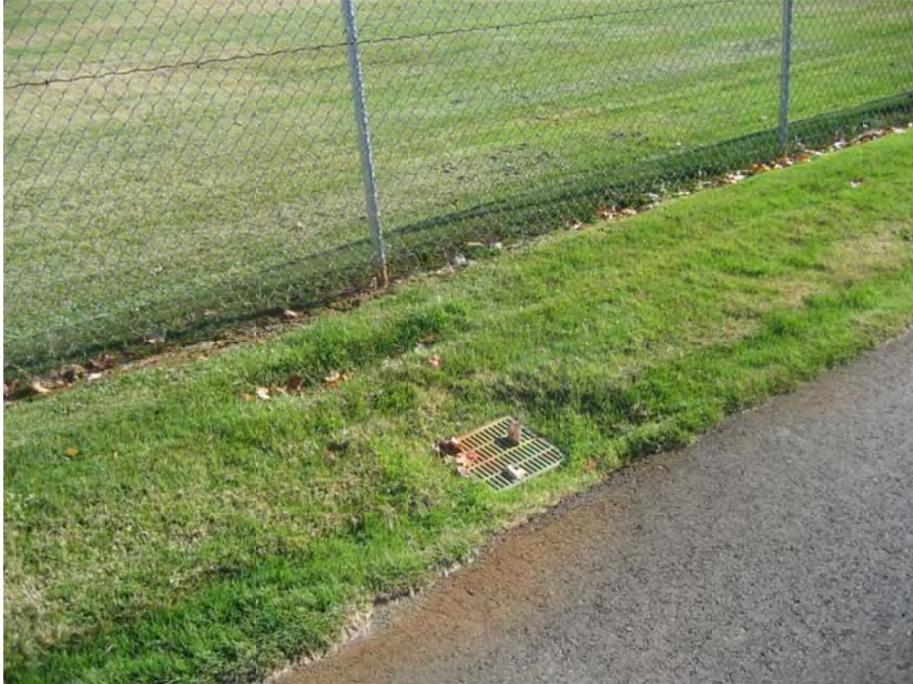
Photo 2. Storm drain next to the paved jogging path on the western perimeter of Travers Park.

Precipitation and snow melt percolate through the landfill. Attempts were made to mitigate seasonal surface water as indicated by Photo 2. This storm drain captures surface water and redirects it under the paved jogging path. The water is then discharged onto the cap again where it continues to percolate through the landfill. The soil typically becomes saturated resulting in surface water flowing to the edge of the cap and emptying into a pond at the base of the landfill. The pond discharges into Chuck Slough.

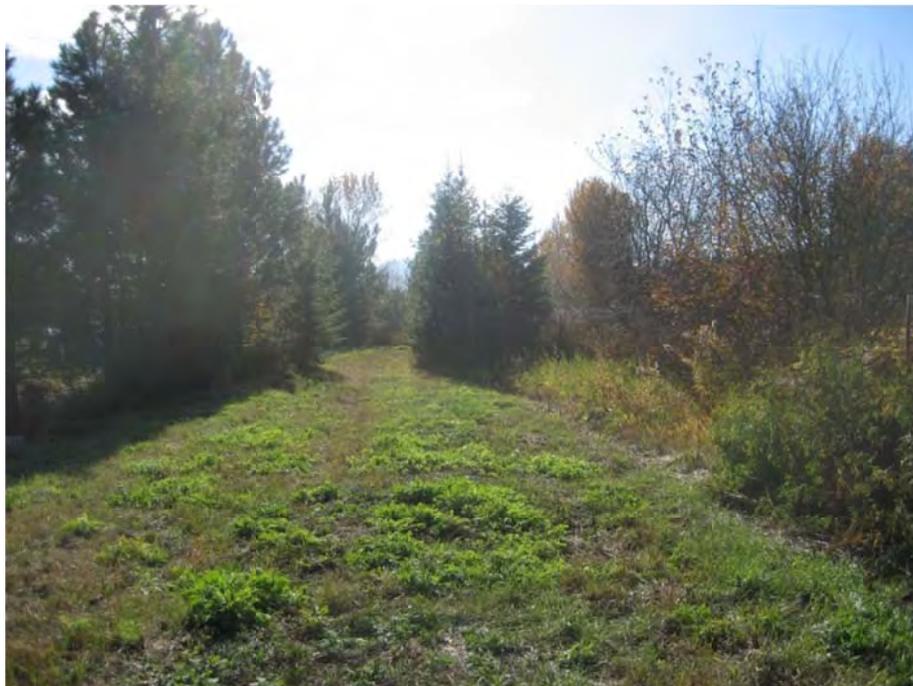
Photo 3. South/southwestern view along a berm installed to create a buffer and define the western boundary of Travers Park.

The fill falls off into a pond and wetland area on the park's southwestern perimeter (Photo 3). The pond and wetland area were partially filled by the landfill. This pond and wetland area was cut off from Chuck Slough by construction of the Union Pacific Railroad (UPRR) early in the twentieth century.

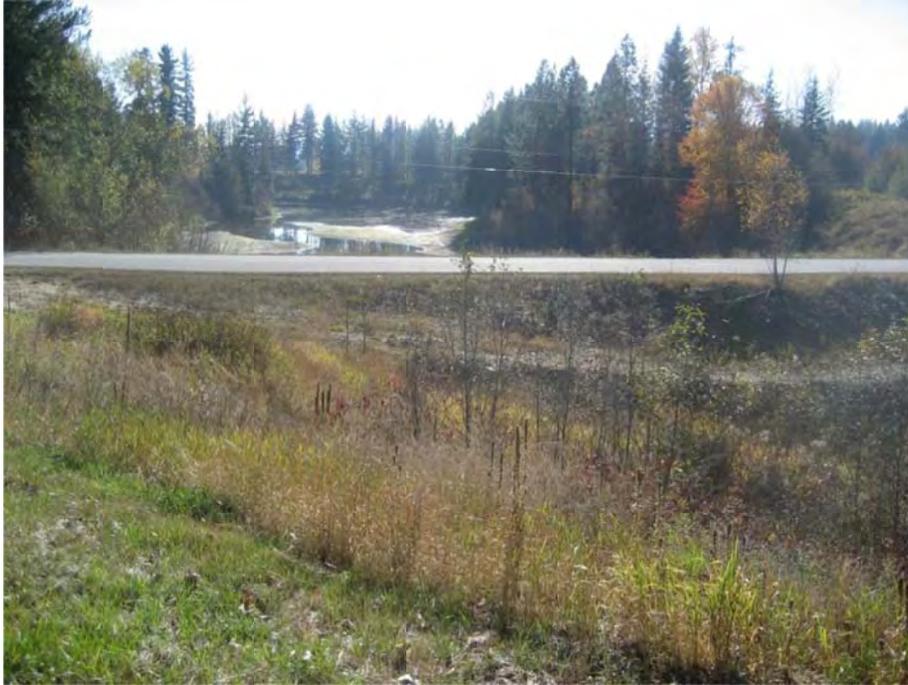
Photo 4. View from the southwest corner of Travers Park looking south.

A small pond and wetland area are located at the toe of the landfill between Travers Park on the east and the UPRR grade on the west. Chuck Slough is located on the south side of Pine Street. In Photo 4 the pond and wetland area are in the forefront, the UPRR grade is on the far right, Pine Street is mid-photo, and Chuck Slough is in the background beyond Pine Street.

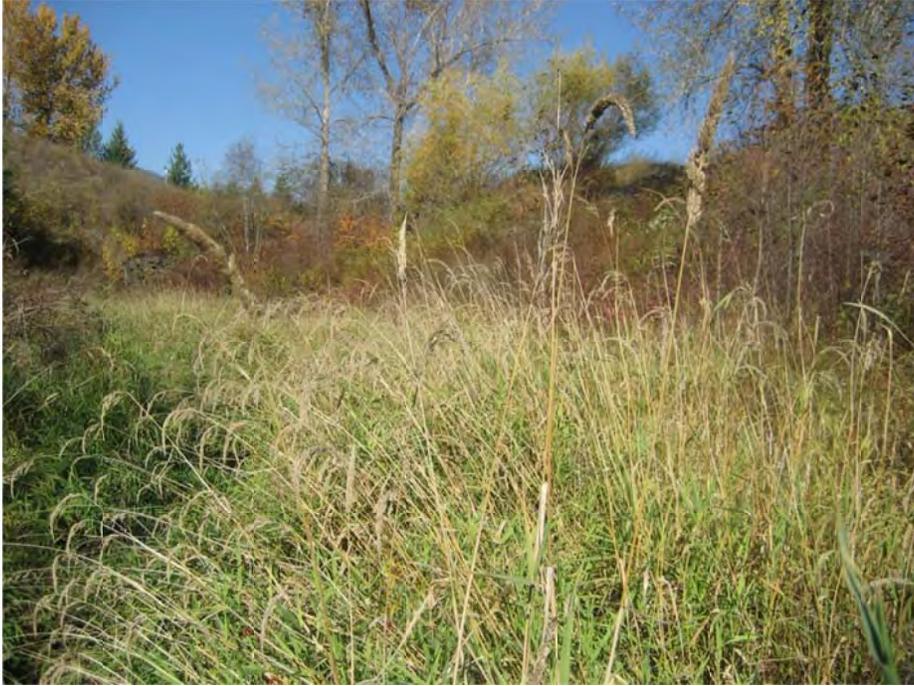
Photo 5 shows the wetland vegetative swath between Pine Street and the pond. The abrupt elevation change on the right side of the photo is the edge of the landfill. The elevation change on the left side is the 30-35 foot fill for the UPRR grade.

Photo 5. Looking north from Pine Street the vegetation surrounding the pond appears healthy with no signs of stress.

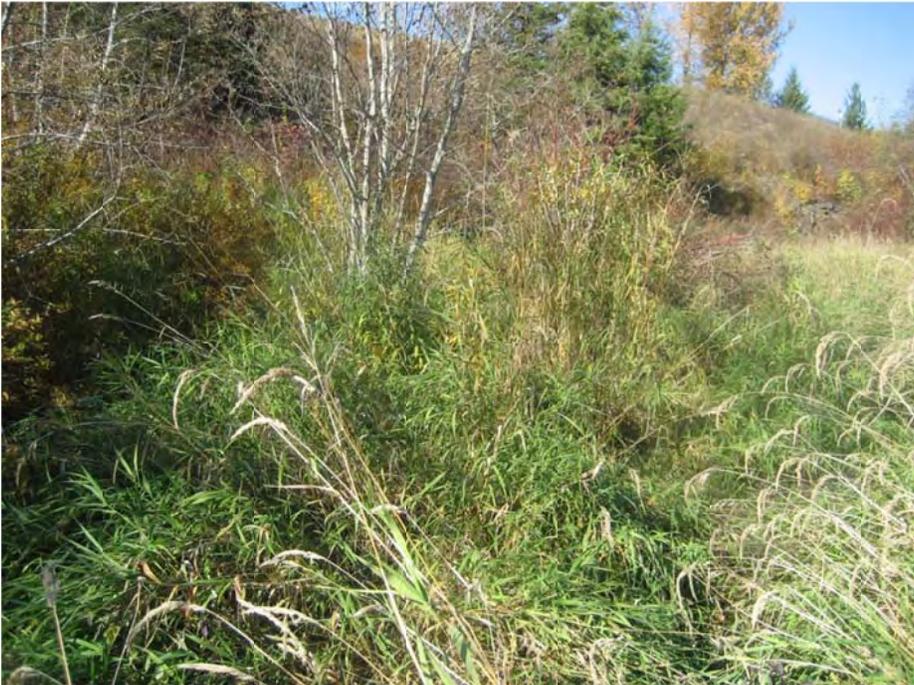
Photo 6. Close-up view of vegetative swath between Pine Street and the pond.

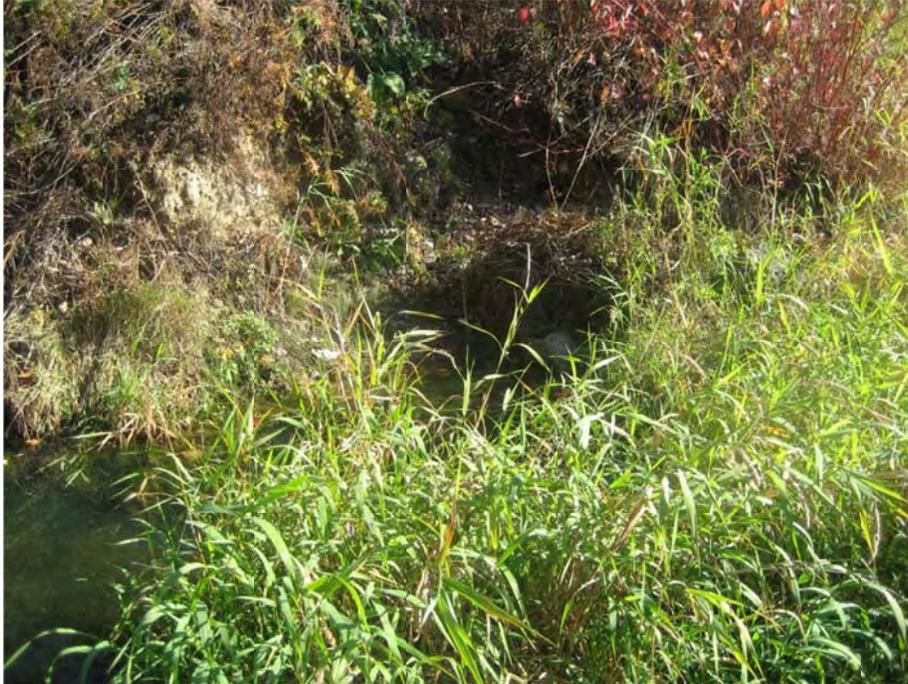
Photo 7. Culvert that goes under Pine Street to Chuck Slough.

Photo 7 shows the culvert that goes under Pine Street to Chuck Slough. It is the outlet for the wetland area and small pond.

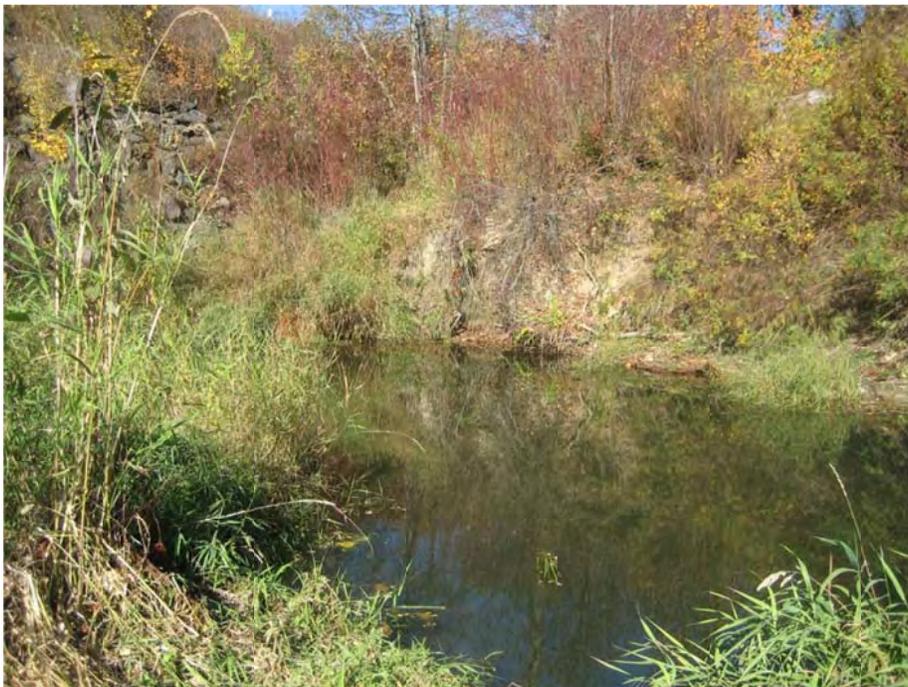
Photo 8. View of the small pond and the steep gradient of the landfill where it encroaches on the pond.

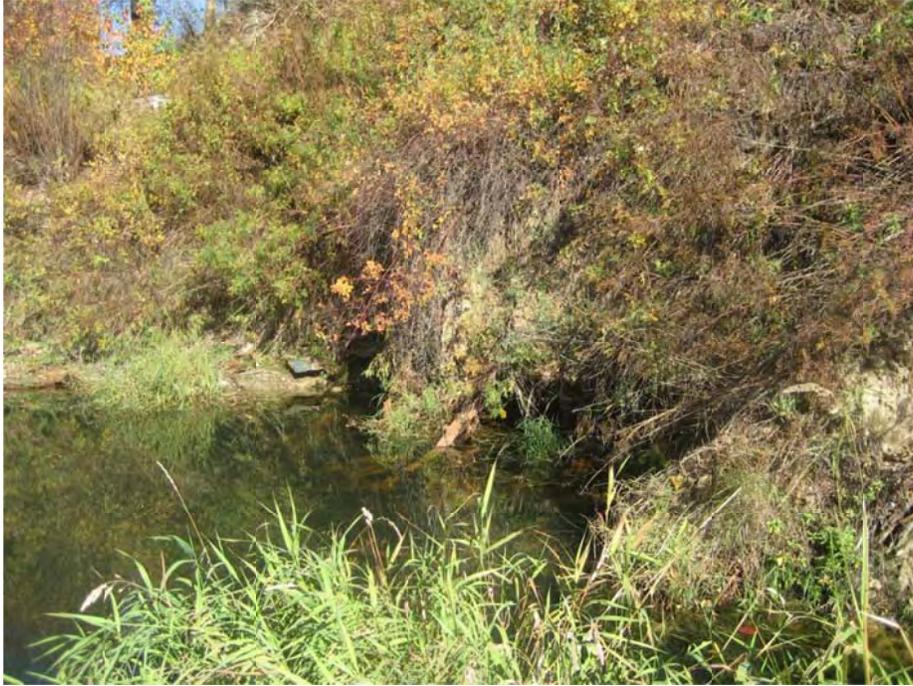
Photo 9. Close-up view of vegetation and overhanging debris at the toe of the landfill.

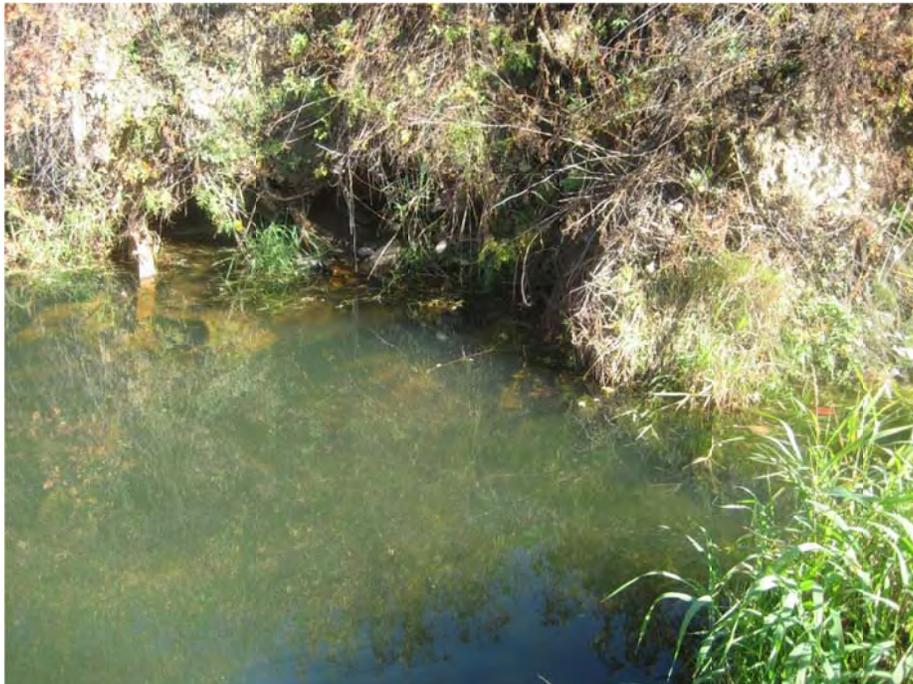
Garbage was “stacked” at the edge of the landfill as it encroached into the pond. The garbage was thinly covered with a soil veneer allowing vegetative growth but because of the steep slope and thin veneer garbage is also visible and continues to “work its way out” from the landfill scarp. Old car frames are submerged in the pond and garbage is observed in the landfill scarp.

Photo 10. View of the frame of an old car submerged in the pond.

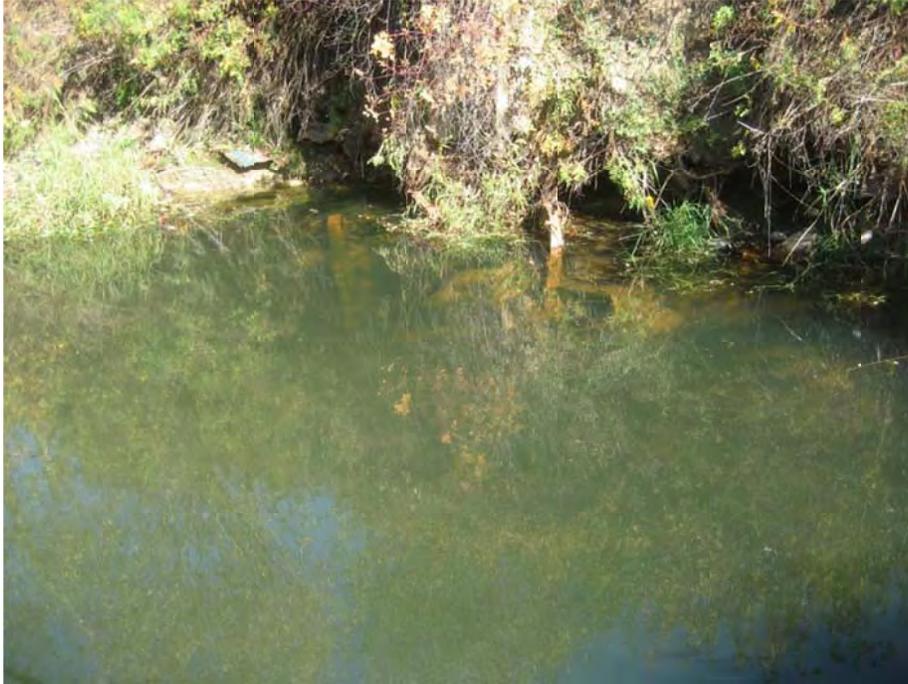
Photo 11. Close-up view of the frame of an old car submerged in the pond.

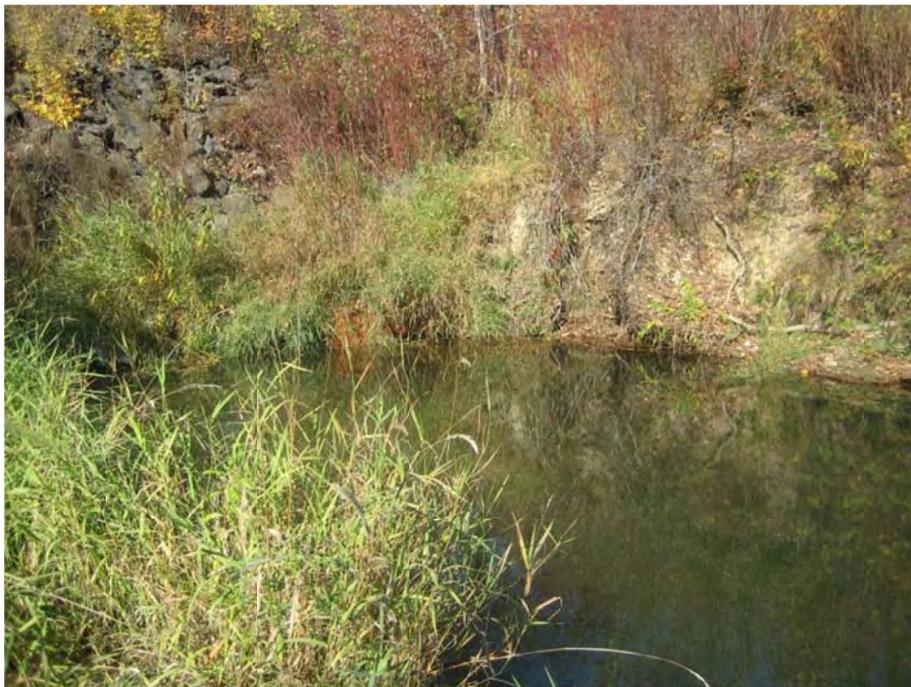
Photo 12. View looking north where the UPRR fill on the left and the landfill on the right meet.

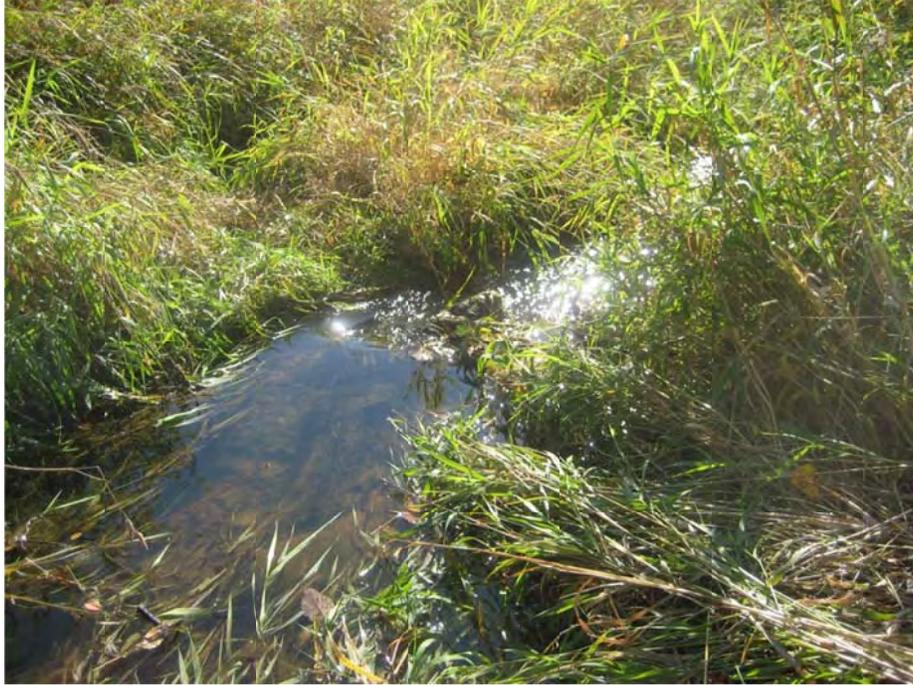
The pond discharges an estimated 1 to 2 feet per second of water through a culvert under the grade into Chuck Slough. The discharge is sustained at this level despite over two months with minimal precipitation and no surface runoff. Even in the dry months the flow doesn't stop. Any contaminants entering the pond from the ground water are transported to Chuck Slough which discharges to the Pend Oreille River. Any contaminants from the landfill should be detectable in

the pond water. Photo 13 shows the outlet channel into Chuck Slough and Photo 14 shows the culvert discharging water under Pine Street into Chuck Slough.

Photo 13. Close-up view of the outlet channel into Chuck Slough.

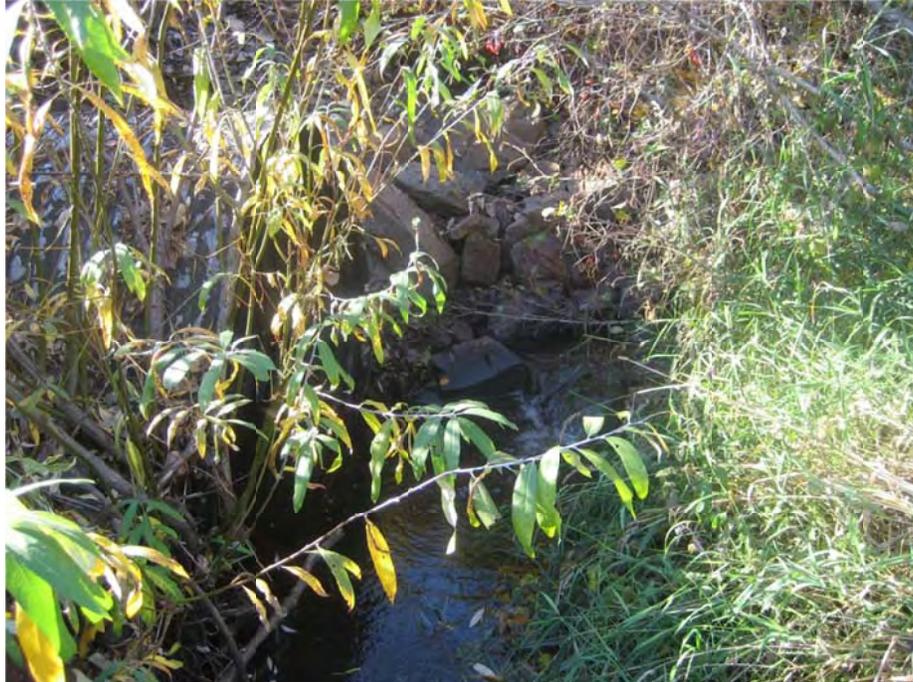
Photo 14. Close-up view of the culvert discharging water under Pine Street into Chuck Slough.

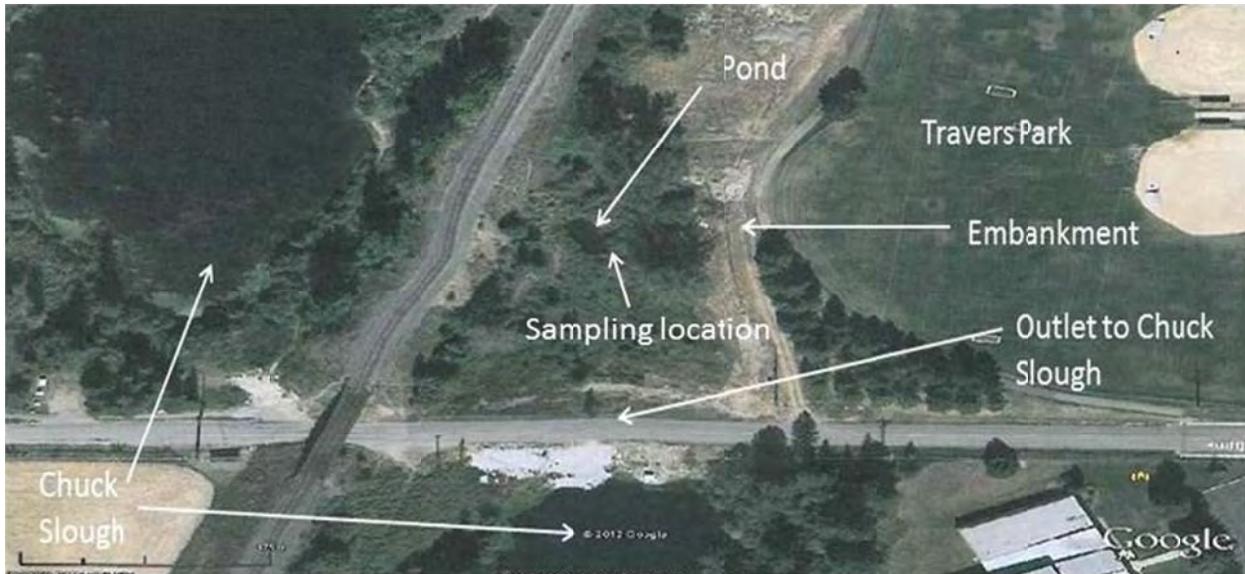
Figure 5. Sample location and features of the Travers Park Landfill.

In accordance with EPA chain-of-custody procedures, DEQ submitted the surface water samples to SVL Analytical, Inc. (SVL) in Coeur d'Alene, Idaho, for analysis of the fifteen 40 CFR 258 Appendix 1 metals and forty-four 40 CFR 258 Appendix 1 organic compounds. SVL sent the samples to Anatek Labs, Inc. in Moscow, Idaho for further analysis. A summary of the laboratory results is included in Table 1 in Section 9.2. A copy of the laboratory reports is included as Appendix A. Figure 5 shows the surface water sample locations.
