HERITAGE BAPTIST CHURCH (PWS 1280279)
SOURCE WATER ASSESSMENT REPORT

April 20, 2001

State of Idaho
Department of Environmental Quality

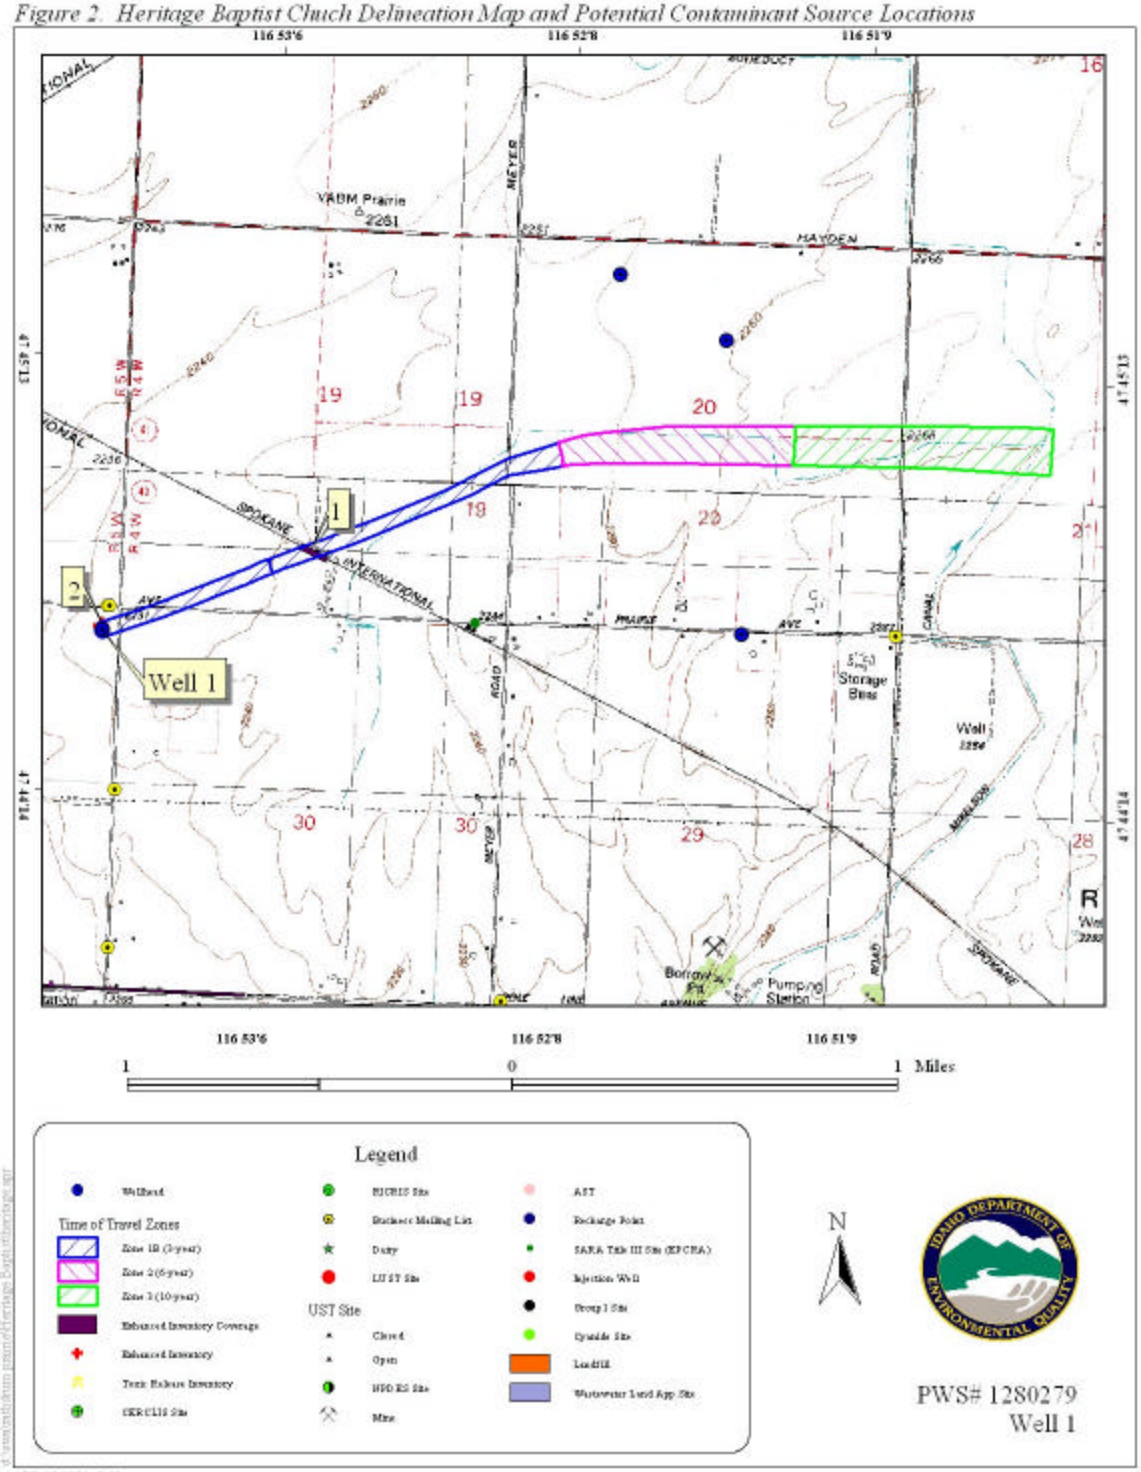
Figure 2. Heritage Baptist Chuch Delineation Map and Potential Contaminant Source Locations

There are two potential contaminant sites located within the delineated source water area (Table 1).

SITE #	Source Description	TOT Zone[1] (years)	Source of Information	Potential Contaminants[2]
1	Railroad	3	Enhanced Inventory	VOC, SOC, IOC
2	Septic Tank	1	PWS File	IOC (Nitrates), Microbials

The Heritage Baptist Church drinking water system is currently threatened by the presence of a septic tank located less than 100 feet from Well 1. The septic tank may become a source of nitrates or microbial contamination.

Heritage Baptist Church should focus source water protection activities on implementation of practices aimed at maintaining the quality of their drinking water system. This will require relocating the septic tank that is currently 50 feet north of the well to a minimum distance of 100' from the well. Alternatively, the well itself must be relocated. The church should also take steps to ensure that their source water assessment area remains free from future potential contaminant sites. Partnerships with state and local agencies and industry groups should be established and are critical to success. Due to the time involved with the movement of ground water, source water protection activities should be aimed at long-term management strategies even though these strategies may not yield results in the near term.
