CHESTERFIELD LDS CHURCH (PWS 6150012)
SOURCE WATER ASSESSMENT FINAL REPORT

April 25, 2001

State of Idaho
Department of Environmental Quality

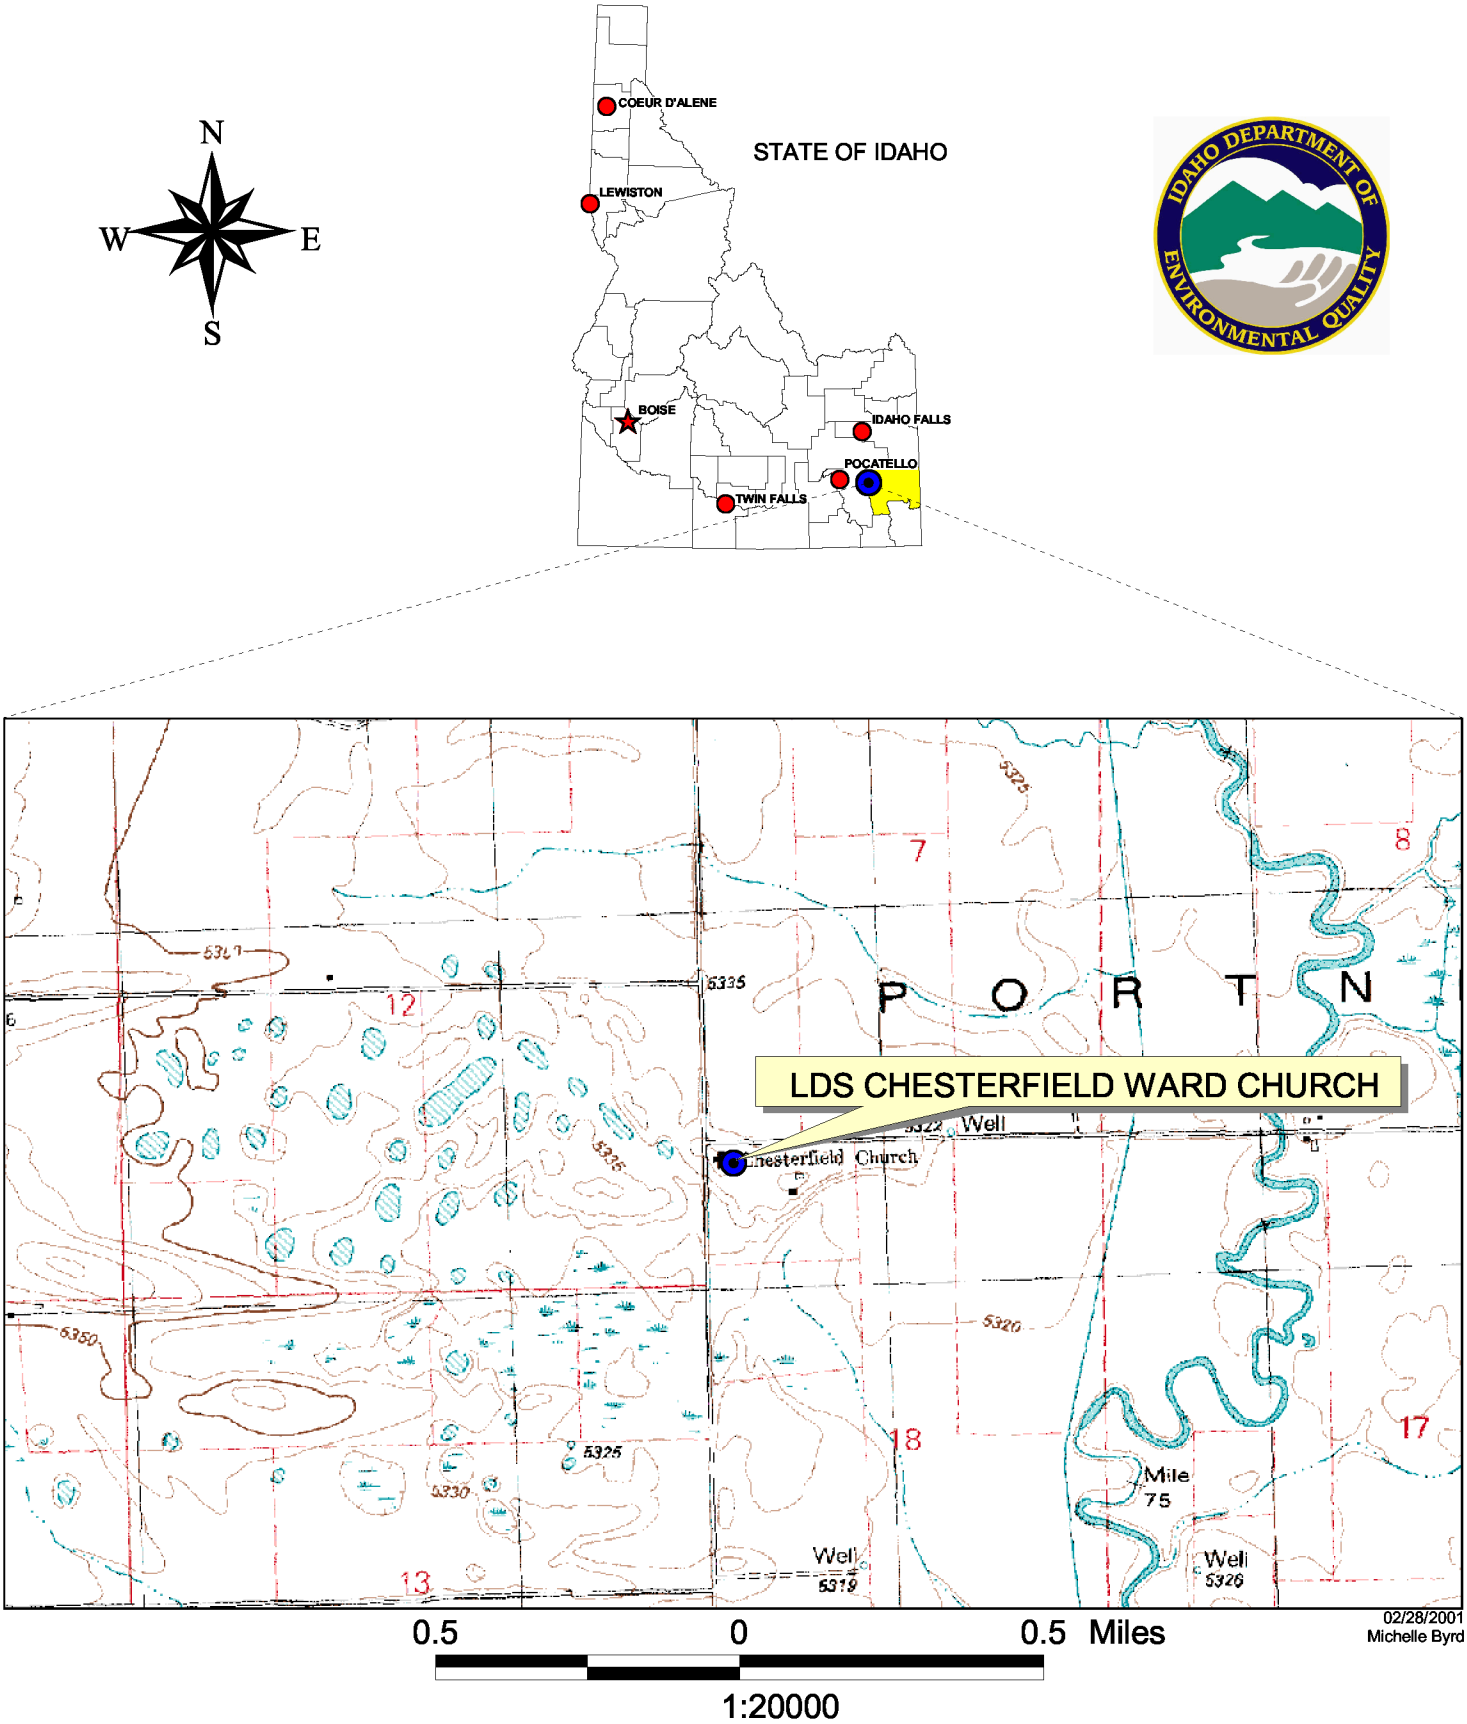
Figure 1 - Geographic Location of LDS Chesterfield Ward Church Well, Caribou County PWS Number: 6150012

The Chesterfield LDS Church drinking water system consists of one well located on the church property (Figure 1). At this time, there appears to be no primary water quality issues associated with the well source. No potential contaminant sources exist within the delineation capture zone (Figure 2).
