SEA GULL BAY YACHT CLUB (PWS 6390021)
SOURCE WATER ASSESSMENT FINAL REPORT

May 7, 2001

State of Idaho
Department of Environmental Quality

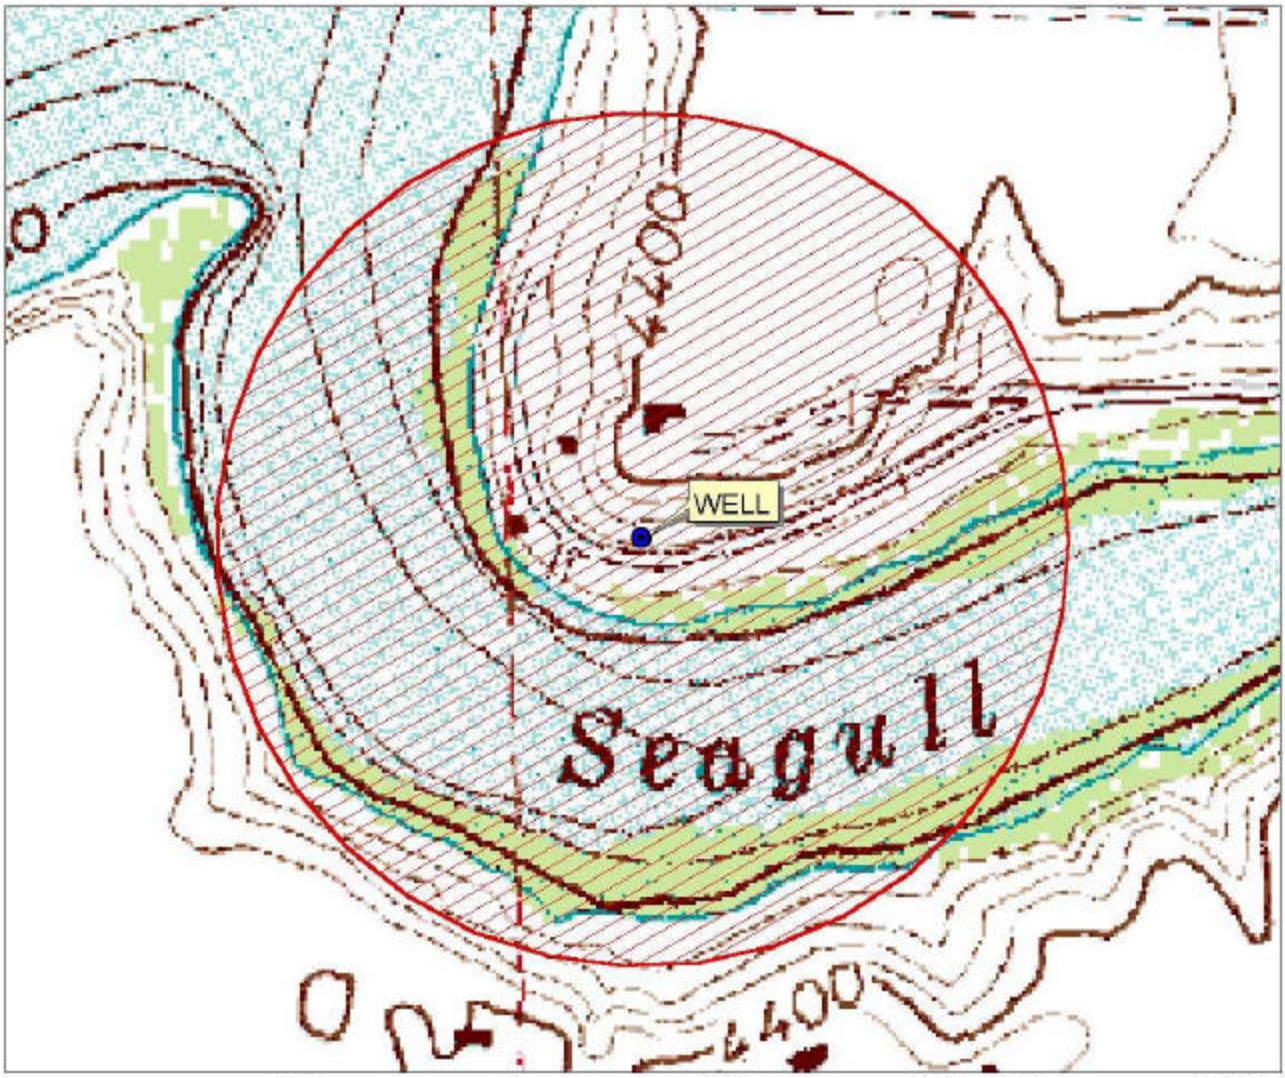
Figure 2 - Sea Gull Bay Yacht Club Well: Delineation Map
PWS Number: 6390021

The Sea Gull Bay Yacht Club drinking water system consists of one well located approximately 200 feet north of Sea Gull Bay (Figure 1). At this time, there appears to be no primary water quality issues associated with the well source. No potential contaminant sources exist within the delineation capture zone (Figure 2).
