# REMEDIAL ACTION COMPLETION REPORT
# PHASE II REMEDIAL ACTION CONSTRUCTION ACTIVITIES
# CENTRAL FARMERS FERTILIZER FACILITY
# IN GEORGETOWN CANYON, IDAHO
# for NU-WEST MINING, INC and
# NU-WEST INDUSTRIES, INC.

October 27, 2011
Prepared by:

GLOBAL ENVIRONMENTAL TECHNOLOGIES L.L.C.

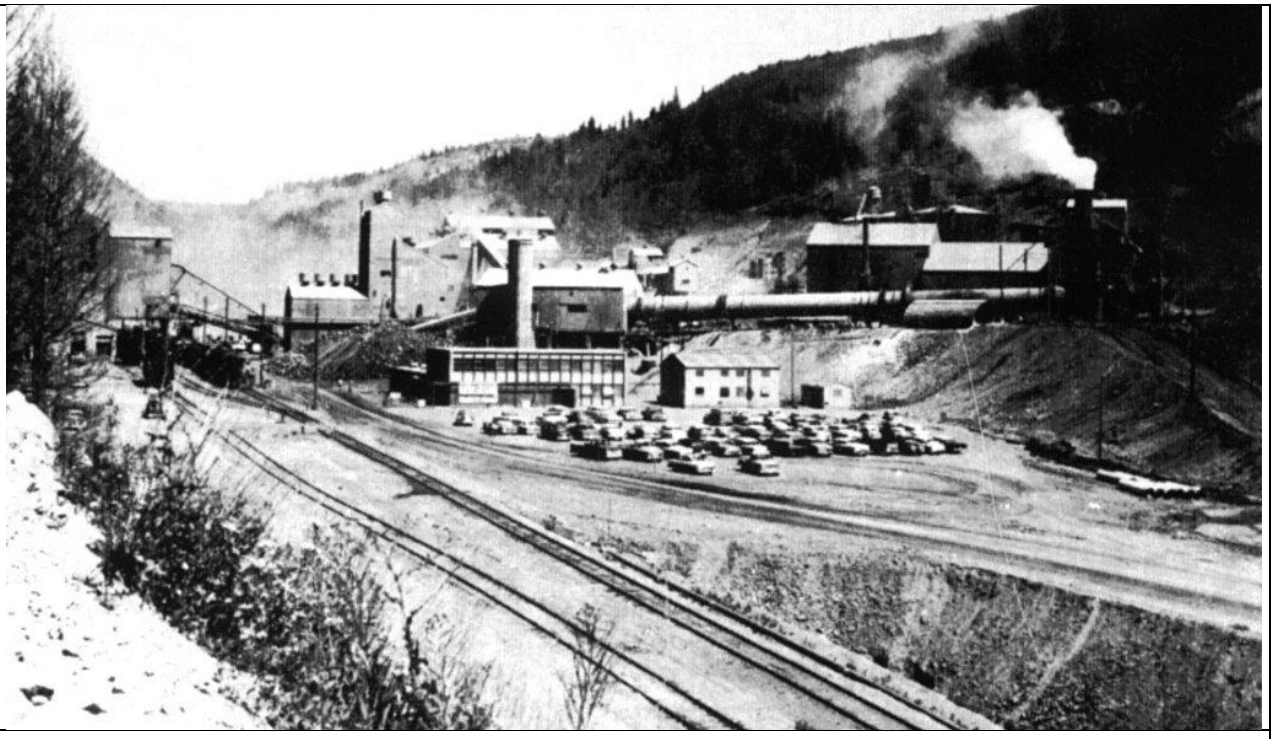
*CENTRAL FARMERS FERTILIZER FACILITY CIRCA EARLY 1960'S LOOKING NORTH-NORTHEAST- PHOTO DATE UNKNOWN - COURTESY USFS*

*POST-PHASE II CONSTRUCTION DURING RECLAMATION- SIMILAR VIEW AS ABOVE - LOOKING NORTHEAST- PHOTO DATED 10/20/10 GET LLC*

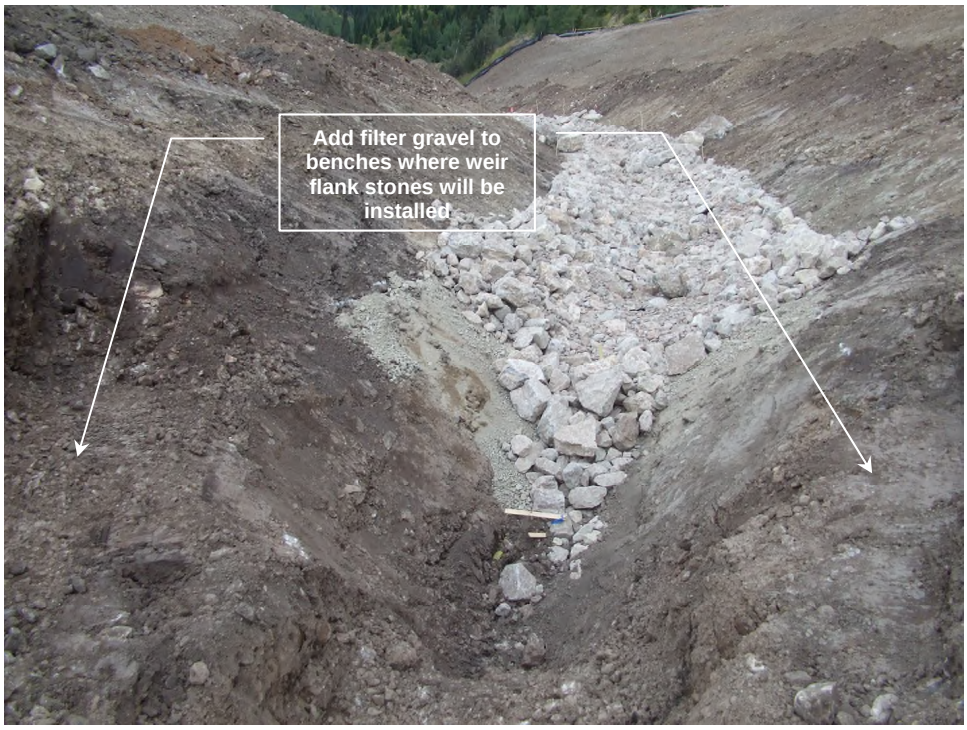
3. Maintain the channel bankfull cross-section through each weir. The four previously installed weirs had header stones that will impede flow. These header stones should be removed on the four previously installed weirs. The weir that was installed while I was on site was constructed without these additional stones. Maintaining cross-sectional capacity through the weirs will reduce the potential for the stream to erode around the ends of the weirs.

4. Make sure the large stones in each weir are touching each adjacent large stone, leaving no gaps between the stones. This will increase the strength of the weir by locking the stones together.
