# Well CM-1 Evaluation

## Craigmont, Idaho

Prepared by Joe Baldwin  
Idaho Department of Environmental Quality  
State Office  
December 2007

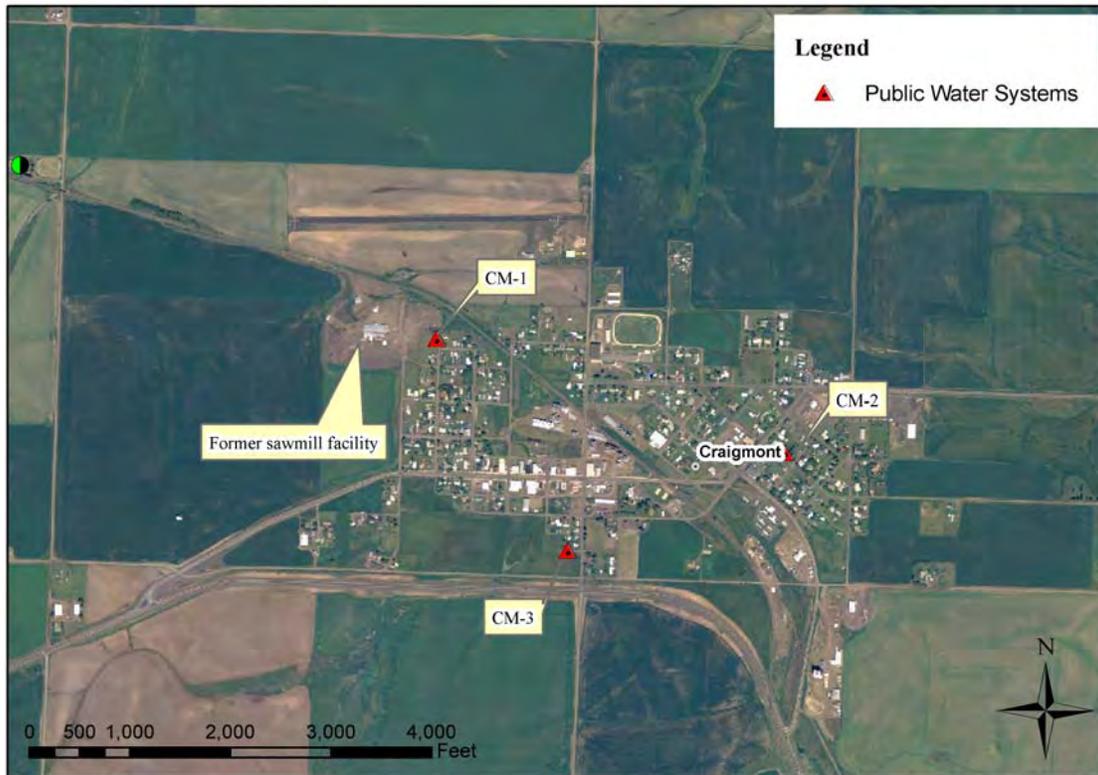
**Figure 1.** Air photo of Craigmont showing water supply wells CM-1, CM-2 and CM-3. Also shown is former sawmill facility.

An industrial facility is located approximately 500 feet west of the well (Figure 1). In the past, the facility was an operational sawmill with log decks, irrigation of the logs, and generation of wood waste. Sampling from a sawmill site in northern Idaho demonstrated that there is the potential for runoff from sawmill facilities to negatively impact ground water. Potential contaminants could include bacteria, phenols, turpenes and other constituents associated with log decks and wood waste. Petroleum contamination in soils around hydraulic equipment at sawmill sites is common and pentachlorophenol may be present in site soils if wood treatment was

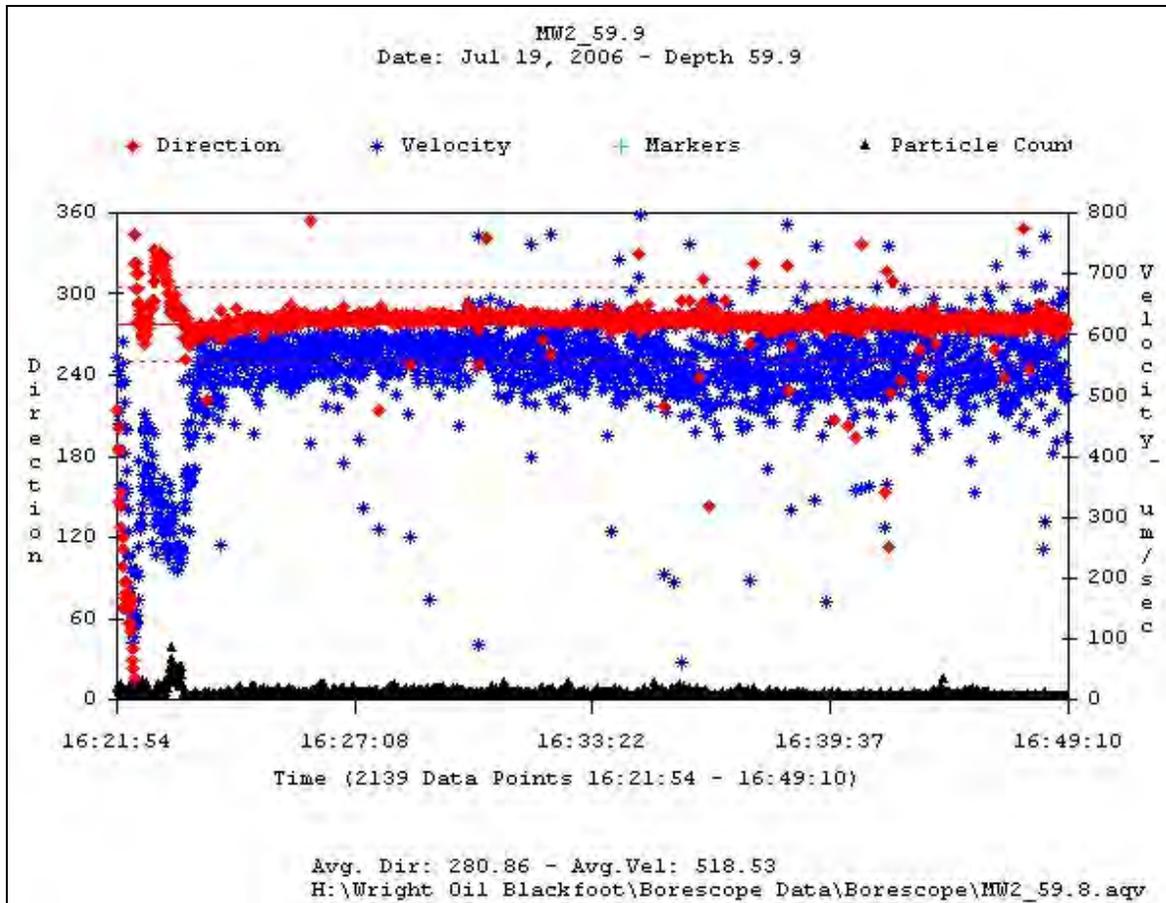
Figures 4 and 5 show the results of colloidal borescope surveys at 145 and 128 feet below land surface. No distinct flow direction and flow velocity pattern was evident at either depth, and the same was true for all other depths investigated. For comparison, Figure 6 shows an example of results from a survey in a different well that produced a distinct flow direction and flow velocity. This survey was conducted at a screened monitoring well completed in saturated sand and gravel at Blackfoot, Idaho.

**Figure 6.** Example of colloidal borescope result from a monitoring well located at Blackfoot, Idaho. The average flow direction was 280 degrees and the average velocity was about 518 micrometers/second (147 feet per day).
