# **Banner Mine Area**

## **Preliminary Assessment Report**

Boise County  
State of Idaho

**Idaho Department of  
Environmental Quality**

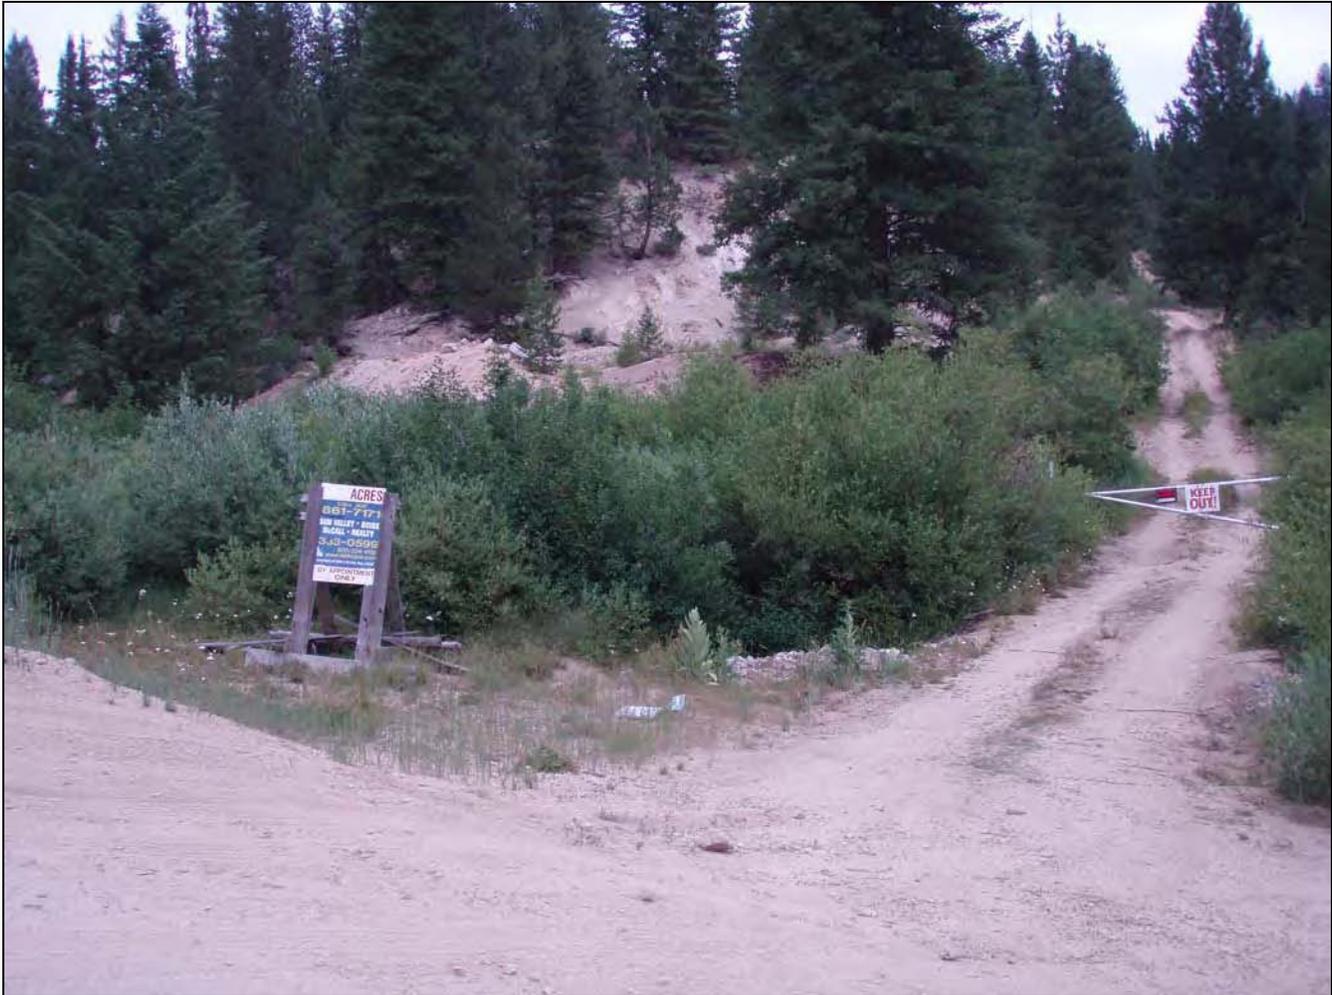
Picture 2. View to NE. Intersection of Banner Creek Road and old mill access road (gate). “For Sale” sign posted at left.

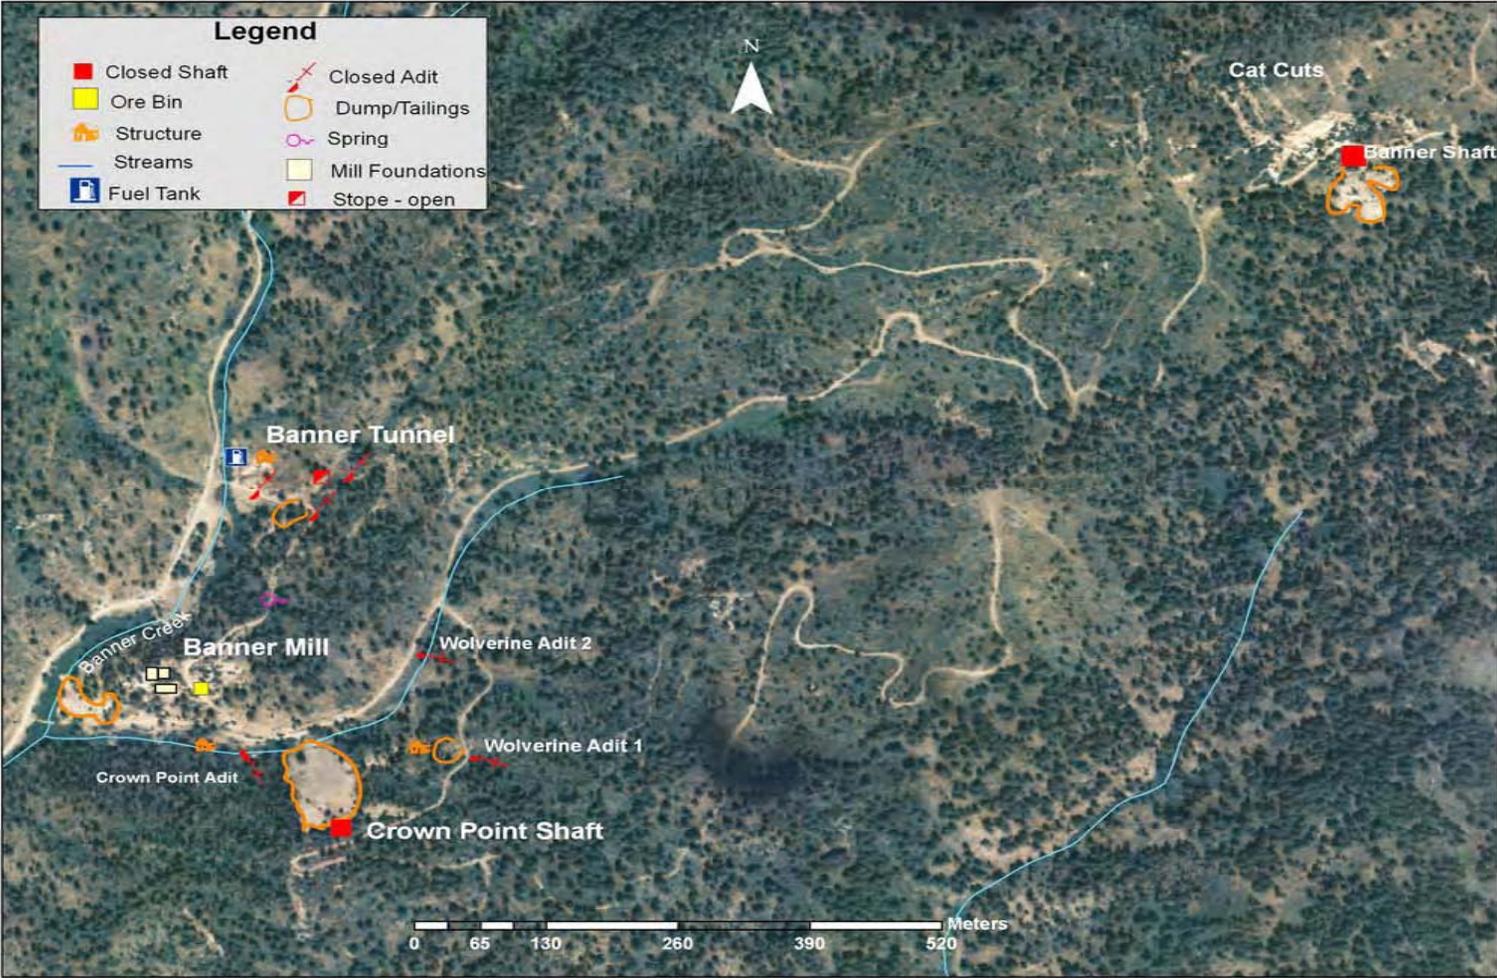
Figure 3: Banner mine workings; mill site

Based upon these accounts, the workings consist of the Banner long tunnel (approximately 3,800 feet in length), the Wolverine tunnels, the Crown Point shaft and 200 level tunnel, the Banner shaft, the Silver Chief tunnel and lesser workings such as those found at the Panamint. Bulldozer trenches were observed along the ridge on the Silver Chief and Banner claims and IDEQ presumes that numerous minor workings, "dog holes" or exploration pits lie scattered throughout the area, as well. IDEQ noted two open workings; an open stope or possible back collapse along the Banner Tunnel and the Crown Point tunnel (200-level). None of the remaining workings were observed to be open.

Concrete footings and foundations, piping, miscellaneous equipment, and tailings are all that remains of the former mill site. It appeared as though portions of the mill site were rebuilt in later years and operated on a limited basis, due to the presence of a PVC pipe network observed in the remains of one building. An adjacent concrete pad appeared to be used as a settling pond. The volume of tailings remaining within these two foundations was estimated to be <75 cubic yards. However, the nature of the milling process used by this network was not determined by IDEQ and historical accounts were not available. Tailings piles, perhaps from the 19<sup>th</sup>-century milling operations, were observed downhill from the concrete foundations along the east side of Banner Creek. These piles were estimated to contain <500 cubic yards of material. Other structures, in various stages of decay, were noted near the major workings.

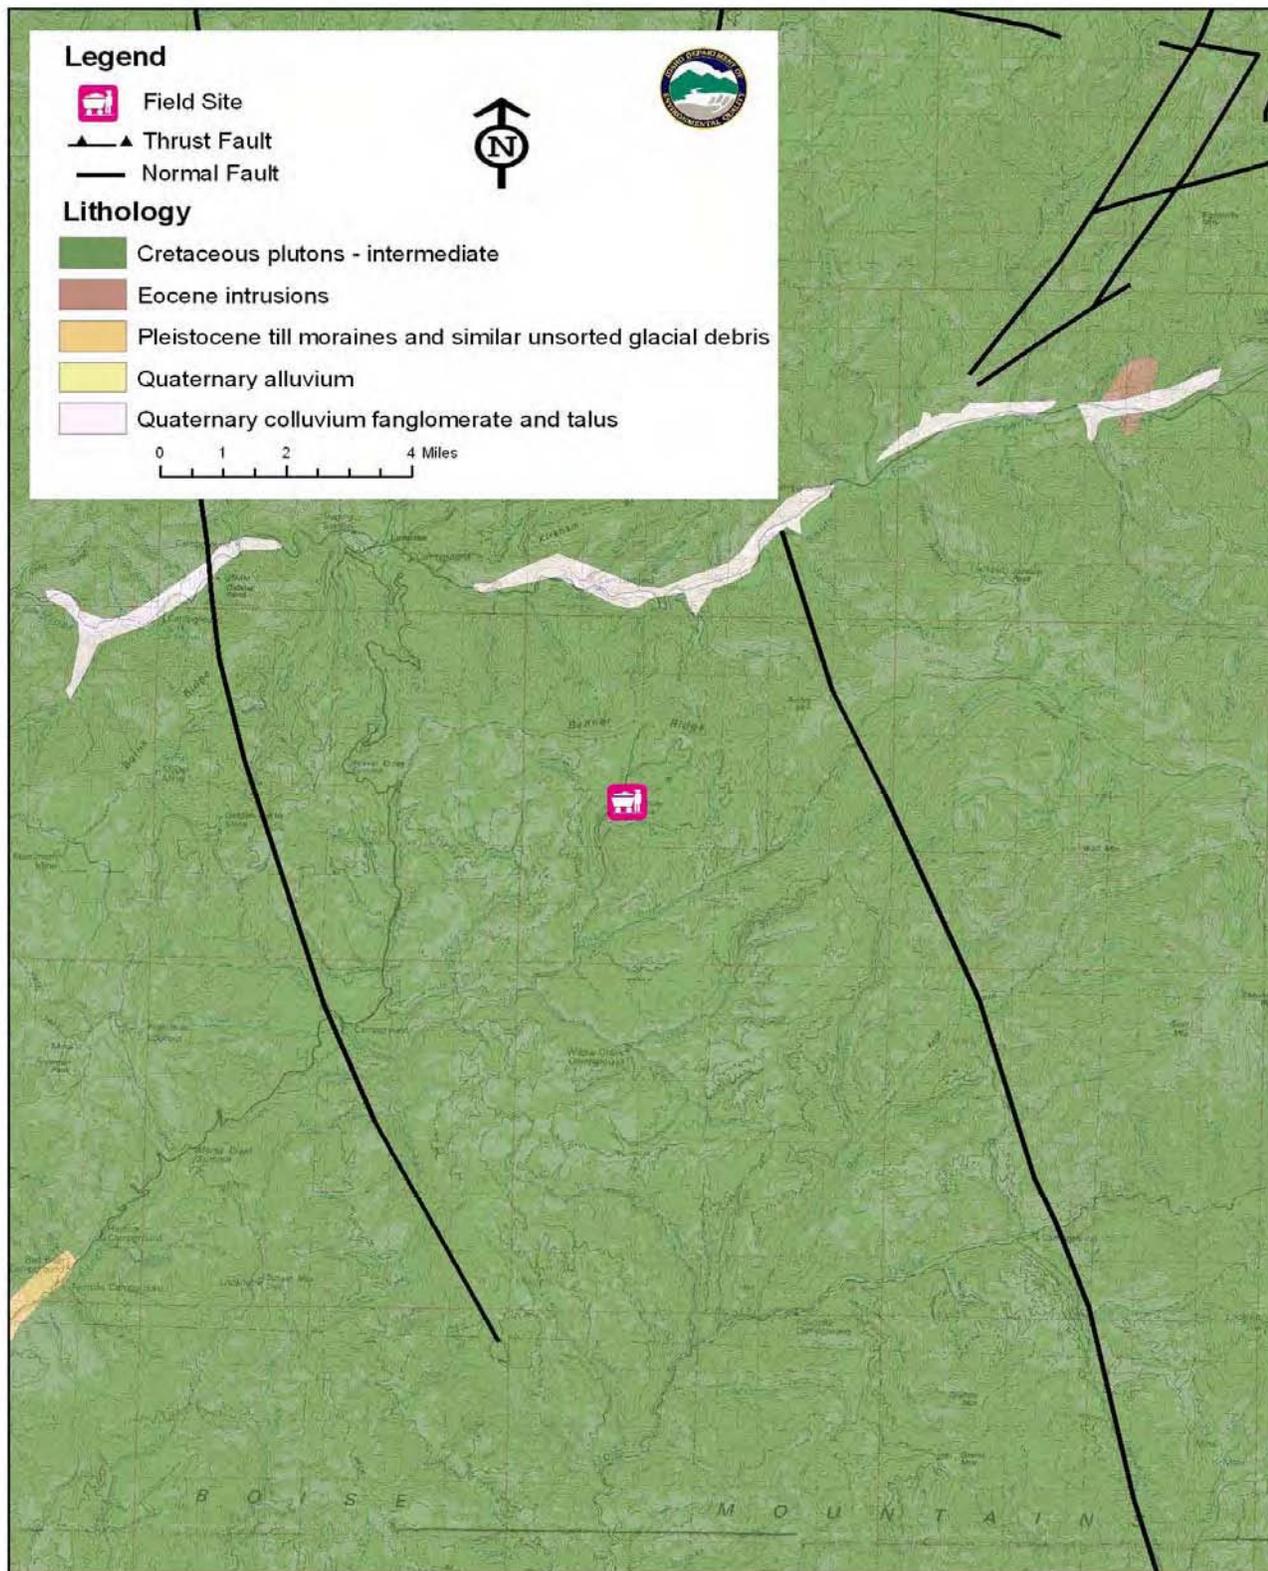
Figure 4: Lithology and Structural Geology of the Banner mine area

*The known hypogene metallic minerals in the ore include pyargyrite, proussite, owyheeite, miargyrite, tetrahedrite, galena, sphalerite, chalcopyrite, arsenopyrite, and pyrite. Of these, the pyargyrite and owyheeite are the only ones conspicuously abundant. Ruby silver comprises from one fourth to one half of the metallic minerals, pyargyrite being more abundant than proussite...The non-metallic gangue minerals include quartz and calcite. Quartz is the chief vein filling; calcite is only locally abundant. (pp. 372-376).*

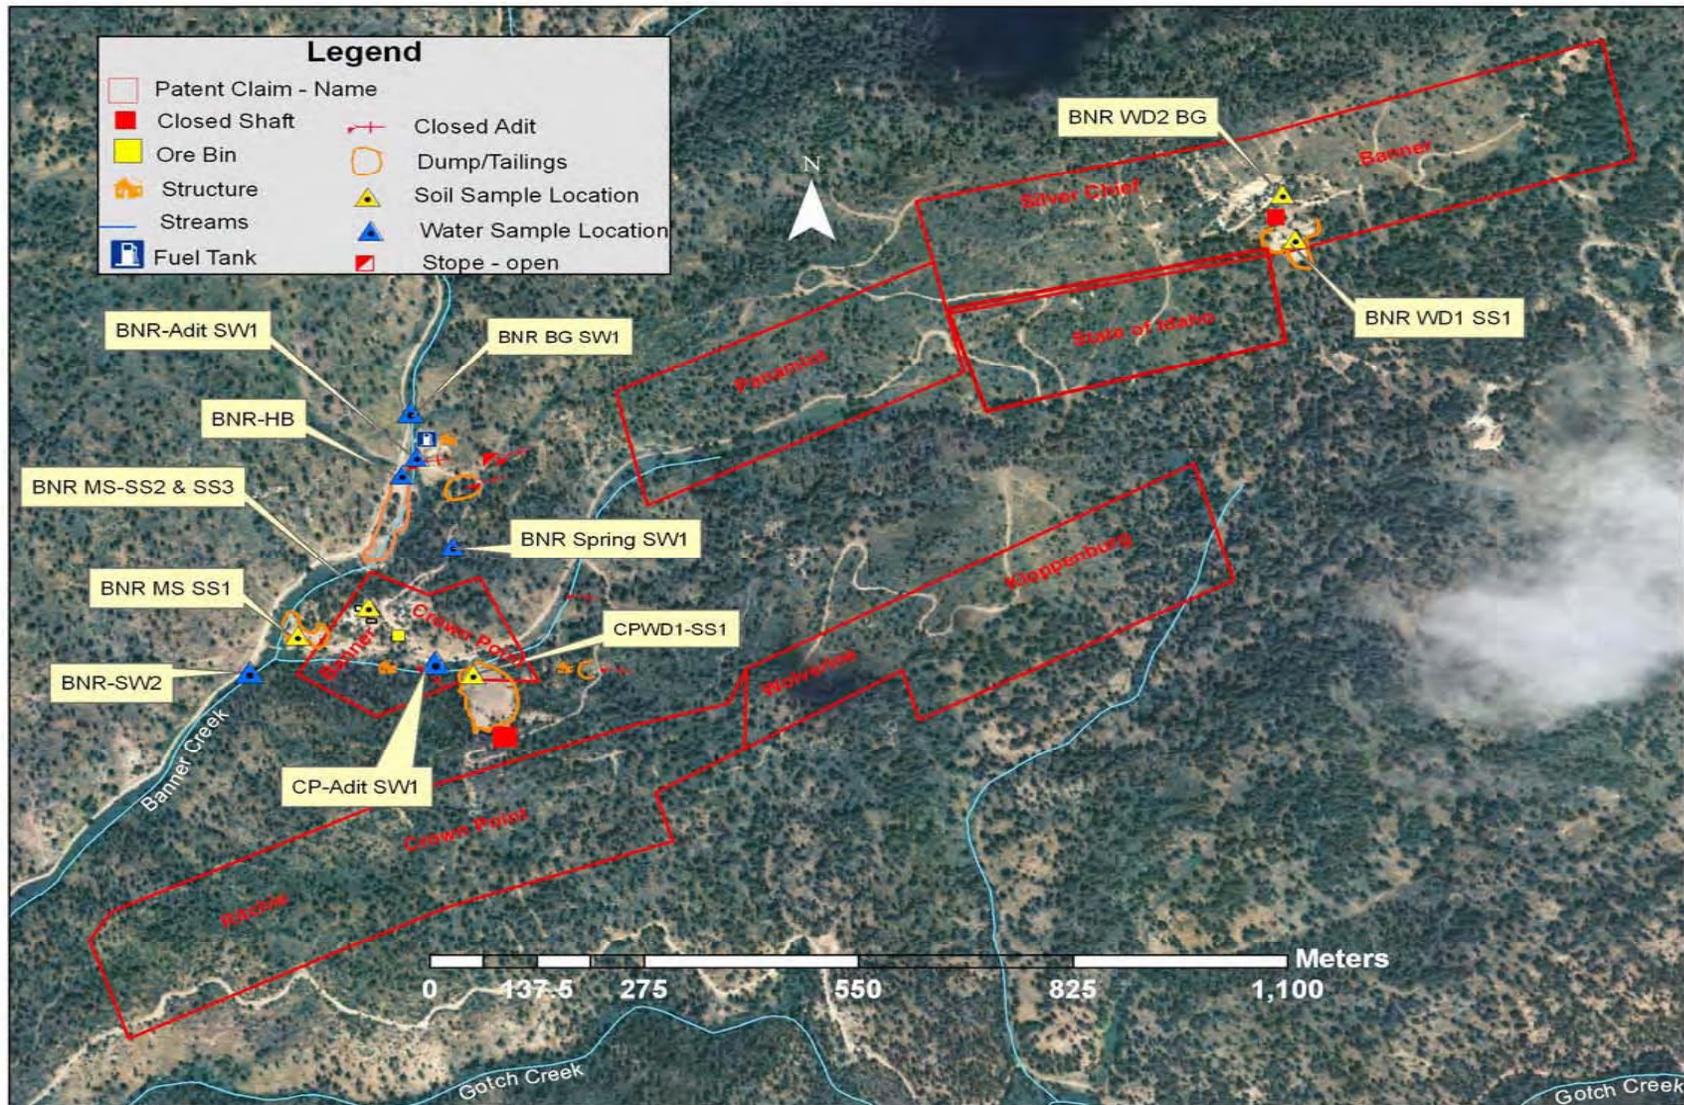
Figure 5: Sample collection locations at the Banner mine

A background water sample [Banner Creek SW1] was collected above the old Banner tunnel. A background soil sample (BNR-WD2-BG) was collected at the highest elevation encountered above the Banner shaft. Sample locations are presented in Figure 5.

IDEQ Sample Analysis of waste dump and tailings is presented in Table 1. Samples were analyzed for Total Recoverable Metals (Totals). Sample BNR-Mill-SS1 was specifically collected for TCLP analyses. In addition to IDTLs, the sample results were compared with the EPA Region 6 Human Health Medium-Specific Screening Levels (HHSL). Although HHSL values are not regulatory, they are derived from EPA guidance equations and commonly used defaults (EPA, 2007).
