**YELLOWJACKET MILL  
PRELIMINARY ASSESSMENT REPORT  
LEMHI COUNTY, IDAHO**

**STATE OF IDAHO  
DEPARTMENT OF ENVIRONMENTAL QUALITY**

December 2002

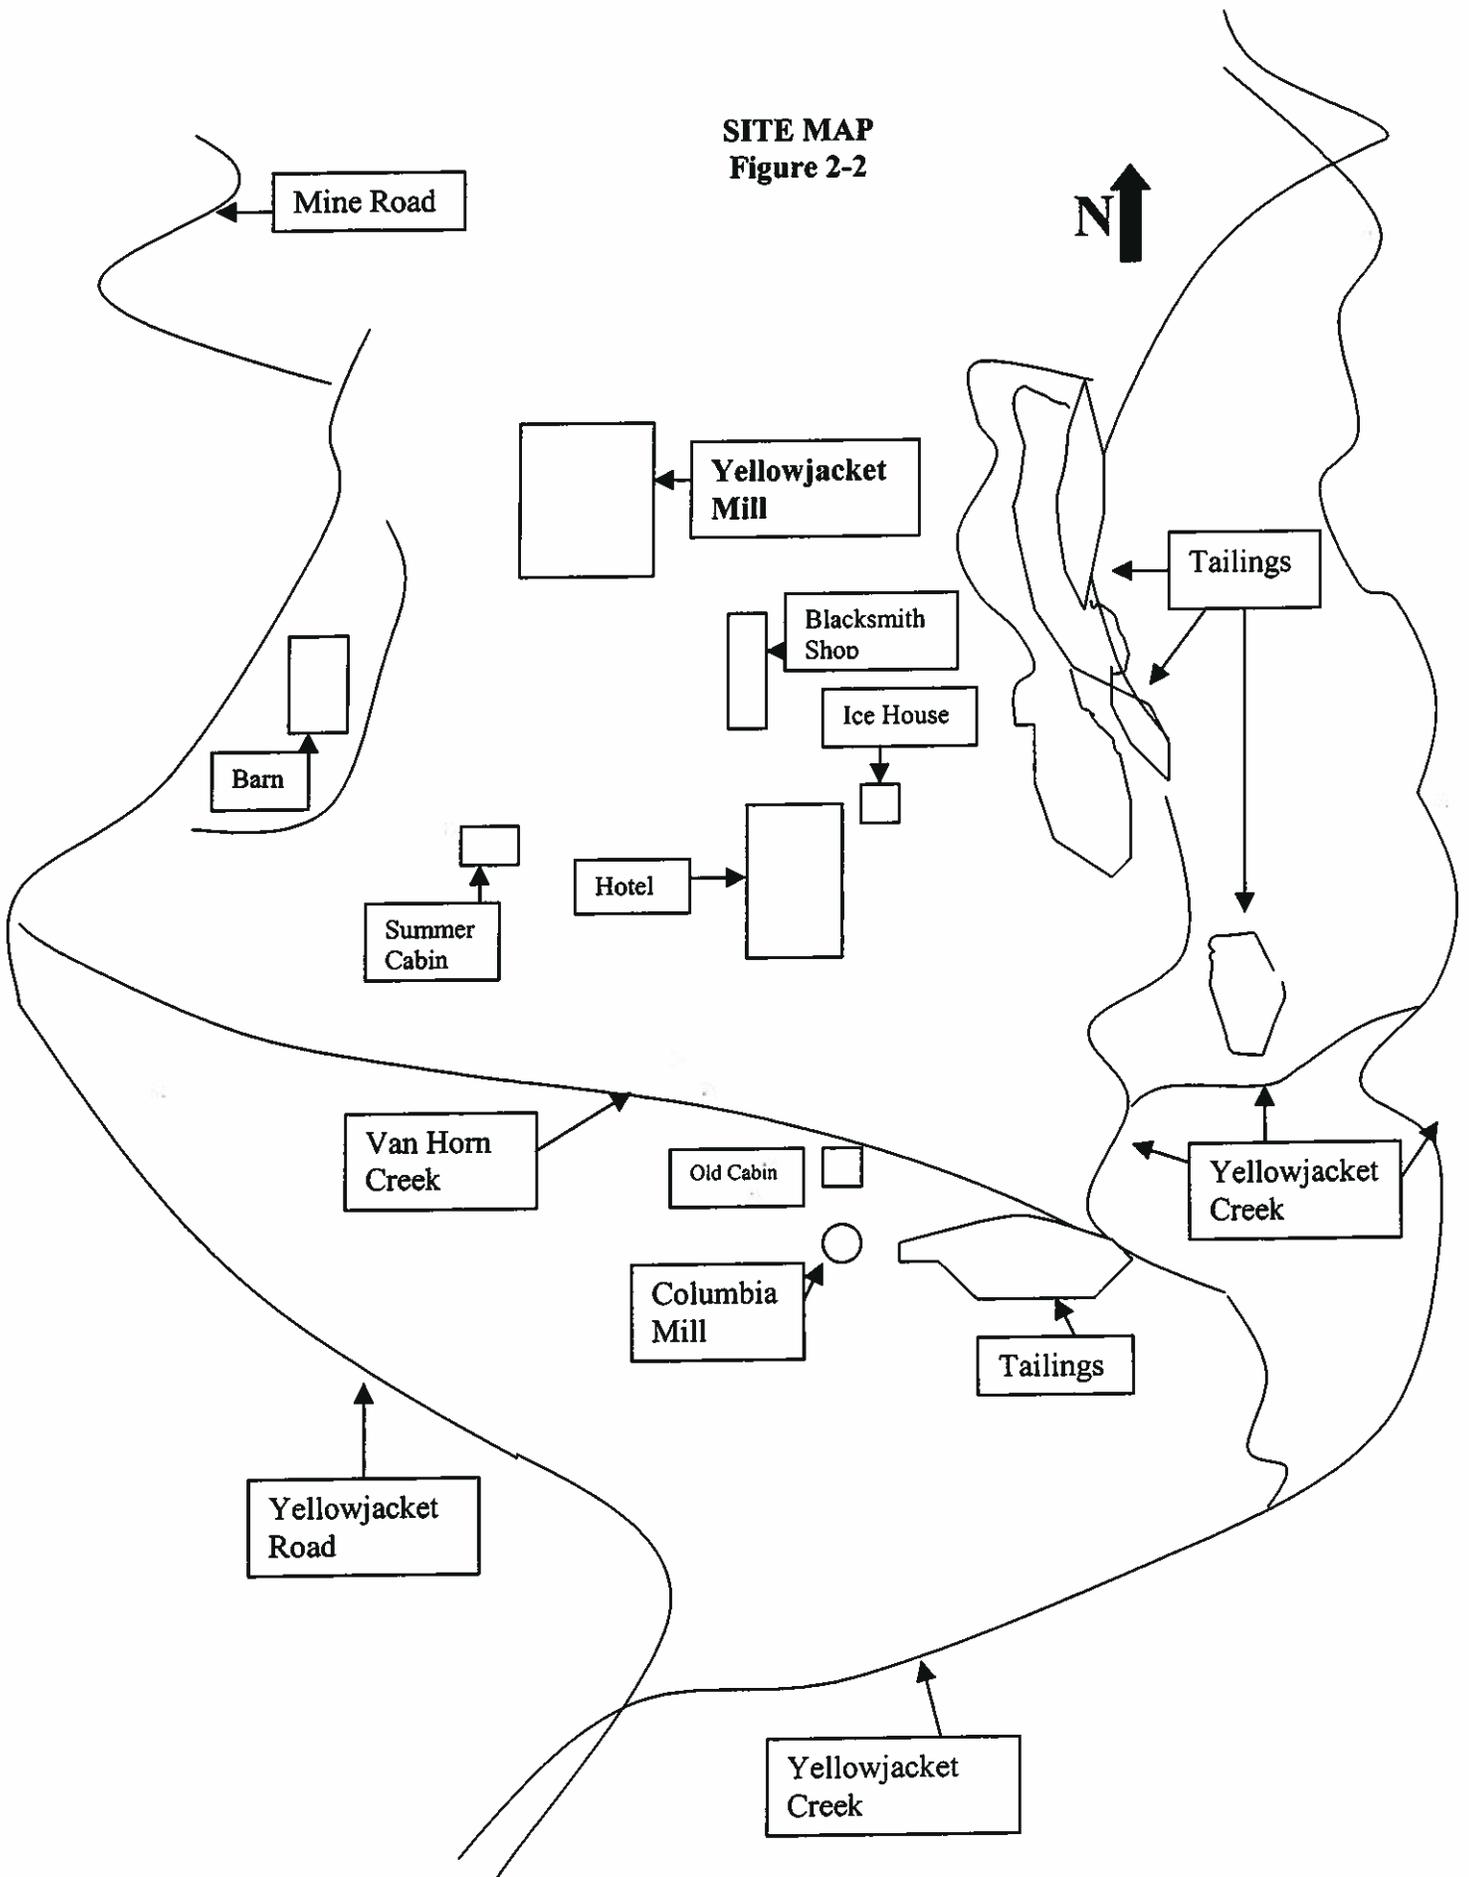
**SITE MAP**  
**Figure 2-2**

One Probable Point of Entry (PPE) is the erosion of the tailings piles by Yellowjacket Creek. Direct observation revealed the incising of the tailings by the creek. Though not observed, a second PPE could be run-off across the site into Yellowjacket Creek.
