NRCS CONSERVATION WORK

St. Joe & St. Maries Rivers
2009-2014

Prepared by: Keith Swallows
Soil Conservationist Technician
NRCS Field Office
Plummer, ID

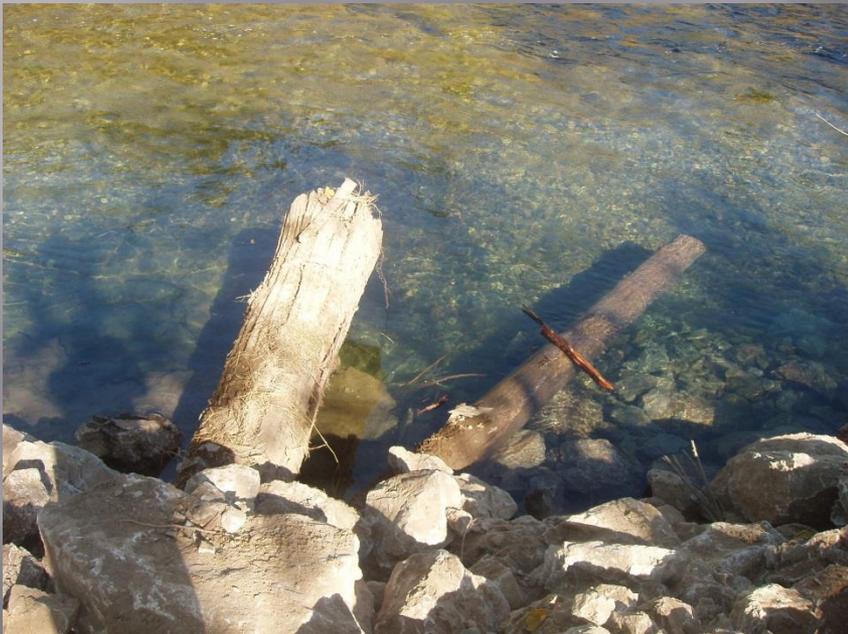
Rootwads/Logs Example

Techniques used to redirect water away from banks and provide in-stream aquatic habitat.

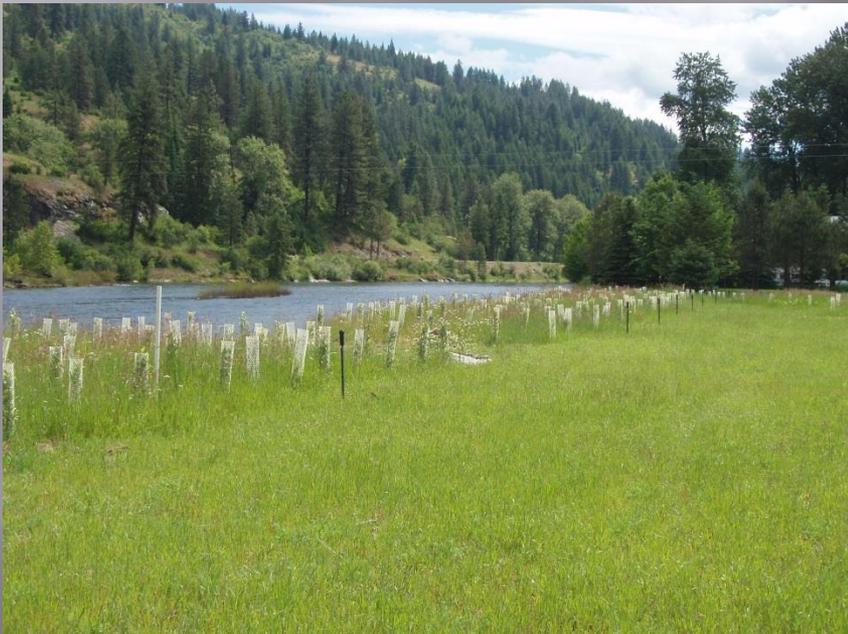
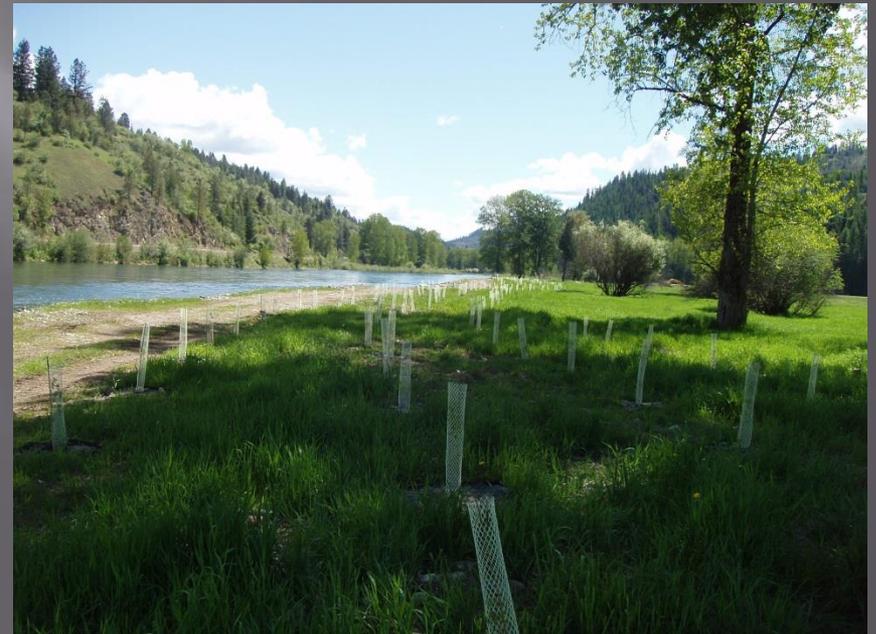
Riparian forest buffers reestablish flood plain riparian zones which will improve habitat, provide shade and help protect banks.

NRCS installed about 35 acres of riparian forest buffer along the St. Joe & St. Maries Rivers.

Planted around 300 trees/acre.
