QUARTZBURG  
PRELIMINARY ASSESSMENT REPORT  
BOISE COUNTY, IDAHO

**STATE OF IDAHO**  
**DEPARTMENT OF ENVIRONMENTAL QUALITY**

September 2004

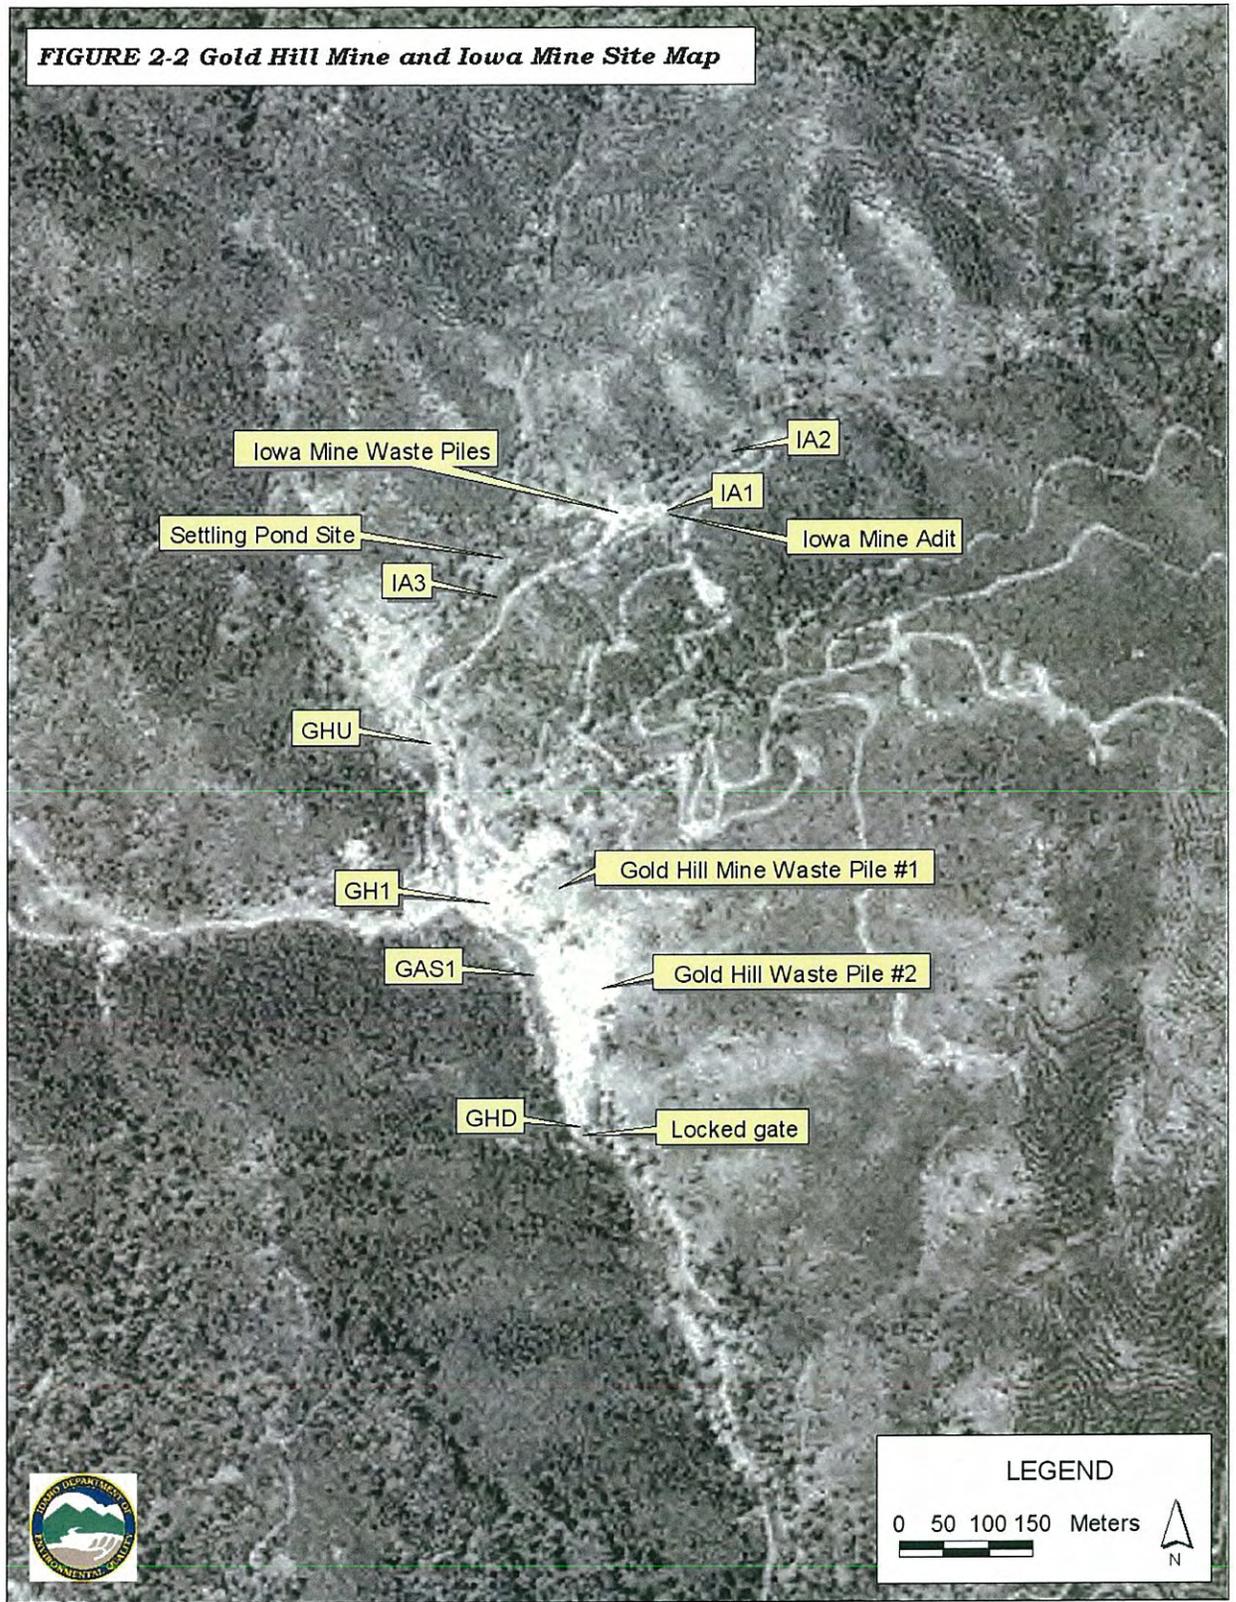
FIGURE 2-2

Ground water was observed seeping from the abandoned adit of the Iowa Mine (Pictures 14 and 15). Water sample IA1 was collected at this point (Figure 2-2). The ground water discharged along the access road where it flowed to the west towards Granite Creek. In between the discharge point and Granite Creek, a marshy wetland that resembled a previous tailing pond collected water before it continued to flow into Granite Creek. Water samples were collected upgradient from the spring (Sample #IA2) and downgradient of the retention pond (Sample #IA3).

A water sample was collected downgradient of all of the mining activity in Granite Creek (Sample #GHD) to investigate the overall impacts of all of the mining activity at Quartzburg. Figure 2-2 shows sampling locations for all samples collected during the site visit and Appendix B summarizes the analytical results.

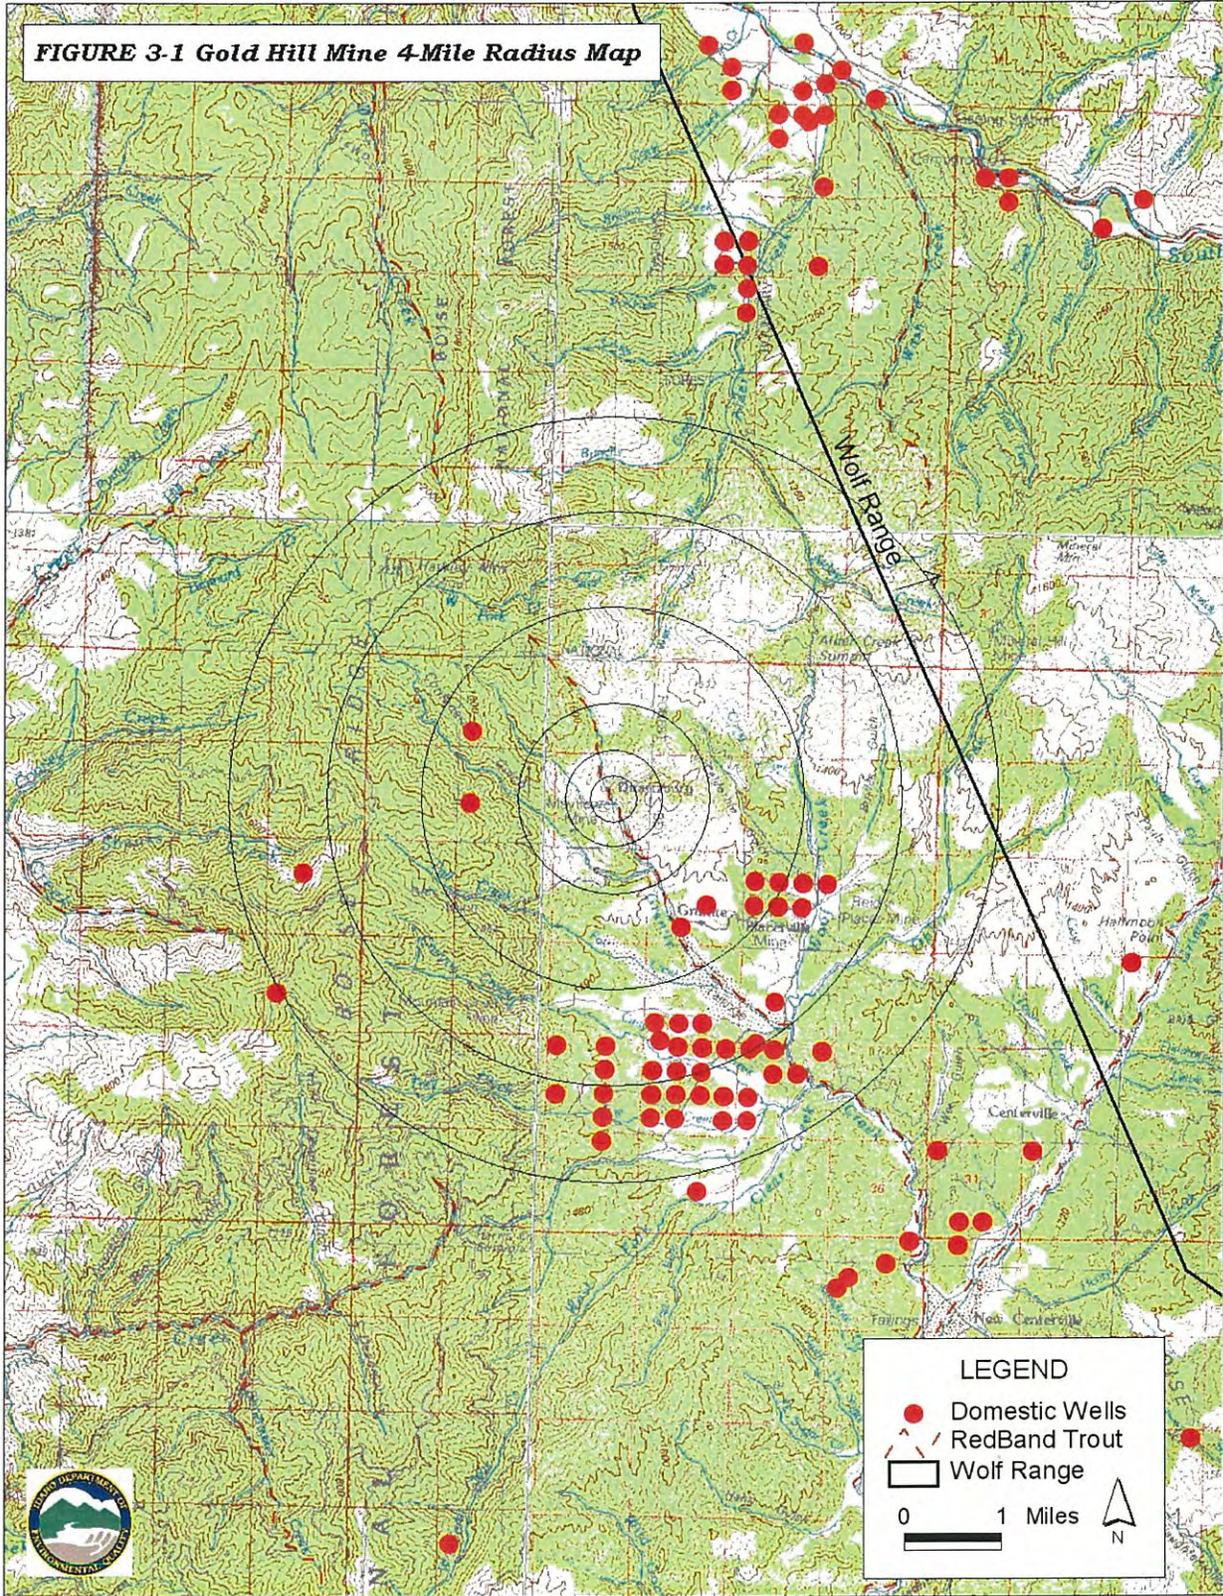
FIGURE 3-1

According to Idaho Department of Water Resources July 2002 records, 81 private drinking water wells are reported to be located within a 4-mile radius of the site. No public drinking water systems are located within a 4-mile radius of the site (Figure 3-1).

No plant species in the area were listed as a species of concern (F&G, 2002) within a 4-mile radius of Quartzburg (Figure 3-1).
