**COLUMBIA MILL
PRELIMINARY ASSESSMENT REPORT
LEMHI, IDAHO**

**STATE OF IDAHO
DEPARTMENT OF ENVIRONMENTAL QUALITY**

December 2002

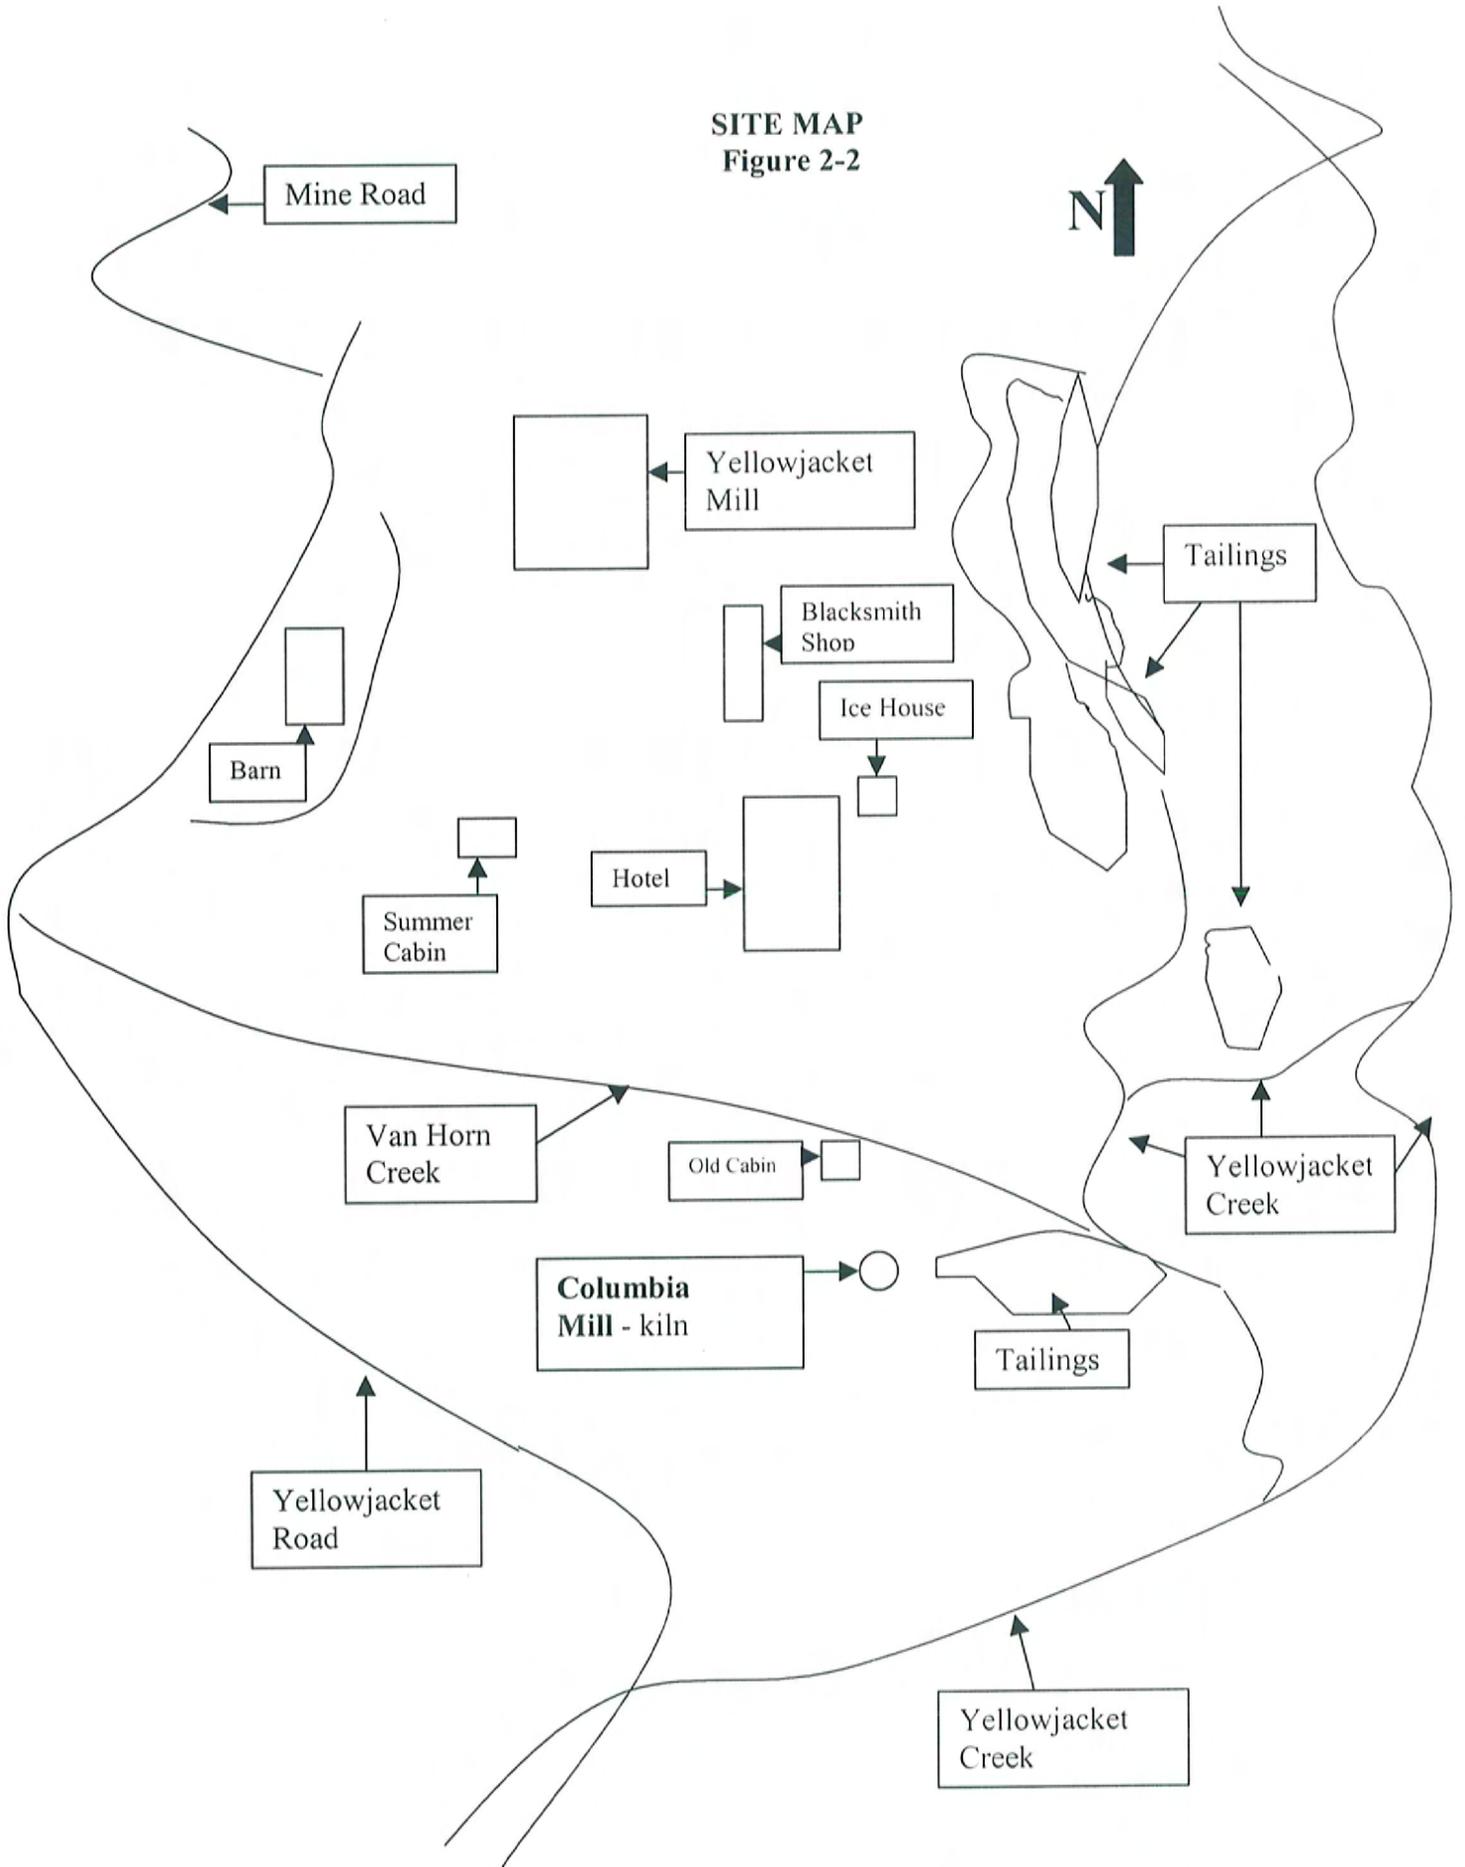
SITE MAP
Figure 2-2

DEQ collected a composite soil sample from the tailings pile located adjacent to the creek (Appendix B). The creek appears to be eroding the old tailings, but discoloration of the water or creek bed is not evident.
