**ABANDONED MINE
SITE INVESTIGATION
OF THE
IDORA MINE SITE
ALONG
BEAVER CREEK
IDAHO**

U.S. Army Corps of Engineers, Sacramento District and
U.S. Army Corps of Engineers, Omaha District

Bitterroot Restoration, Inc.
445 Quast Lane
Corvallis, MT 59828

July 23, 2003

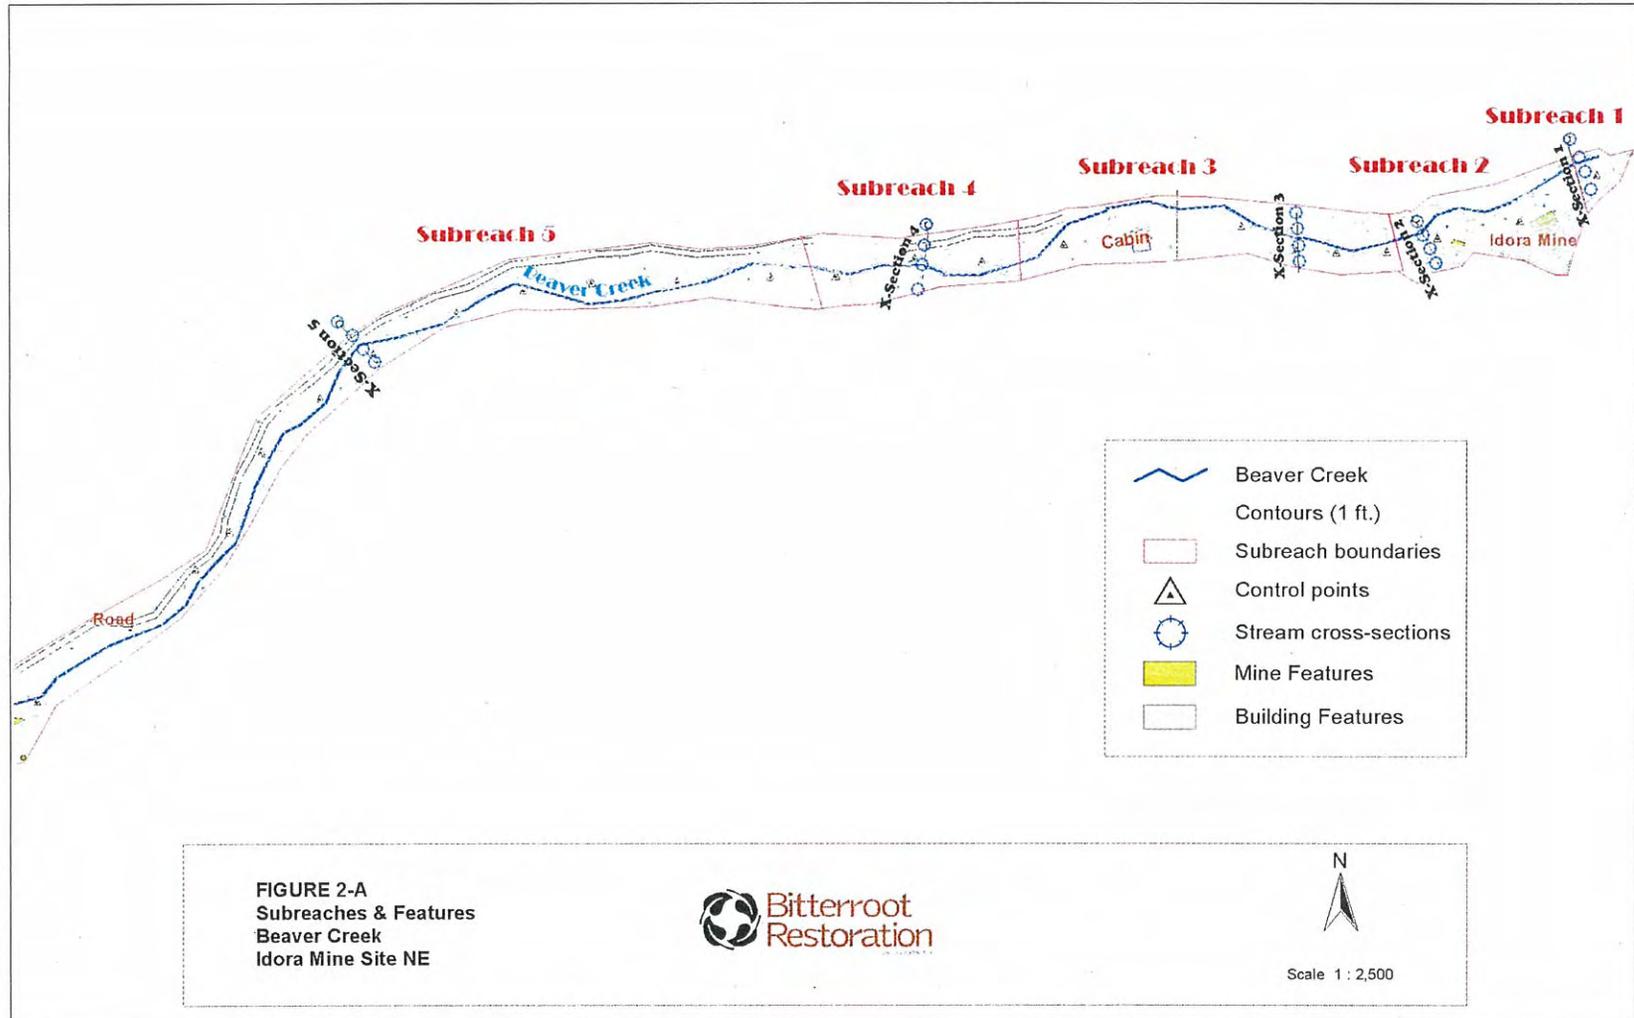
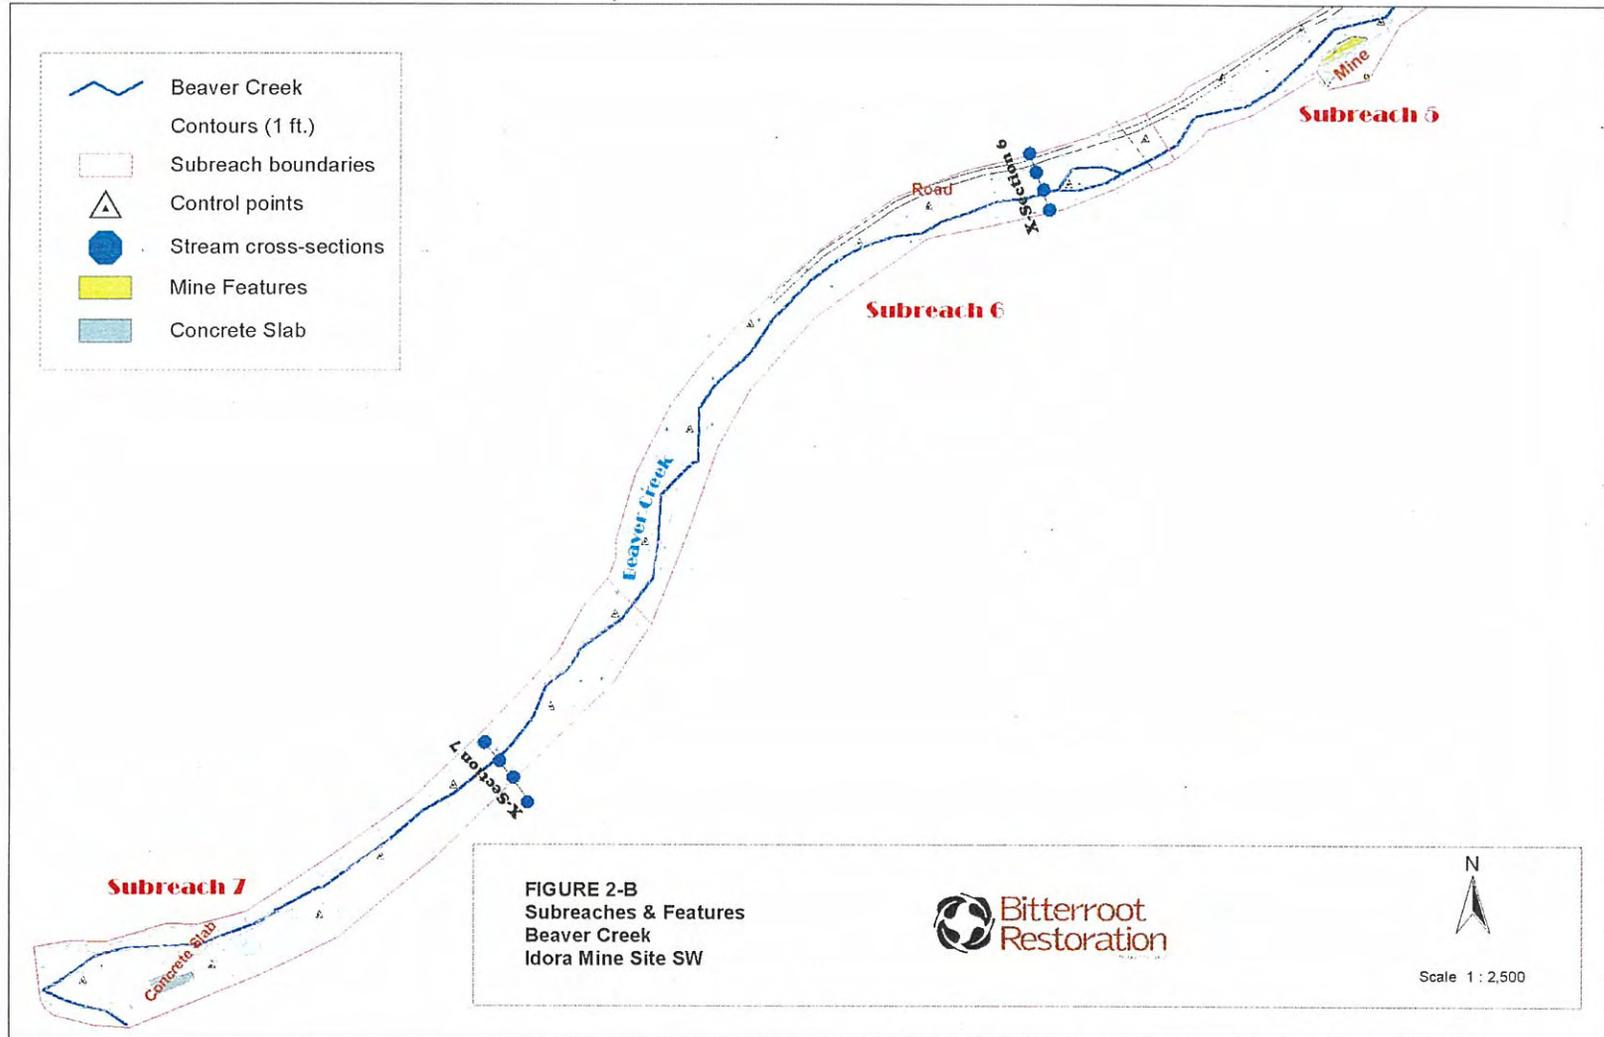
Figure 2-A.

In addition to boundary determinations, seven hydrologic subreaches (displayed in Figures 2-A and 2-B) were delineated across the injured area. Subreach boundaries were based upon hydrologic and geomorphic changes within the stream channel, as well as distinct changes in mine waste deposition. Subreaches are described below sequentially from the top (highest elevation) boundary on Beaver Creek to the lower boundary at the confluence of Beaver and Carbon Creeks.

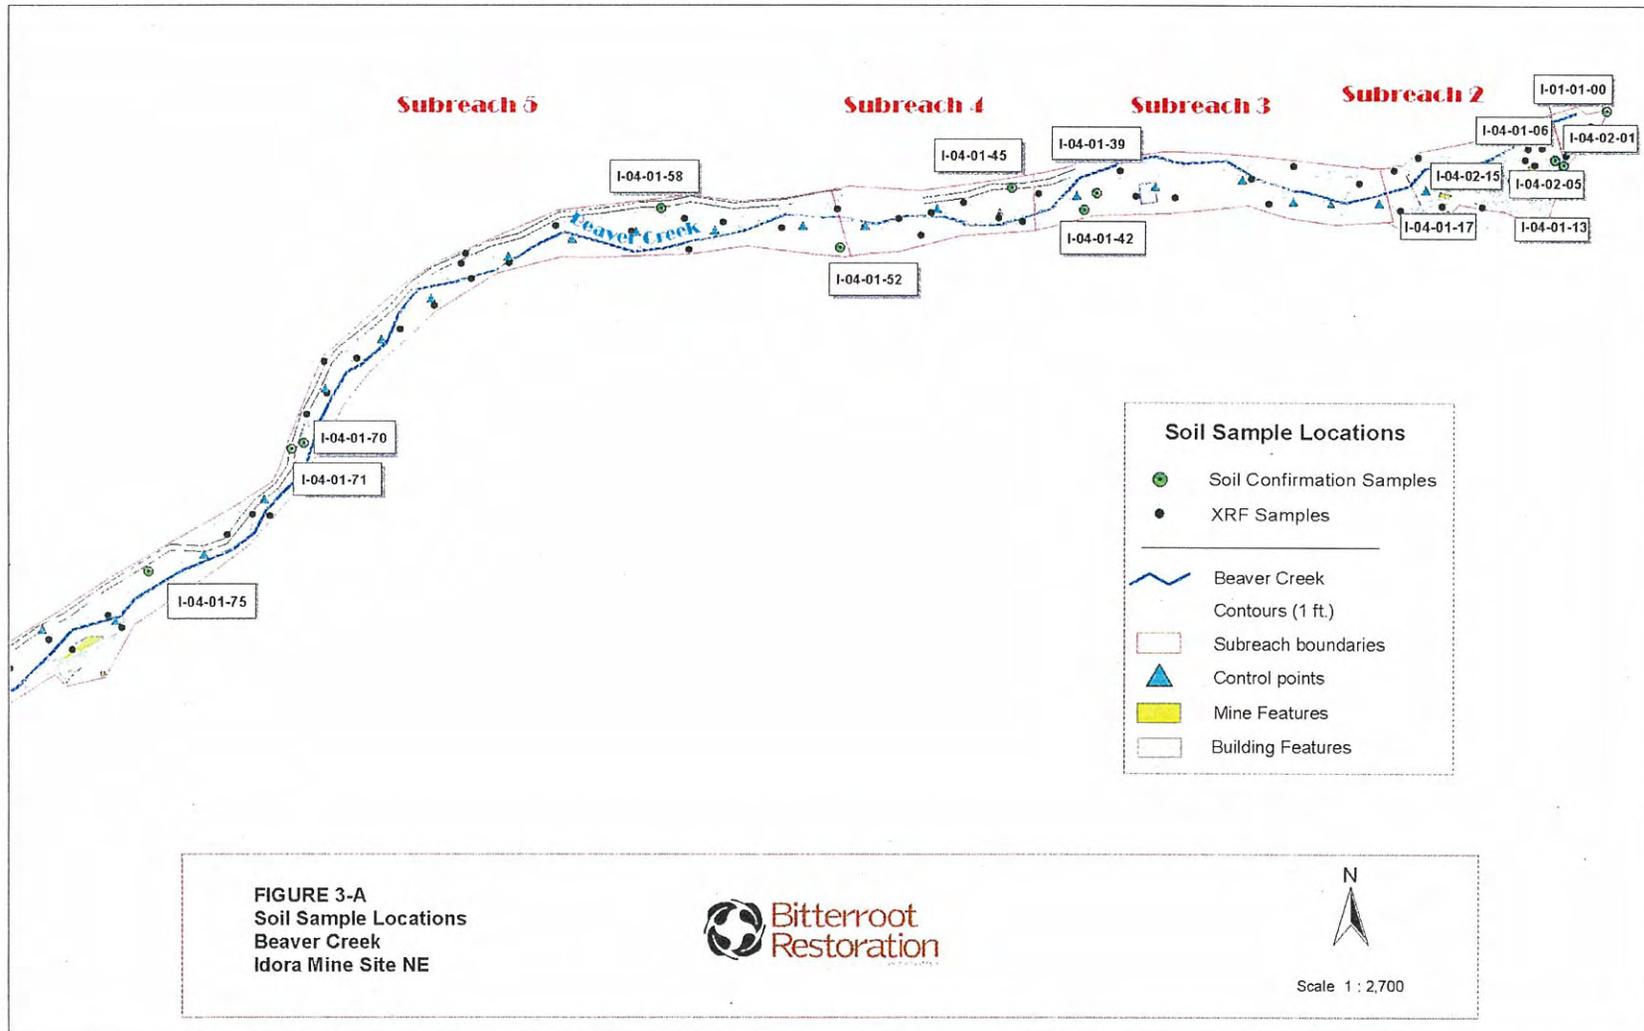
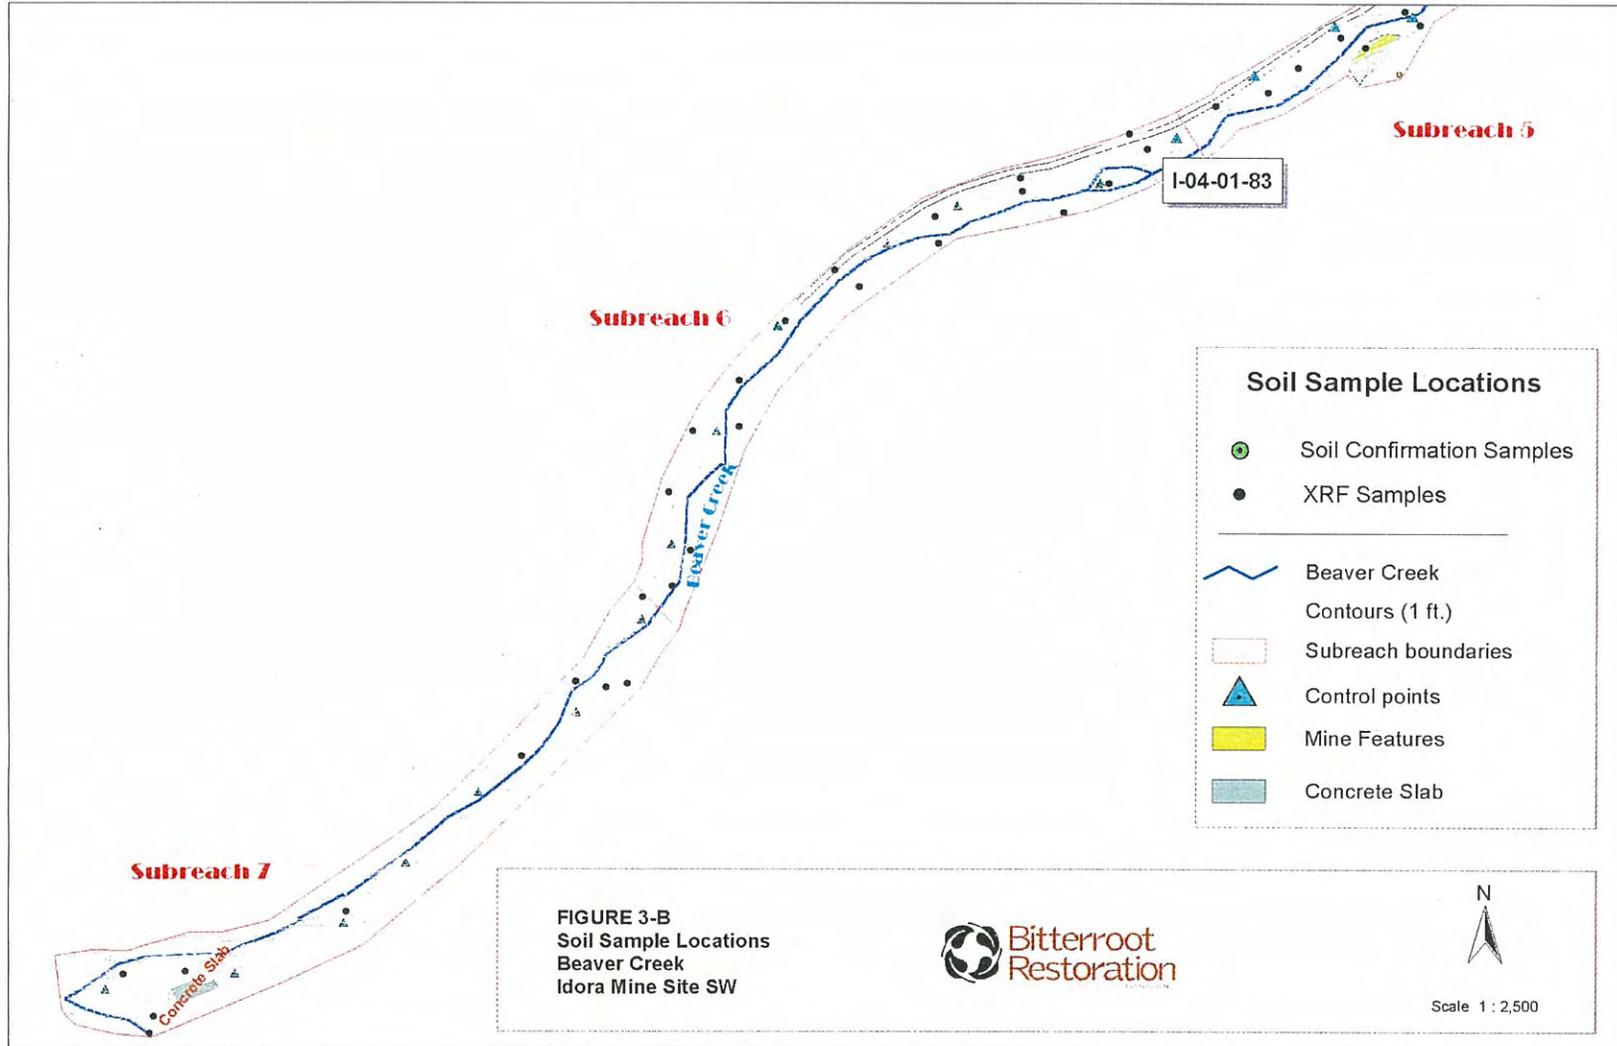
Figure 3-A.

The sampling locations were situated on and around mine waste tailings piles, as well as in areas adjacent to mine waste materials, such as surface soils in places exposed to runoff/erosion from waste areas and/or soils beneath waste piles. The sampling sites, located at cross-sections along the contaminated stream, were designed to determine the types and amounts of contamination. For the most part, sampling locations were evenly distributed throughout the site. Samples were extracted to a maximum depth of one meter (39.4 inches). The samples were composited by mixing them in a clean container (a new heavy gauge plastic “trash compactor” bag for each sample, lining a five-gallon plastic bucket). Sample locations are displayed on maps in Figures 3-A and 3-B.

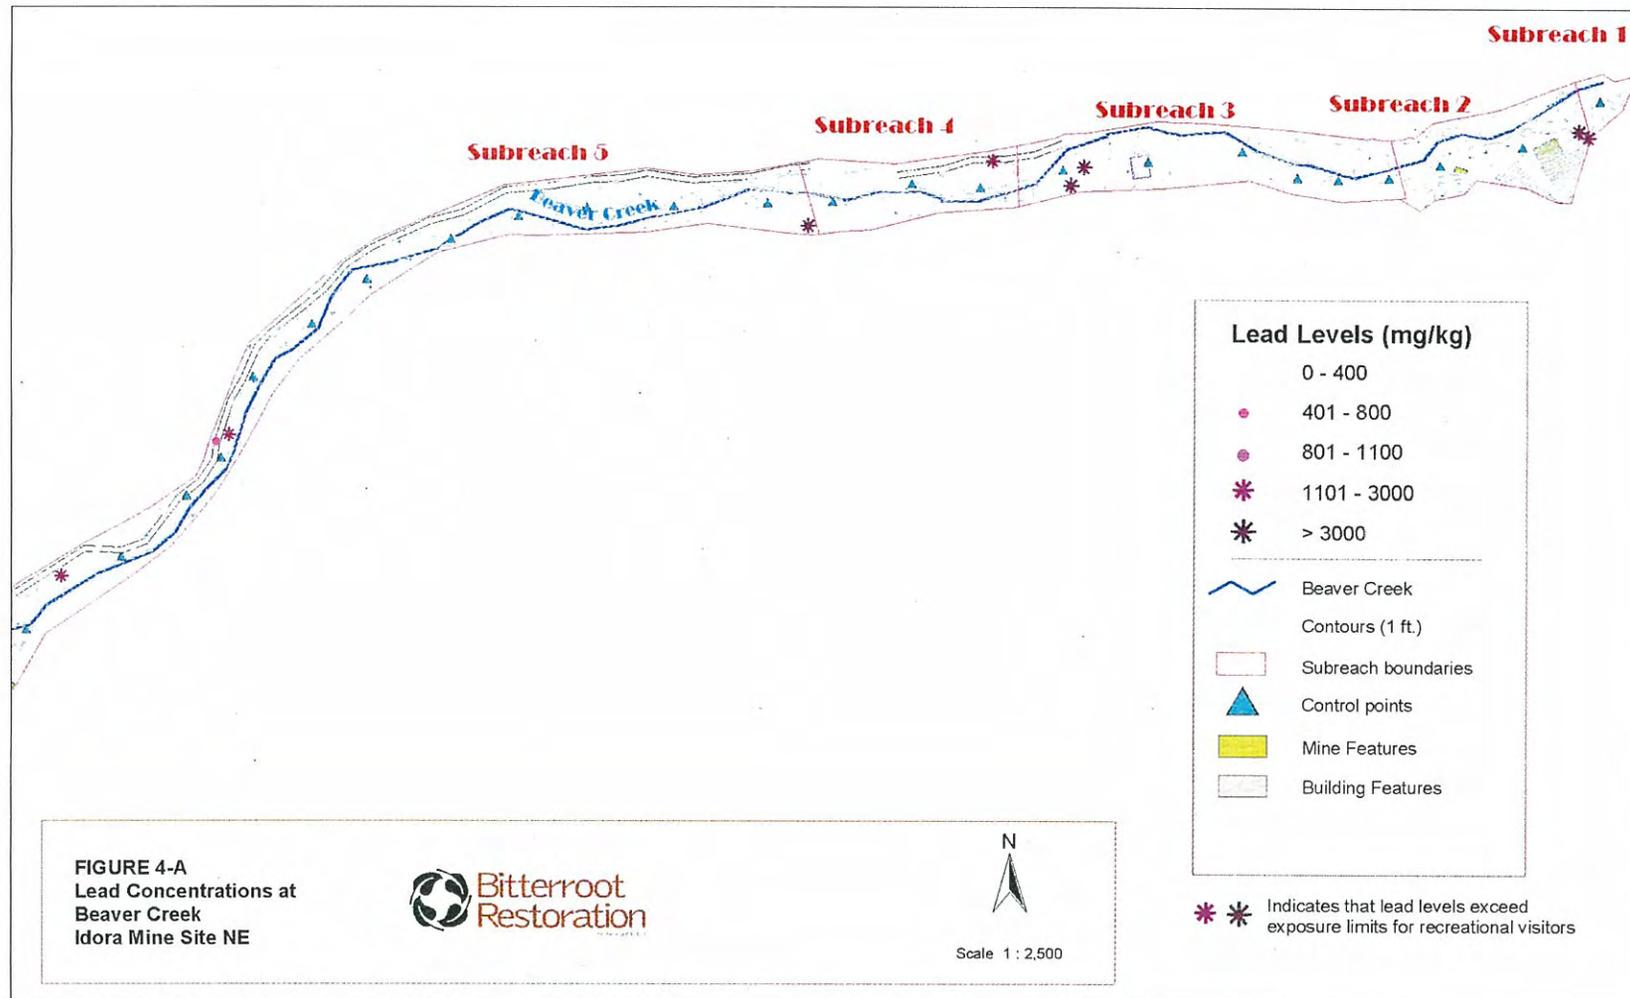
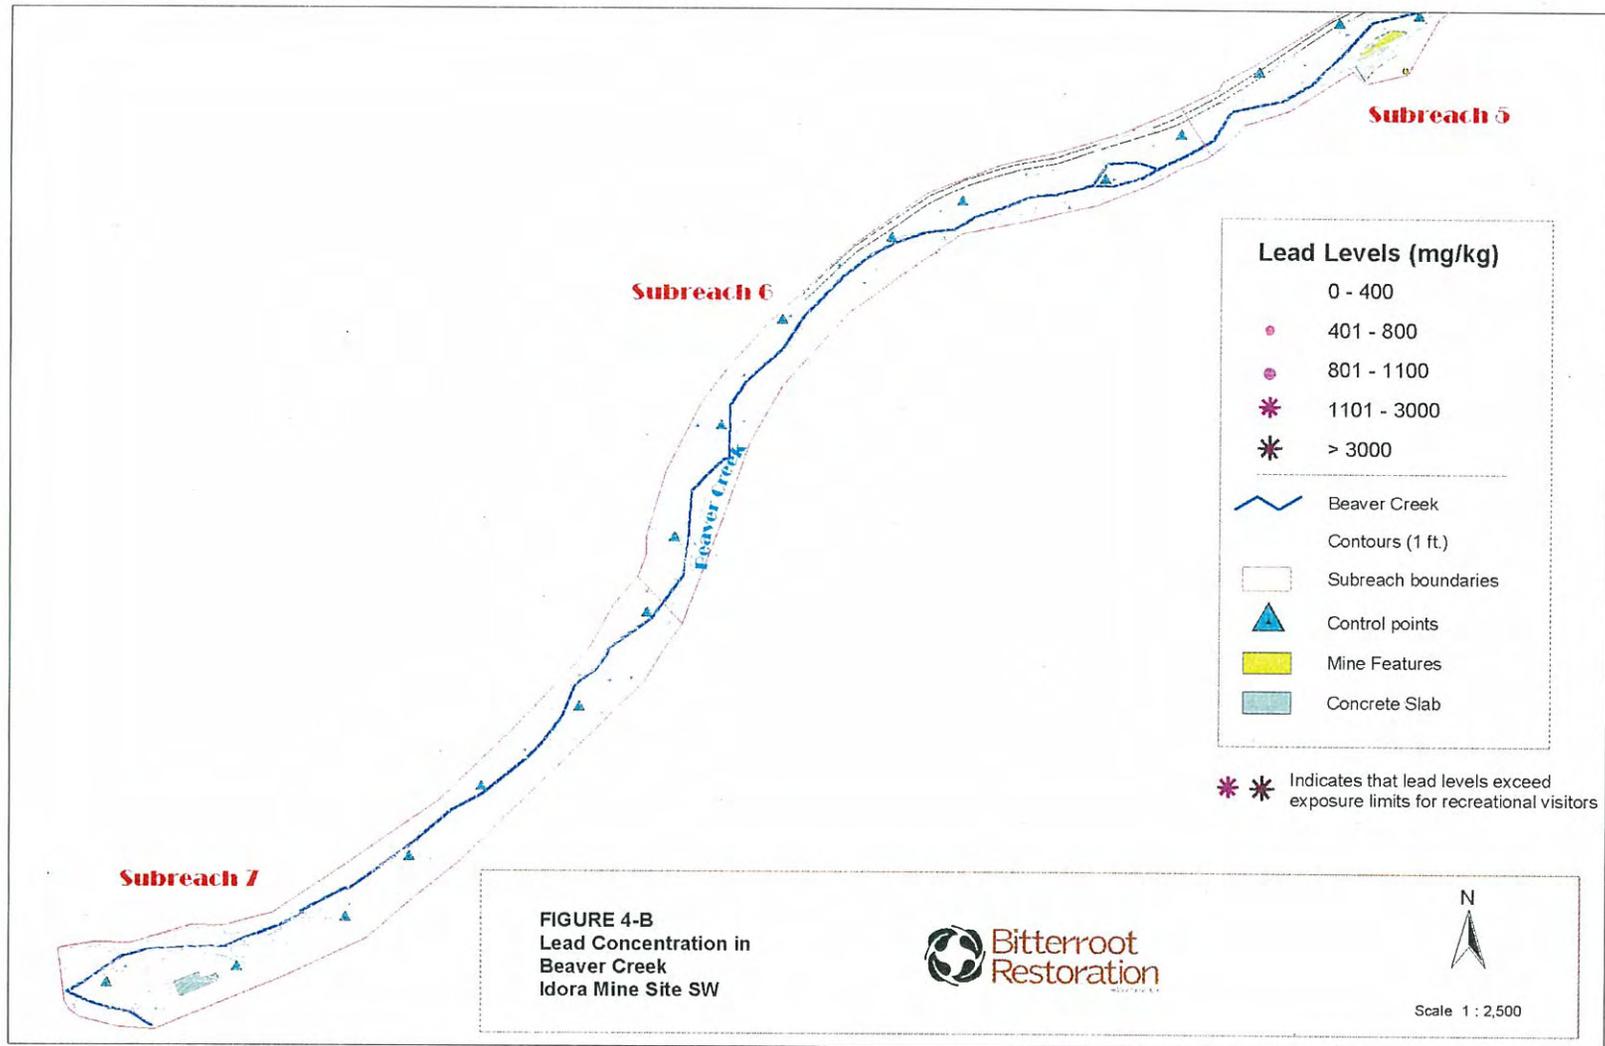
Figure 4-B.

Table 7.1 and Figures 4-A and 4-B present total metal concentrations statistics for the soil/mine waste samples collected from the Idora Mine project site, as analyzed by field XRF. The XRF trends for the trace elements follow the results of the ICP analyses, with lead having the greatest percentage of samples above the COPC limits for recreational visitors.

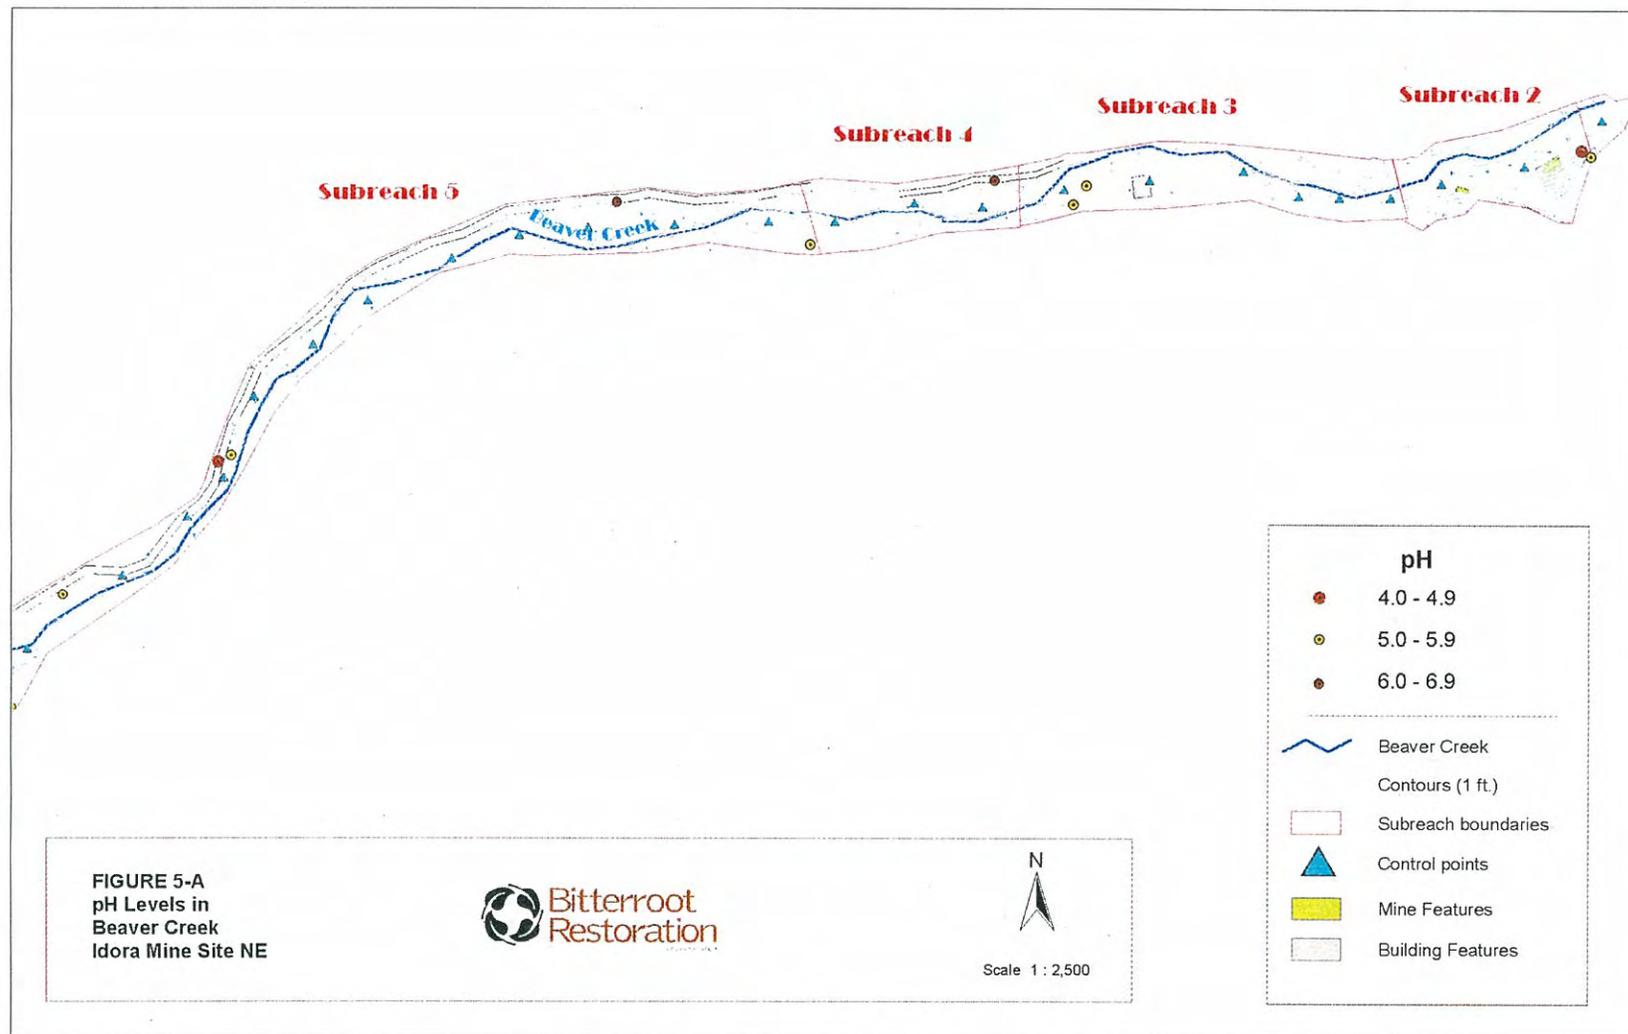
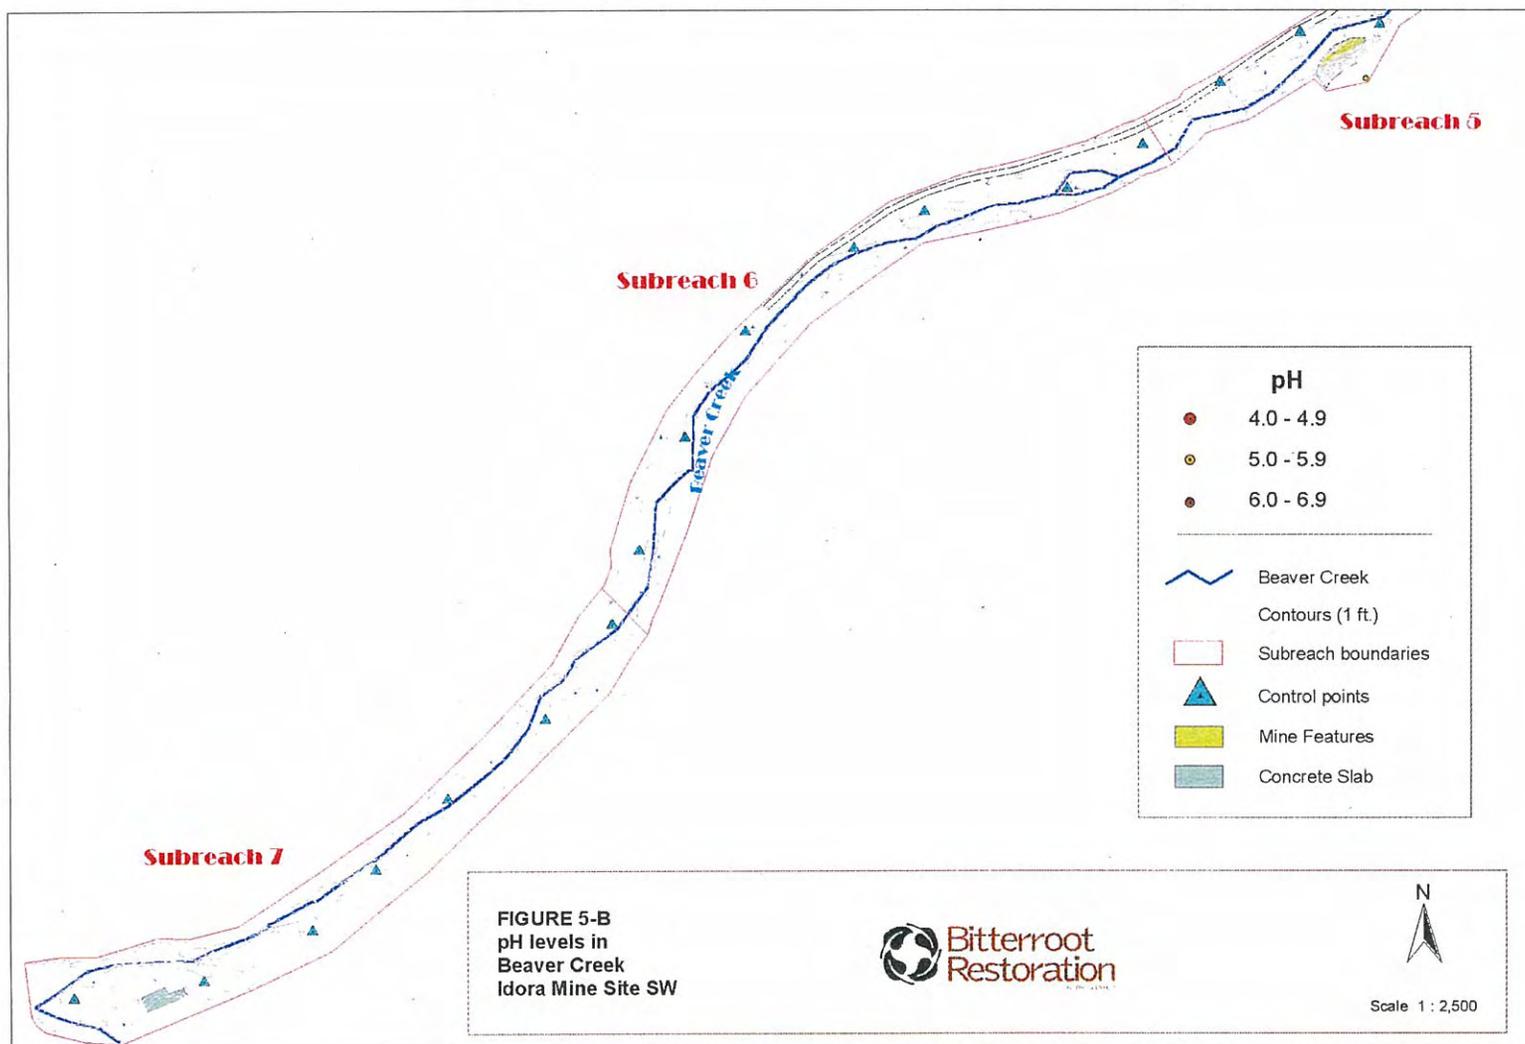
Figure 5-A.

Table 7.5 and Figures 5-A and 5-B present pH and conductivity statistics for the soil/mine waste samples collected from the Idora Mine project site. All samples had acidic values (i.e., less than 7.0 standard units). Fourteen of the 17 samples had pH values less than 5.8 standard units, an indication of significant acidity and low percentage base saturation. Four of the samples had pH values lower than 3.5 and 4.5, a level of high acidity at which exchangeable aluminum can be significantly phytotoxic.

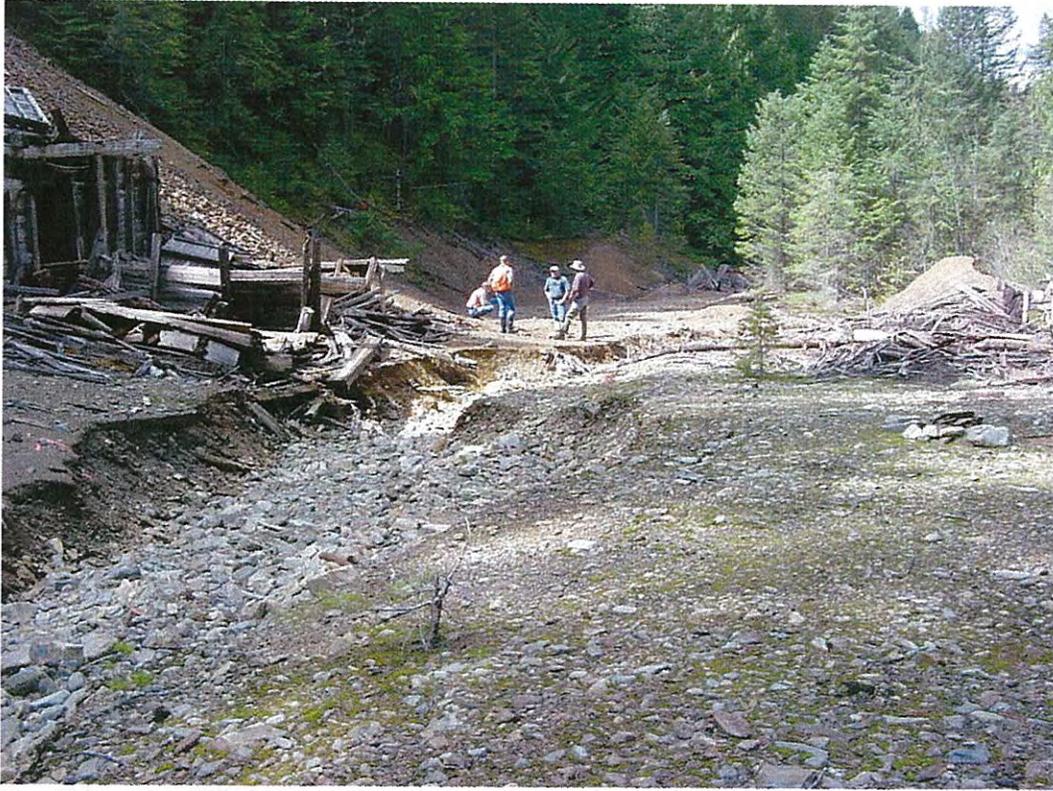
Possible consolidation area in center in back of people.

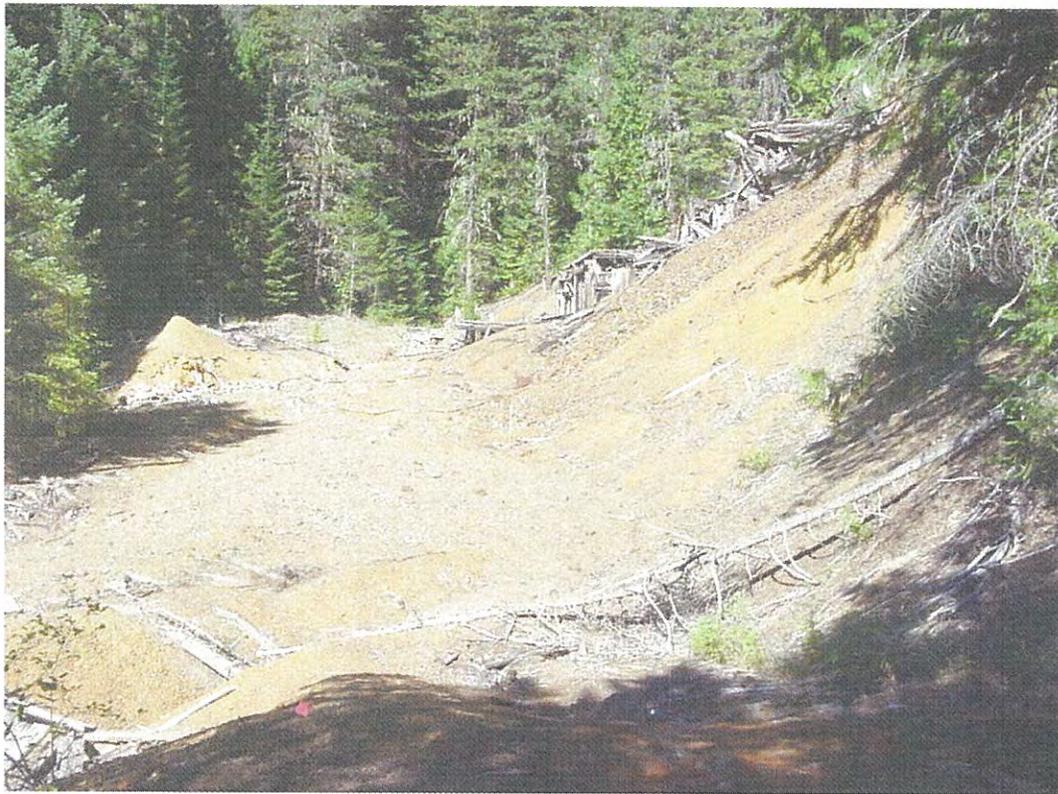
View of proposed consolidation area on hill slope at right.
