REPORTING WATERSHED IMPROVEMENT

Based on Multiple Evidence of Watershed-wide Improvement (Option 2b)

Jordan, Cub, and Calamity Creeks (HUC 170103010103):

North Fork Coeur d'Alene River Watershed, Idaho

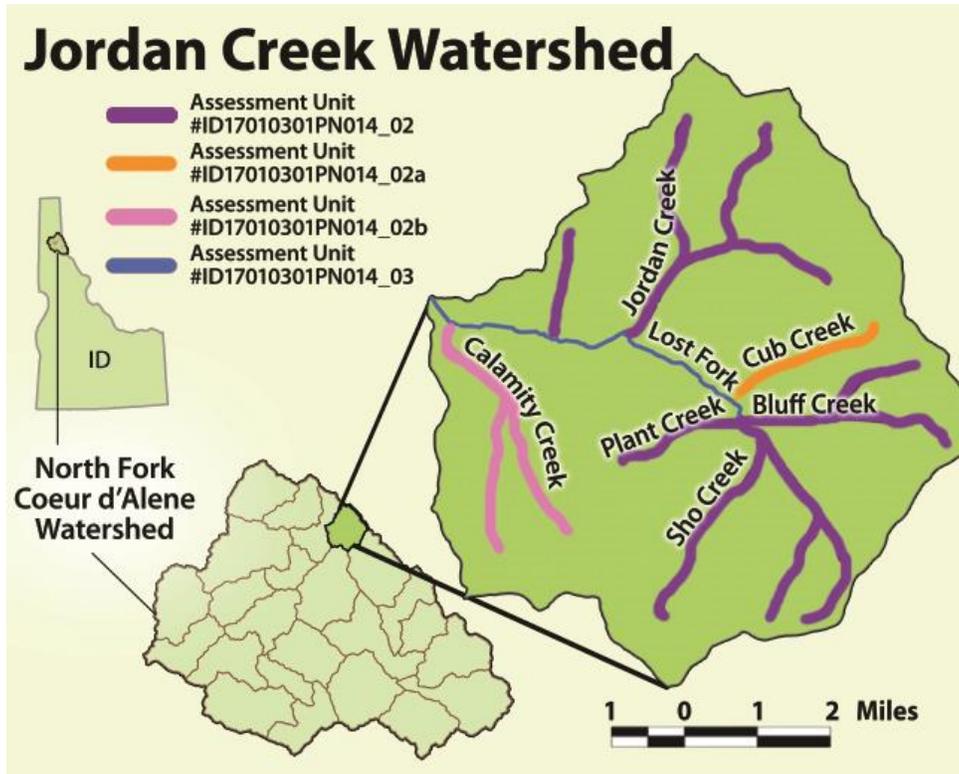
Figure 1. One HUC-12 watershed was improved thanks to the watershed approach (170103010103, Jordan Creek) in the North Fork Coeur d'Alene River Subbasin in northern Idaho. This HUC had three segments listed as impaired for sediment in 2002. In the 2014 integrated report, all of these sediment impairments are being removed: (1) Jordan Creek (17010301PN014_02), (2) Cub Creek (17010301PN014_02a), and (3) Calamity Creek (17010301PN014_02b). Lower reaches of Lost Fork Creek and Jordan Creek (17010301PN014_03) were not listed as impaired in 2002.

e	Watershed(s)	HUC 170103010103: Jordan Creek
f	2002 Impairments	Within HUC 170103010103: <ul style="list-style-type: none"> • Jordan Creek. Listing ID: AU# ID17010301PN014_02 (sediment) • Cub Creek. Listing ID: AU# ID17010301PN014_02a (sediment) • Calamity Creek. Listing ID: AU# ID17010301PN014_02b (sediment)
g	Map (optional)	See Attachment A, Figure 1
