BLACKHAWK HOMEOWNERS ASSOCIATION

DRINKING WATER

FACILITY PLANNING STUDY

December 2012

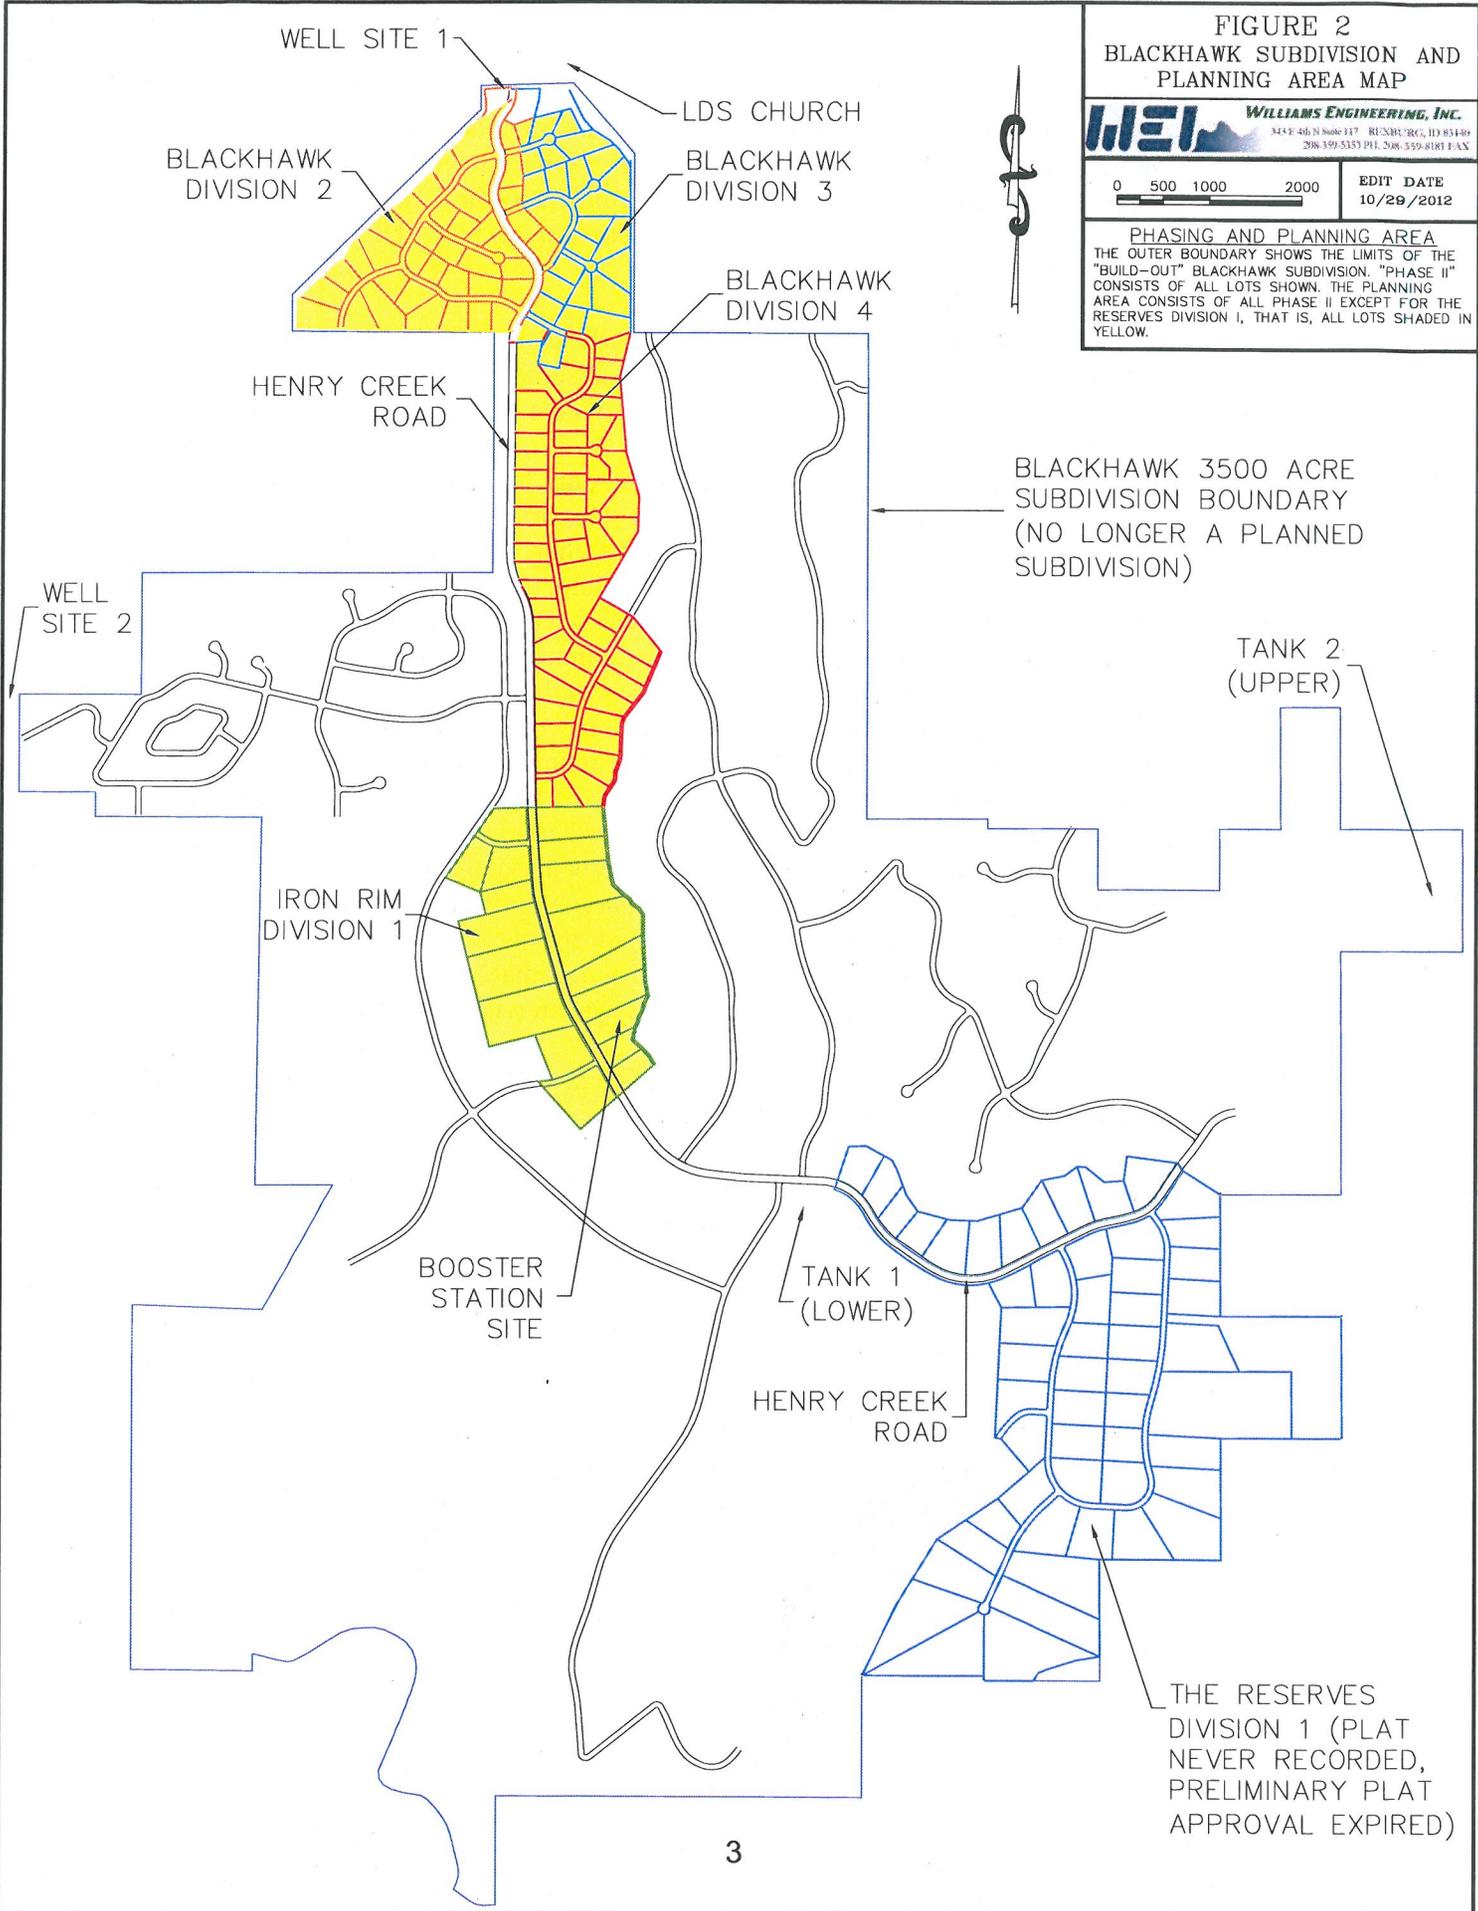
PHASING AND PLANNING AREA

THE OUTER BOUNDARY SHOWS THE LIMITS OF THE "BUILD-OUT" BLACKHAWK SUBDIVISION. "PHASE II" CONSISTS OF ALL LOTS SHOWN. THE PLANNING AREA CONSISTS OF ALL PHASE II EXCEPT FOR THE RESERVES DIVISION I, THAT IS, ALL LOTS SHADED IN YELLOW.

System modeling was for build-out of the entire 3500 acre subdivision and also a more immediate Phase II that would consist of Blackhawk Divisions 2, 3, and 4, Iron Rim Division 1, The Reserves Division 1, and the LDS Church near Well Site 1. In each case, the proposed system would meet DEQ and fire code requirements.

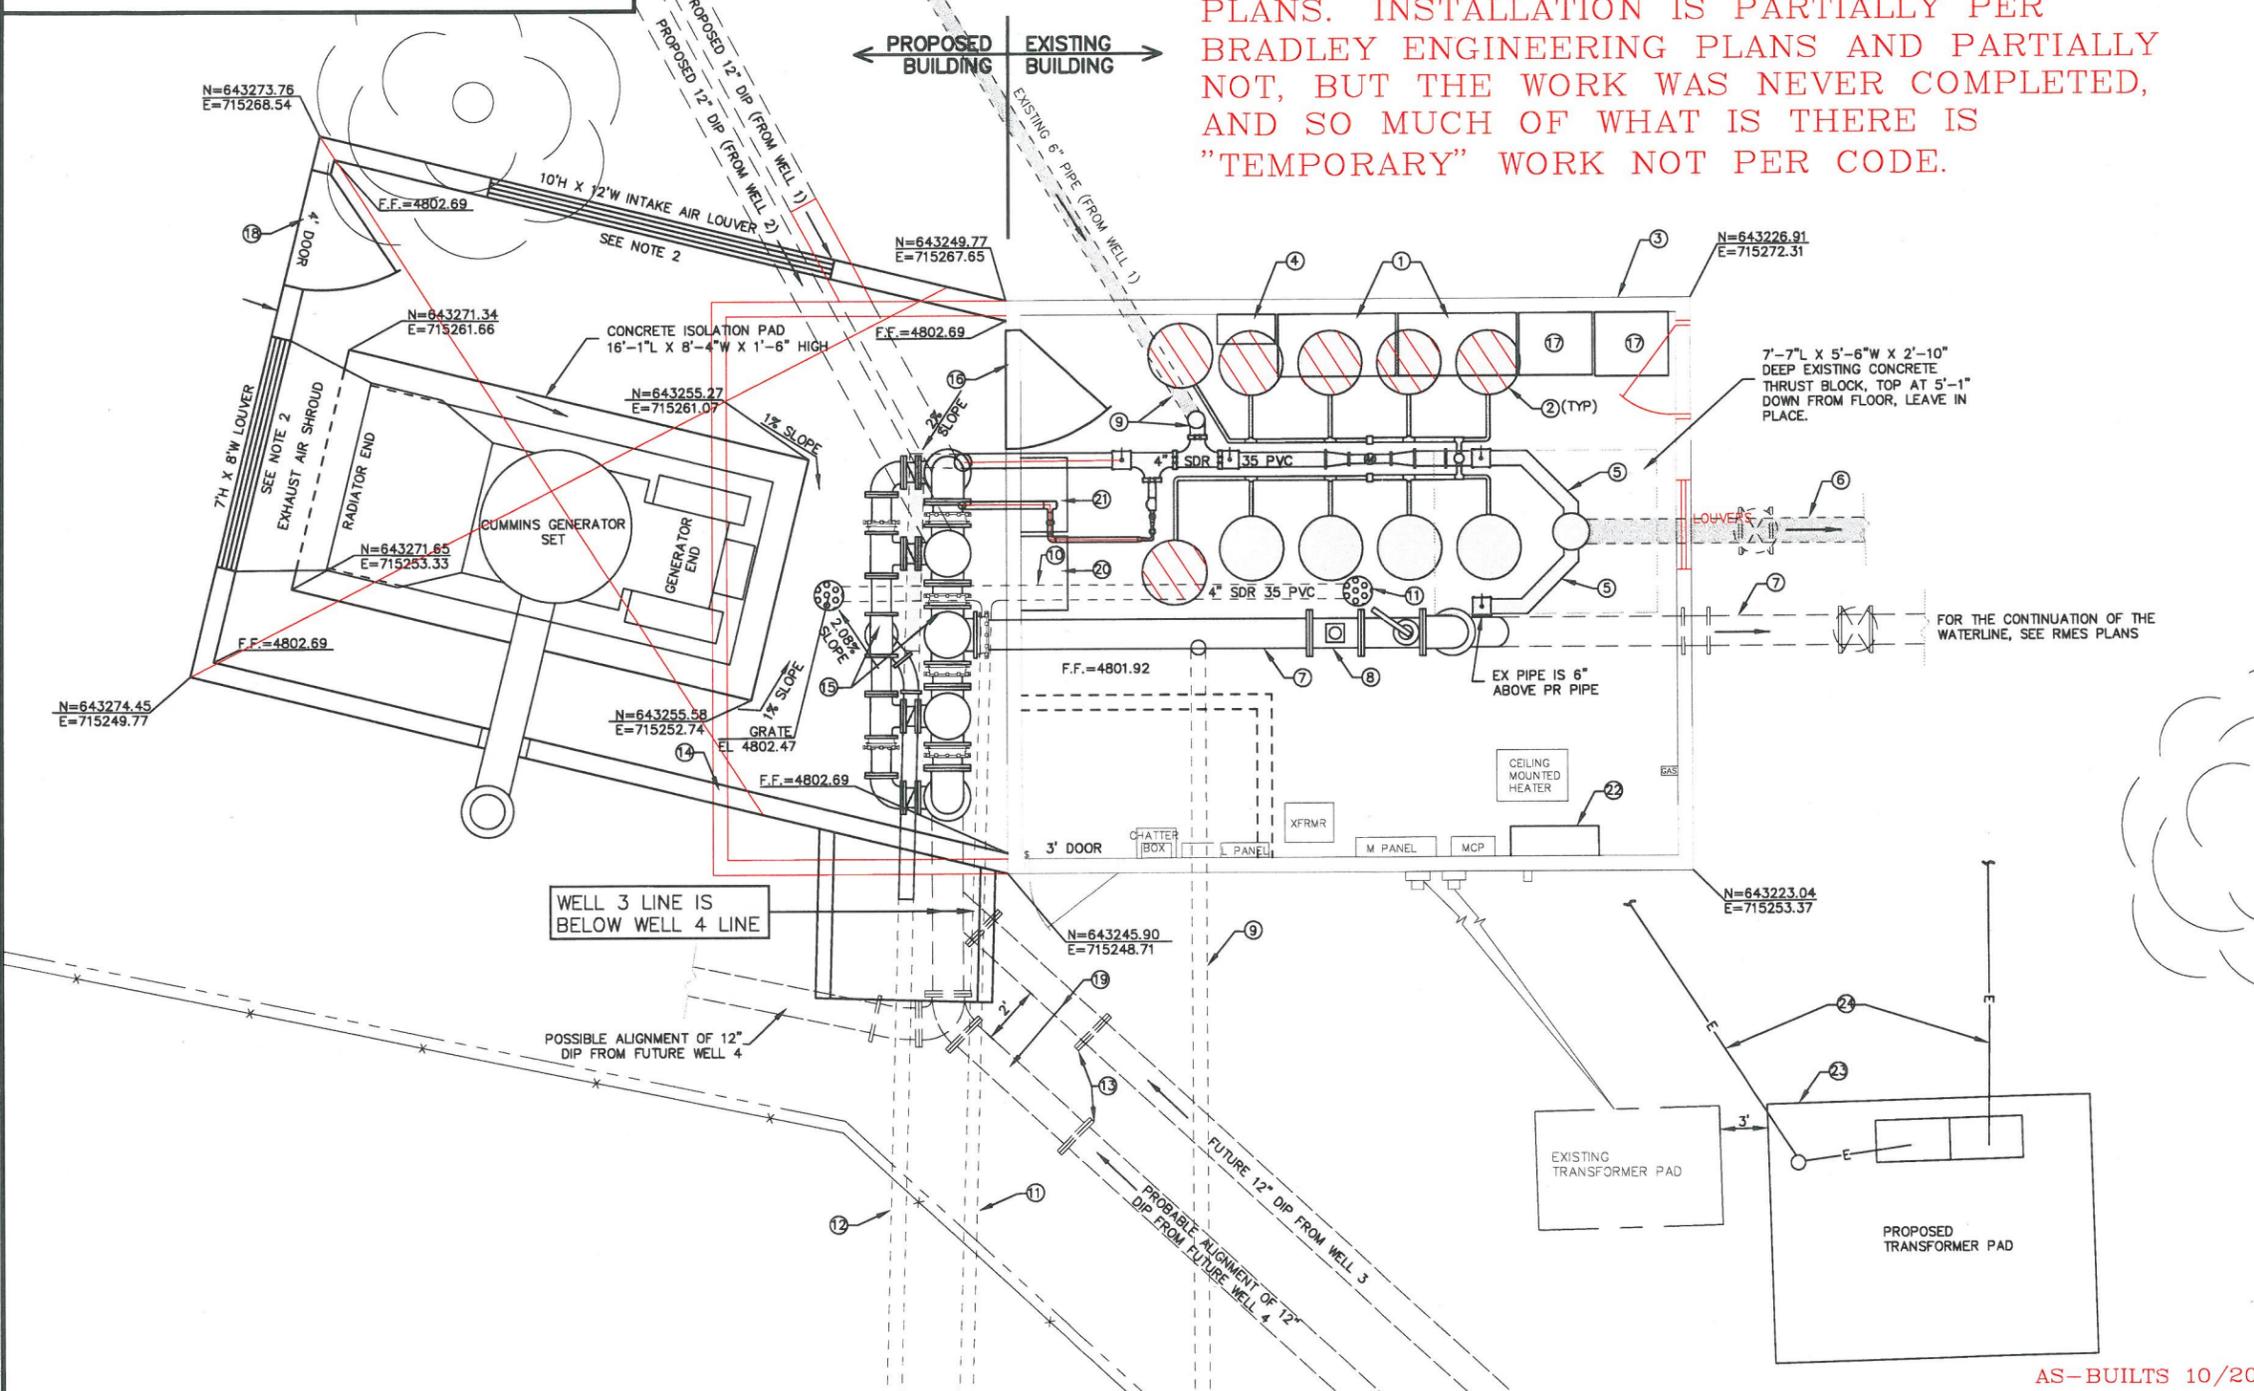
NOTE:
ELECTRICAL EQUIPMENT IS NOT PER THESE PLANS. INSTALLATION IS PARTIALLY PER BRADLEY ENGINEERING PLANS AND PARTIALLY NOT, BUT THE WORK WAS NEVER COMPLETED, AND SO MUCH OF WHAT IS THERE IS "TEMPORARY" WORK NOT PER CODE.

- DRAWING KEY & NOTES**
- 1 PROPOSED VFD'S FOR WELLS 1 & 2
 - 2 EXISTING BLADDER TANKS
 - 3 EXISTING 8" CMU WALL
 - 4 PROPOSED PROGRAMMABLE LOGIC CONTROLLER (PLC)

- 5 EXISTING DISCHARGE LINE
 - 6 EXISTING 10" WATER LINE
 - 7 PROPOSED 12" DIP WATER LINE
 - 8 PROPOSED FLOW METER, MX ULTRA MAG (SEE SHEETS 9H AND 9I)
 - 9 EXISTING 6" LINE FOR SECOND WELL (REMOVE RISER IN HOUSE, FLOOR OPENING PLUGGED, AND UNDERGROUND TO BE ABANDONED)

Exhibits 1A through 1C are a reproduction of WEI's Well Site 1 Improvements design drawing Sheets 1-3, with noted known as-built differences. Well 2 was drilled and pump installed and connected as shown. Well 1 was disconnected, with the higher capacity pump and appurtenances not installed, nor the pipeline or power line from the well house to the well. Reportedly there is a pipeline stubbed out approximately 3 feet from the building ready for extension to Well 1. WEI witnessed the trench for it but the pipe was partially covered over for freeze protection. The building extension is only 10 feet and houses the additional piping system for the multiple well connections and surge anticipator valve. There are no other pumping facilities. Well logs and information are provided on the DVD in the back cover of WEI-furnished hard copies of this report. There are no as-builts on the well house construction as nothing was ever completed and approved.

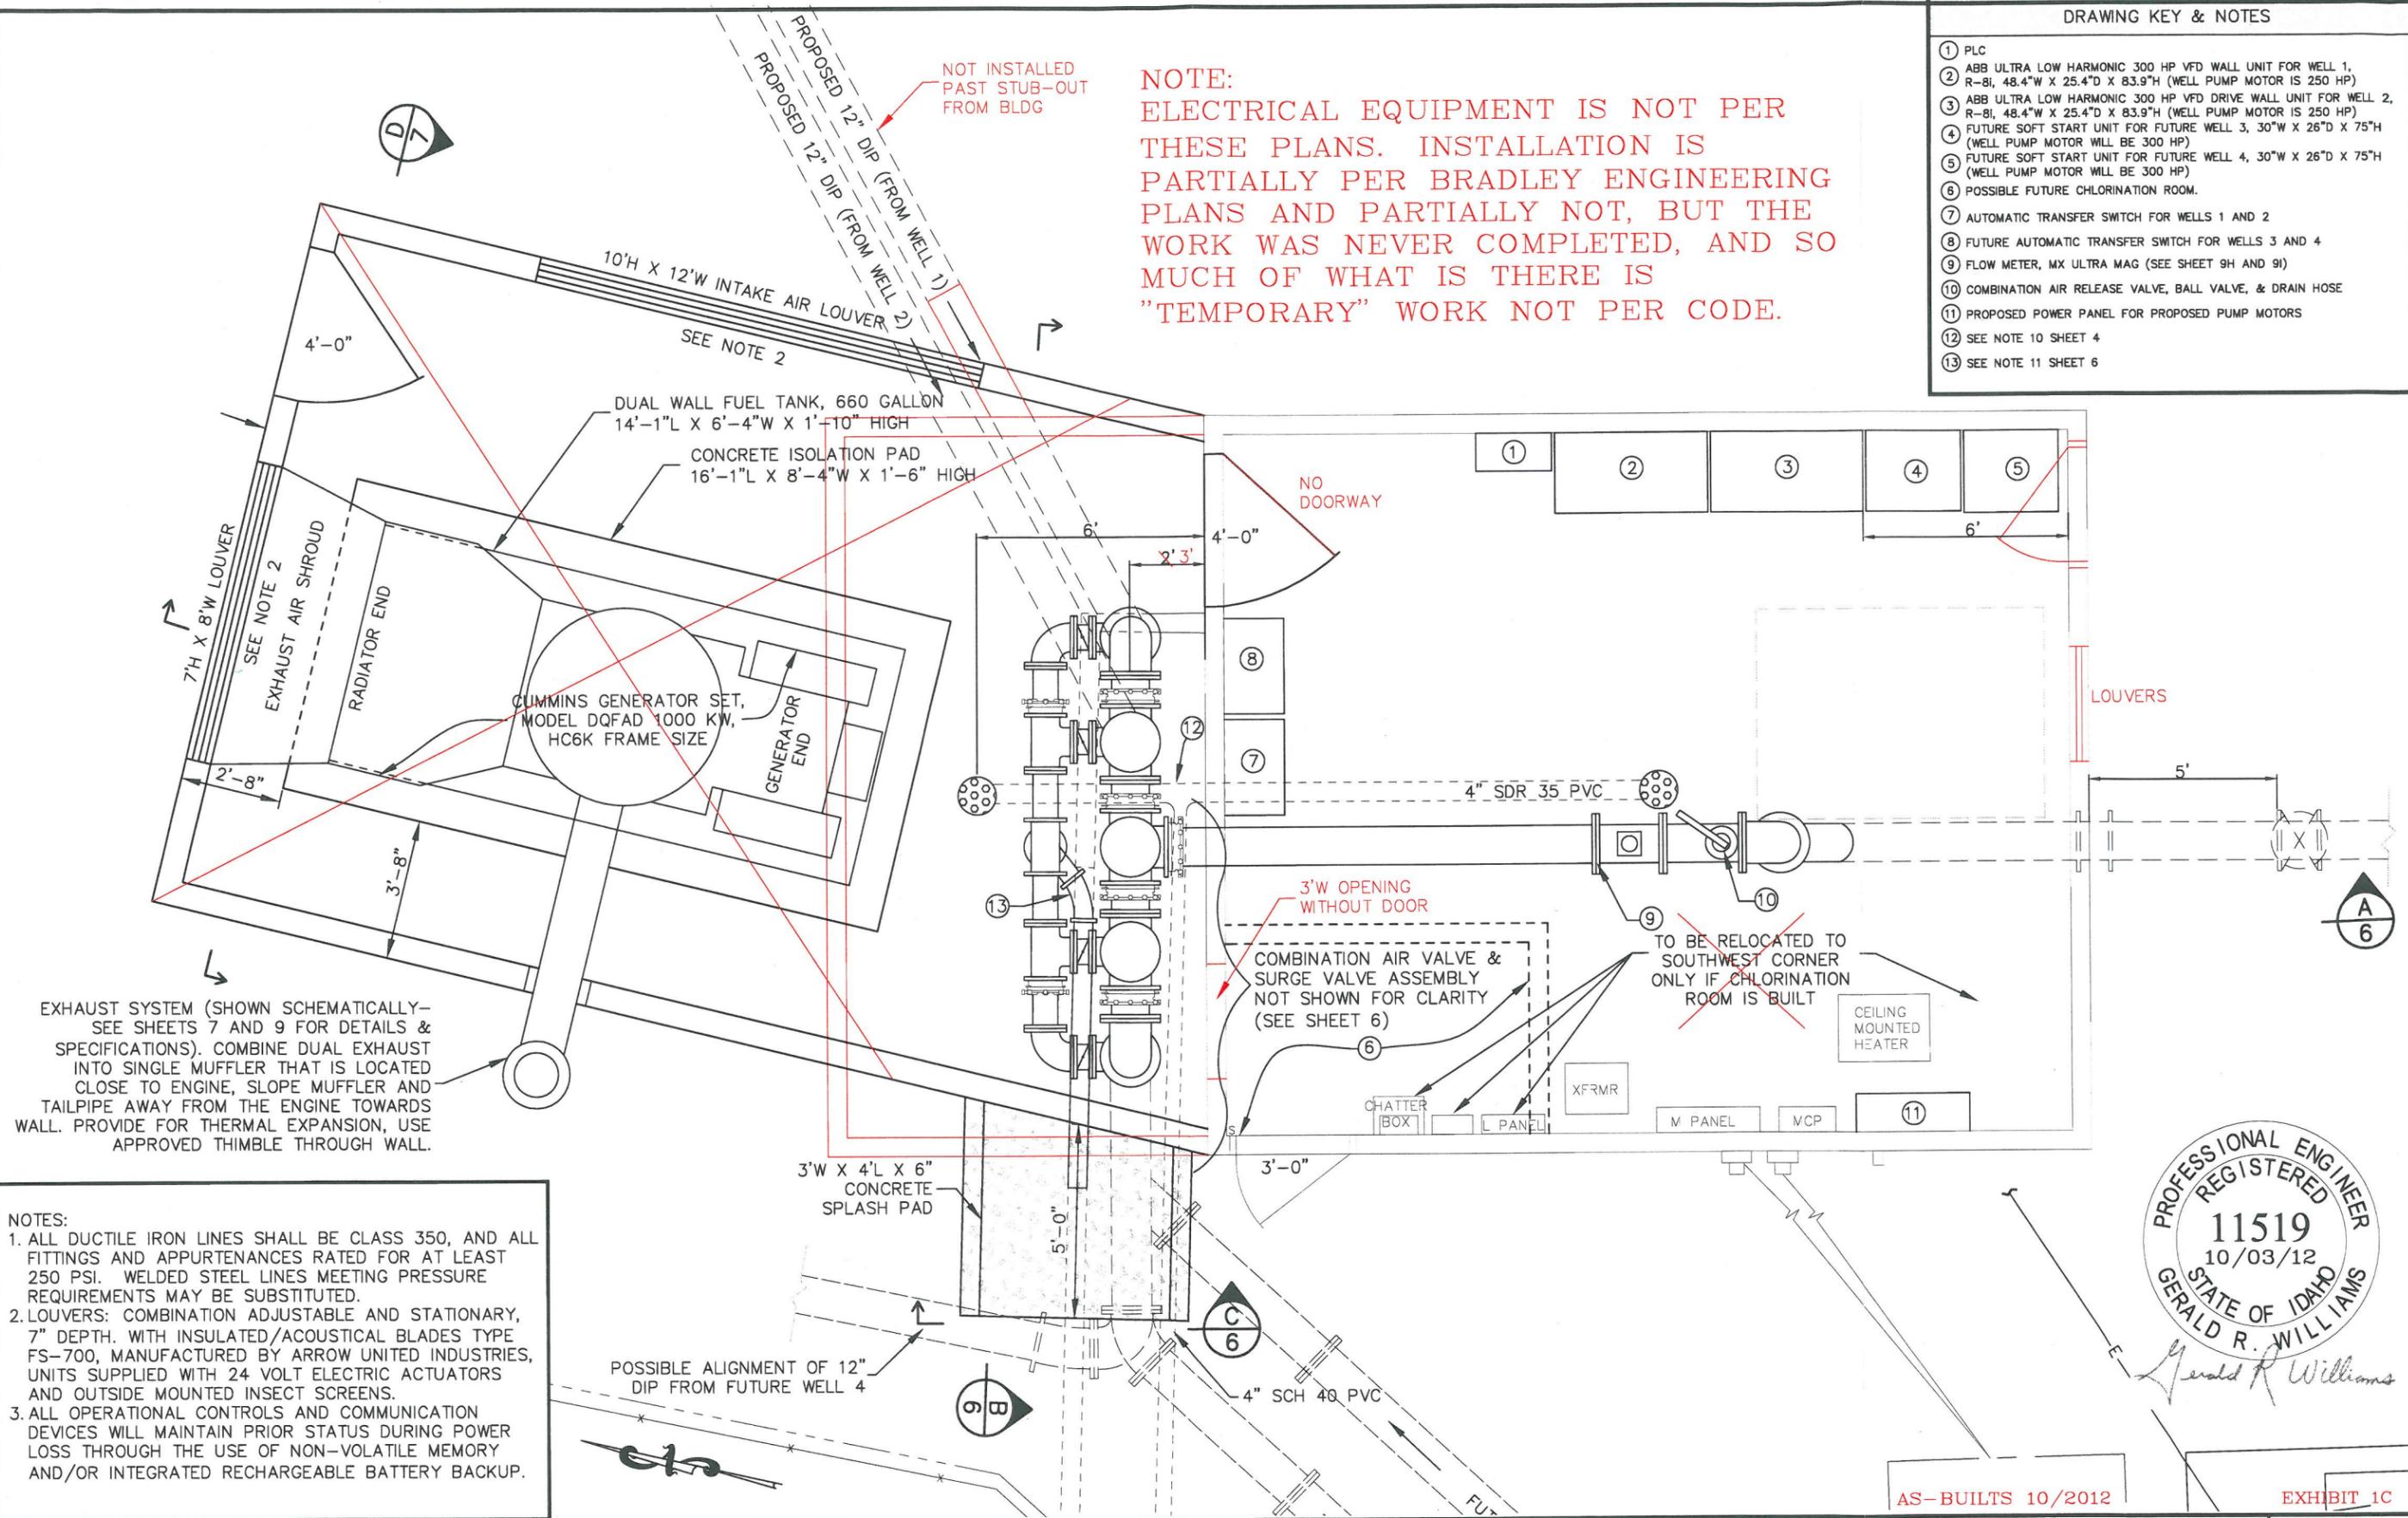
- ① PLC
- ② ABB ULTRA LOW HARMONIC 300 HP VFD WALL UNIT FOR WELL 1, R-81, 48.4"W X 25.4"D X 83.9"H (WELL PUMP MOTOR IS 250 HP)
- ③ ABB ULTRA LOW HARMONIC 300 HP VFD DRIVE WALL UNIT FOR WELL 2, R-81, 48.4"W X 25.4"D X 83.9"H (WELL PUMP MOTOR IS 250 HP)
- ④ FUTURE SOFT START UNIT FOR FUTURE WELL 3, 30"W X 26"D X 75"H (WELL PUMP MOTOR WILL BE 300 HP)
- ⑤ FUTURE SOFT START UNIT FOR FUTURE WELL 4, 30"W X 26"D X 75"H (WELL PUMP MOTOR WILL BE 300 HP)
- ⑥ POSSIBLE FUTURE CHLORINATION ROOM.
- ⑦ AUTOMATIC TRANSFER SWITCH FOR WELLS 1 AND 2
- ⑧ FUTURE AUTOMATIC TRANSFER SWITCH FOR WELLS 3 AND 4
- ⑨ FLOW METER, MX ULTRA MAG (SEE SHEET 9H AND 9I)
- ⑩ COMBINATION AIR RELEASE VALVE, BALL VALVE, & DRAIN HOSE
- ⑪ PROPOSED POWER PANEL FOR PROPOSED PUMP MOTORS
- ⑫ SEE NOTE 10 SHEET 4
- ⑬ SEE NOTE 11 SHEET 6

NOTE:
 ELECTRICAL EQUIPMENT IS NOT PER THESE PLANS. INSTALLATION IS PARTIALLY PER BRADLEY ENGINEERING PLANS AND PARTIALLY NOT, BUT THE WORK WAS NEVER COMPLETED, AND SO MUCH OF WHAT IS THERE IS "TEMPORARY" WORK NOT PER CODE.

EXHAUST SYSTEM (SHOWN SCHEMATICALLY—SEE SHEETS 7 AND 9 FOR DETAILS & SPECIFICATIONS). COMBINE DUAL EXHAUST INTO SINGLE MUFFLER THAT IS LOCATED CLOSE TO ENGINE, SLOPE MUFFLER AND TAILPIPE AWAY FROM THE ENGINE TOWARDS WALL. PROVIDE FOR THERMAL EXPANSION, USE APPROVED THIMBLE THROUGH WALL.

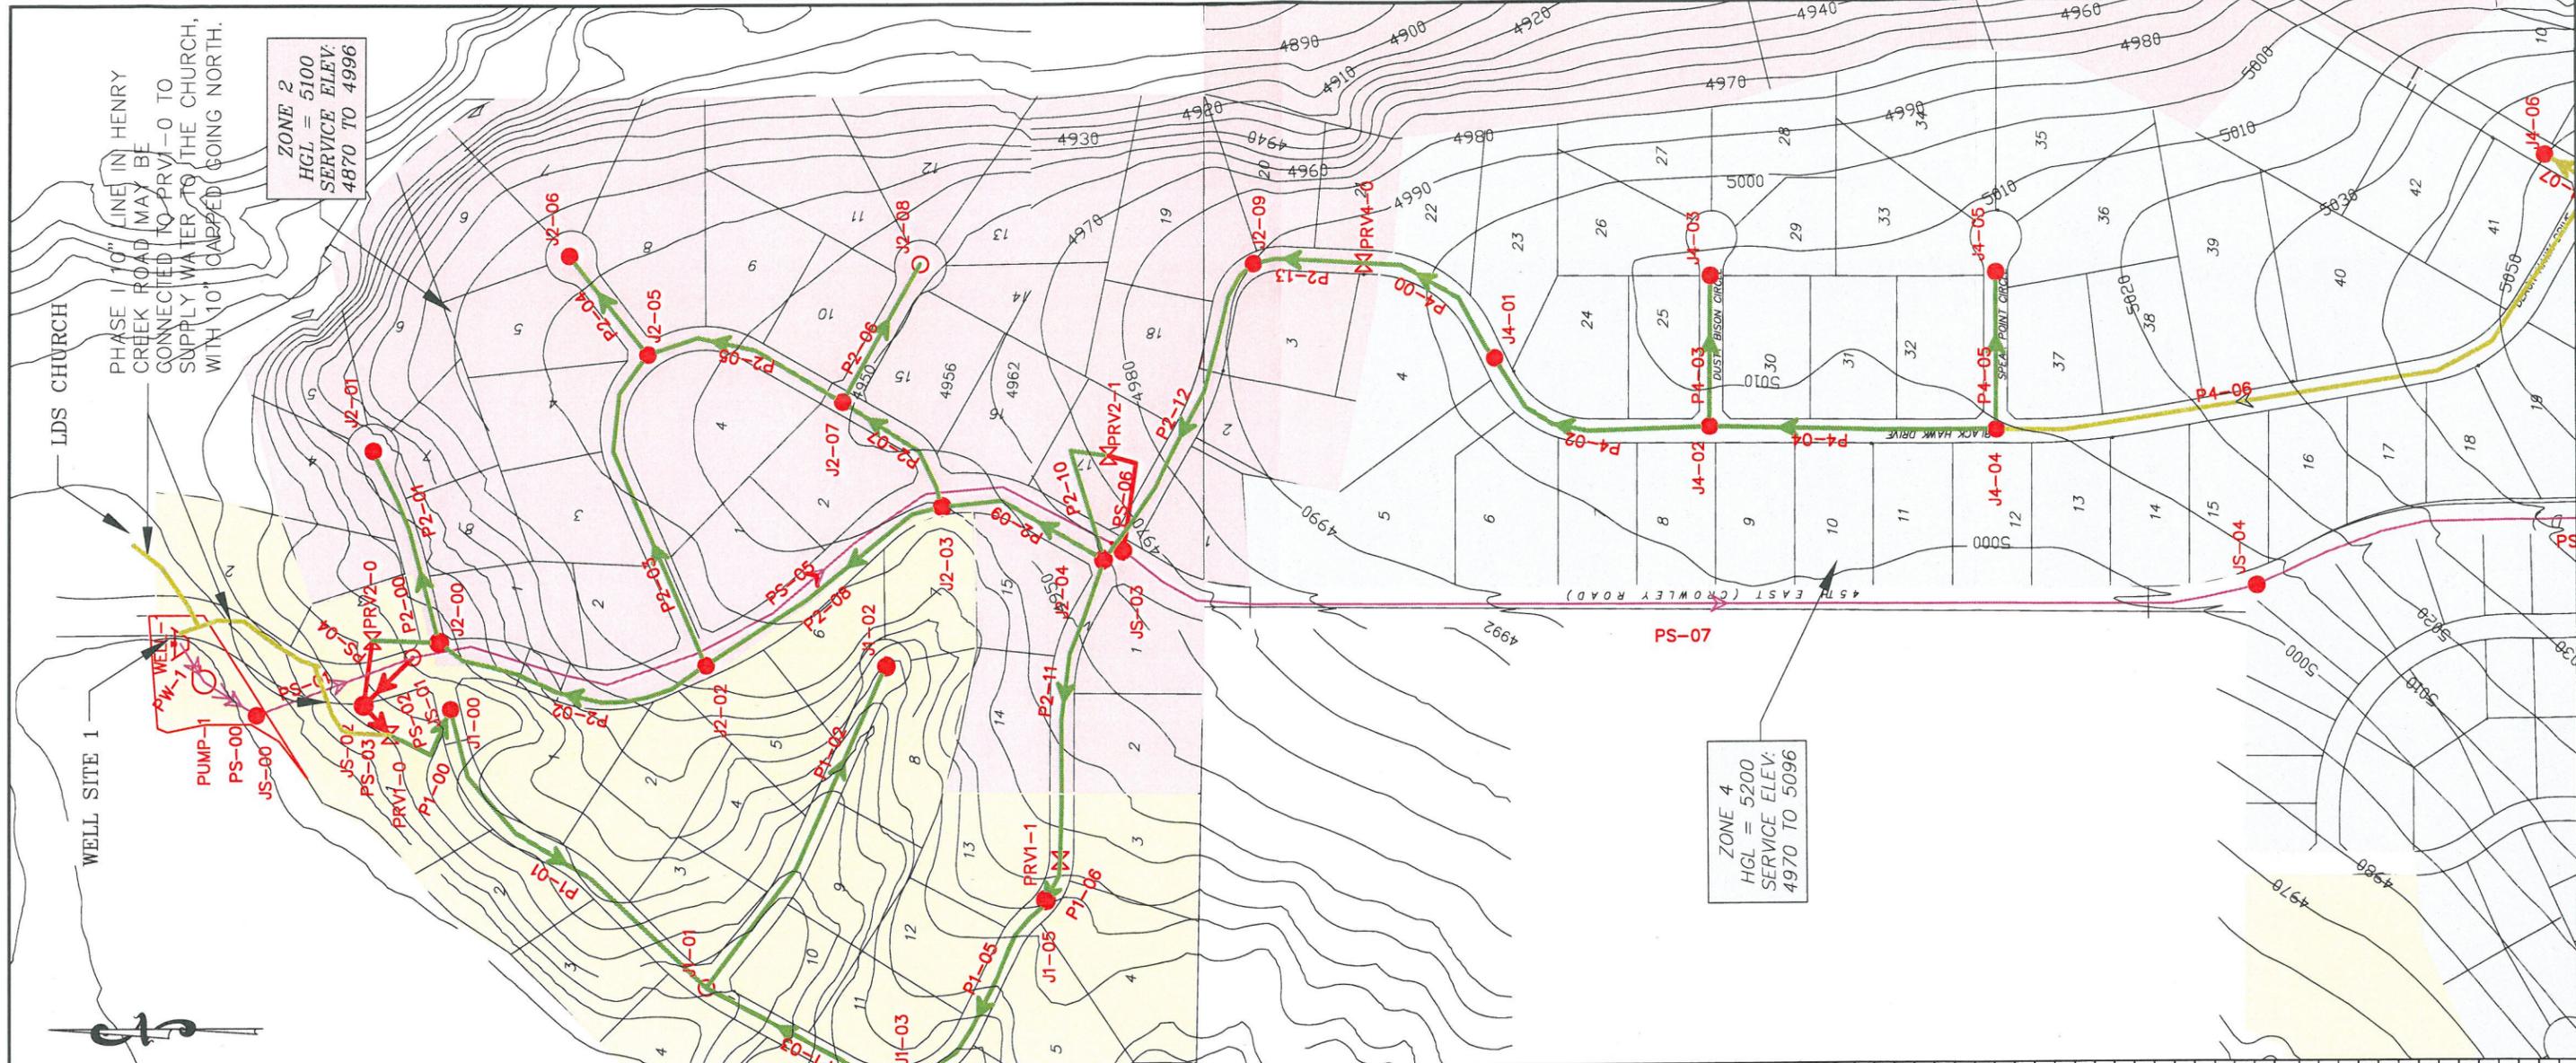
ZONE 2
 HGL = 5100
 SERVICE ELEV.
 4870 TO 4996

ZONE 4
 HGL = 5200
 SERVICE ELEV.
 4970 TO 5096

Junctions: Supply Lines w/ No-Flow			Pipe Data			
Junction Label	Elev. (ft)	Zone HGL	Model	Length (ft)	Dia. (in)	Type
J1-00	4853	1	5040.07	80.94	8	PVC
J1-01	4822	1	5040.07	94.35	8	PVC
J1-02	4880	1	5040.07	69.25	8	PVC
J1-03	4862	1	5040.07	77.91	10	PVC
J1-04	4822	1	5040.07	94.35	8	PVC
J1-05	4910	1	5040.07	56.27	8	PVC
J2-01	4877	2	5100.09	96.52	8	PVC
J2-02	4920	2	5100.09	77.91	8	PVC
J2-03	4940	2	5100.09	69.26	8	PVC
J2-04	4961	2	5100.09	60.18	8	PVC
J2-05	4935	2	5100.09	71.43	8	PVC
J2-06	4926	2	5100.09	75.32	8	PVC
J2-07	4948	2	5100.09	65.8	8	PVC
J2-08	4948	2	5100.09	47.63	10	PVC
J2-09	4990	2	5100.09	47.63	10	PVC
J4-00	5110	4	5220.06	47.61	12	PVC
J4-01	5003	4	5220.06	93.91	8	PVC
J4-02	5008	4	5220.06	91.75	8	PVC
J4-03	5008	4	5220.06	91.75	8	PVC
J4-04	5009	4	5220.06	91.32	8	PVC
J4-05	5013	4	5220.06	89.58	8	PVC
J4-06	5050	4	5220.06	73.58	16	DIP
J4-07	5057	4	5220.06	70.55	16	DIP
J4-08	5056	4	5220.06	70.98	8	DIP
J4-32	5070	4	5220.06	64.92	8	DIP

J4-34	5085	4	5220.06	58.43	8	DIP
J4-35	5080	4	5220.06	60.6	8	DIP
J5-01	5170	5	5350	77.88	16	DIP
J5-16	5210	5	5350	60.57	16	DIP
PRV Data			Pressure Setting			
Label	Dia. (in)	Ground Elev. (ft)	Static HGL (ft)	Small PRV (psi)	Large PRV (psi)	Type
PRV1-0	6	4850	5040	82.27	77.27	DIP
PRV1-1	6	4919	5040	47.39	42.39	DIP
PRV2-0	6	4860	5100	103.92	98.92	DIP
PRV2-1	8	4961	5100	60.19	55.19	DIP
PRV2-4	6	4996	5100	45.03	40.03	DIP
PRV4-1	10	5055	5220	71.45	66.45	DIP
PRV4-6	10	5110	5220	47.63	42.63	DIP
PRV4-8	6	5085	5220	53.46	48.46	DIP
PRV5-0	10	5201	5350	64.52	59.52	DIP
PS-01			4970	245.31	16	DIP
PS-02			4970	245.31	16	DIP
PS-03			4970	245.31	16	DIP
PS-04			4970	245.31	16	DIP
PS-05			4970	245.31	16	DIP
PS-06			4970	245.31	16	DIP
PS-07			4970	245.31	16	DIP
PS-08			4970	245.31	16	DIP
PS-09			4970	245.31	16	DIP
PS-13			4970	2804.75	16	DIP
PS-15			4970	329.05	16	DIP
PS-19			4970	835.8	16	DIP
PS-45			4970	66.59	16	DIP
PS-46			4970	109.55	16	DIP

5. **Existing System Hydraulic Modeling** The *Basis of Design* report provided hydraulic modeling not only for the build-out condition, but also the Phase II condition that is very similar to the Planning Area condition of platted lots. The Phase II condition included The Reserves and the Planning Area does not, but that is the only difference. That does not affect the modeling as far as what is built or needed except that the Booster Station that was to serve the upper zones, including the reserves, is no longer needed. All the Planning Area lots are served by a system that is unaffected by the elimination of the Booster Station, and thus the Phase II modeling is good for the Planned Area so long as there is adequate pumping source, storage volume, or a combination thereof.

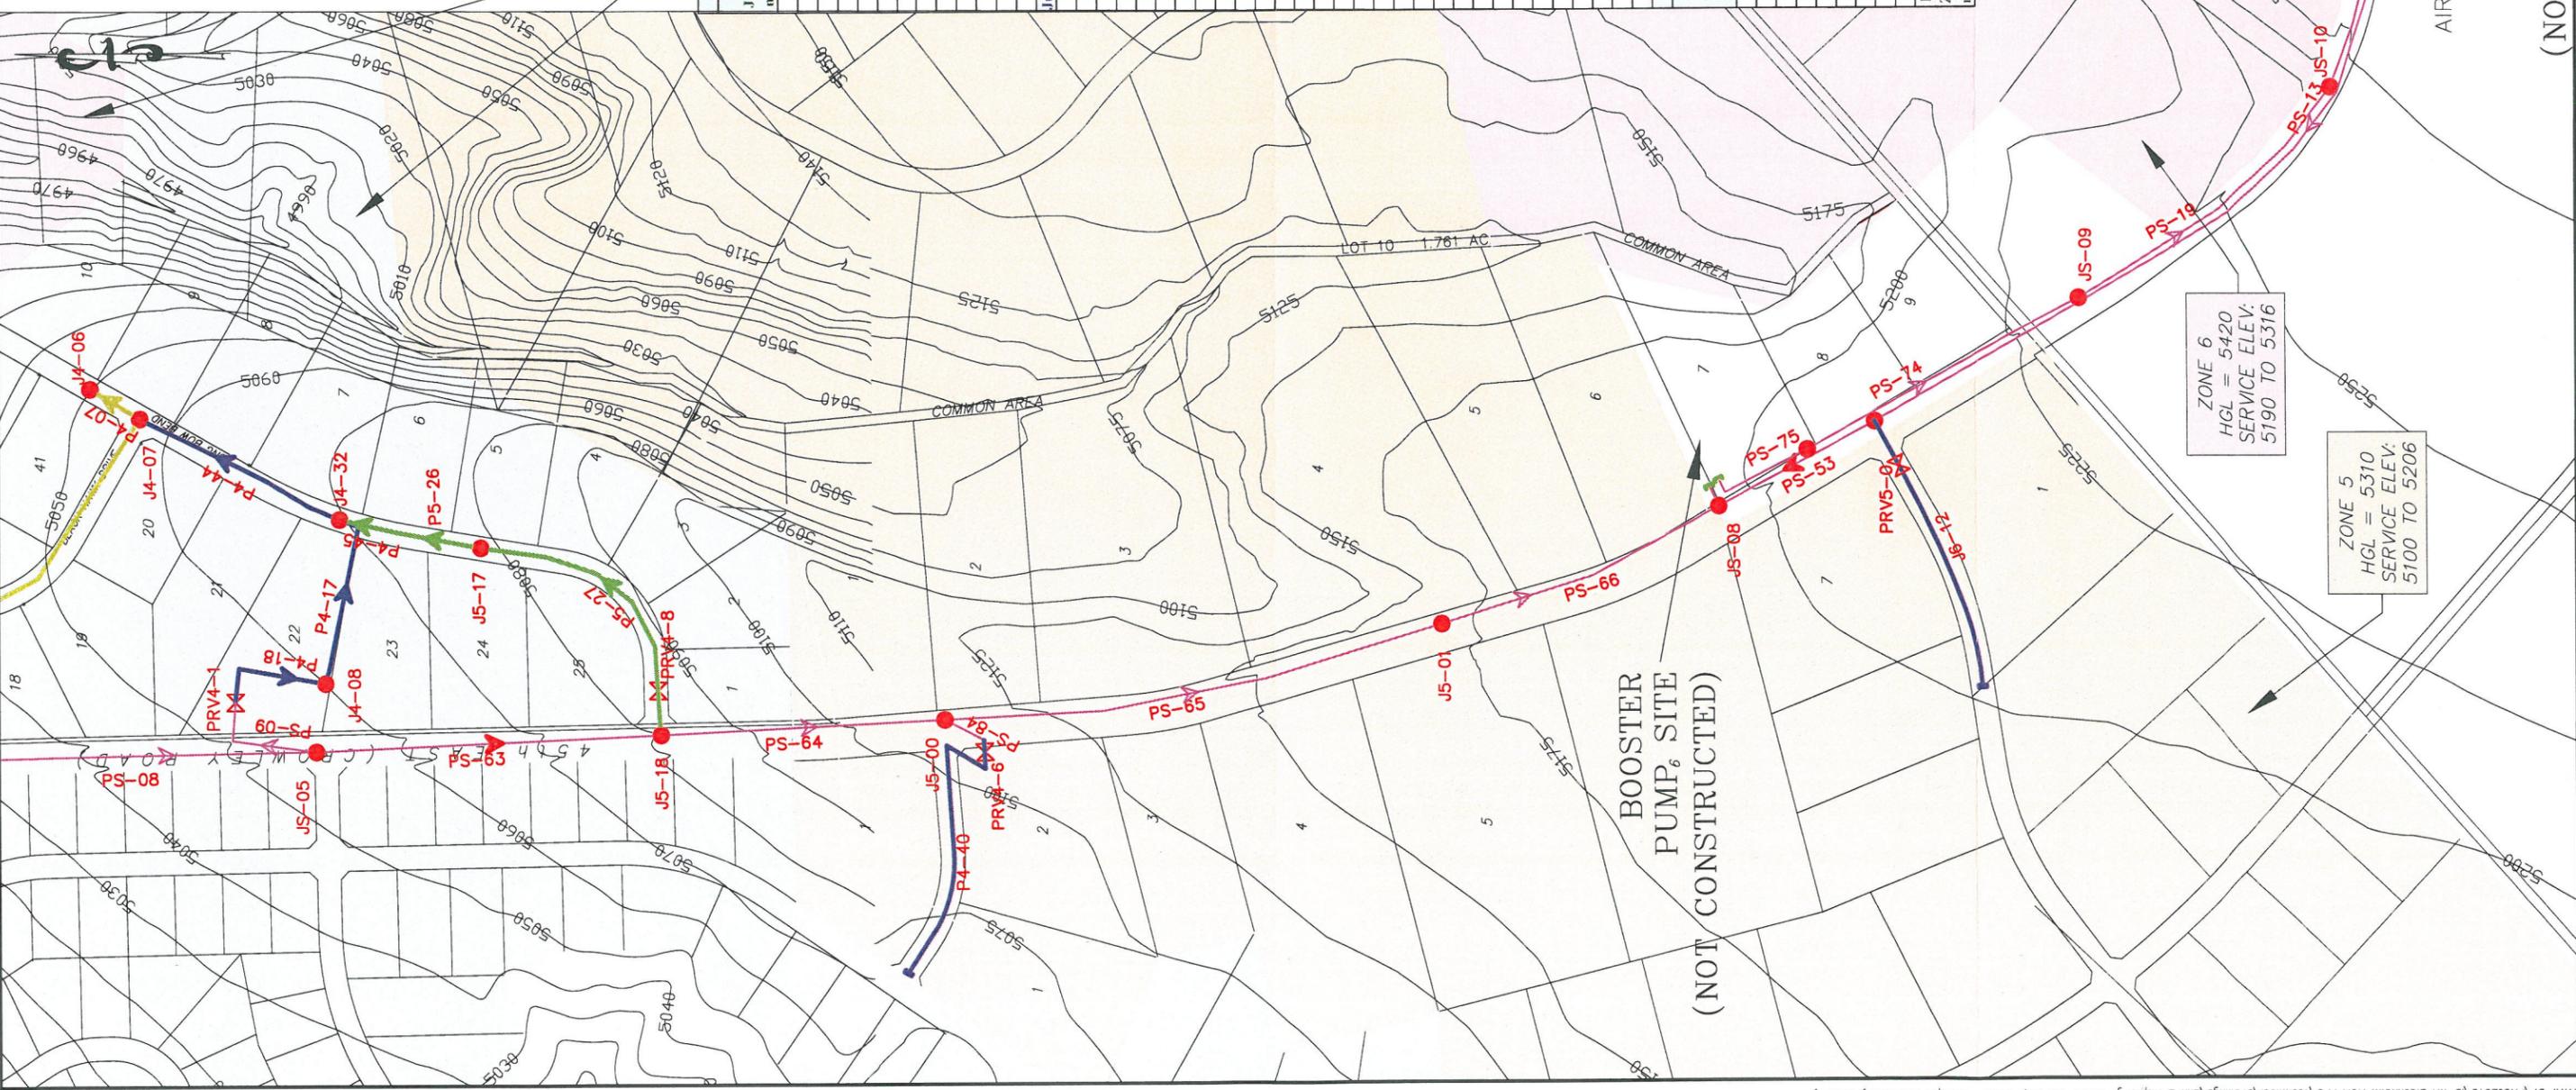
Junctions: Distribution Lines w/ No-Flow				PRV Data			
Junction Label	Elev. (ft)	Zone Name	HGL (ft)	Static Zone	Pressure Setting	Small	Large
PRV1-0	4850	6	5040	82.27	77.27	77.27	77.27
PRV1-1	4919	6	5040	47.39	42.39	42.39	42.39
PRV2-0	4860	6	5100	103.92	98.92	98.92	98.92
PRV2-1	4961	6	5100	60.19	55.19	55.19	55.19
PRV2-4	4996	6	5100	45.03	40.03	40.03	40.03
PRV4-1	5055	4	5220	71.45	66.45	66.45	66.45
PRV4-6	5110	4	5220	47.63	42.63	42.63	42.63
PRV4-8	5085	4	5220	33.46	28.46	28.46	28.46
PRV5-0	5201	5	5350	64.52	59.52	59.52	59.52

1) Italicized PRV values are 5 psi less than Zone HGL because another small PRV maintains peak pressure in the zone.
