Draft Voluntary Remediation Workplan

Former Timber Treatment Products Facility

Santa, Idaho

August 19, 2013

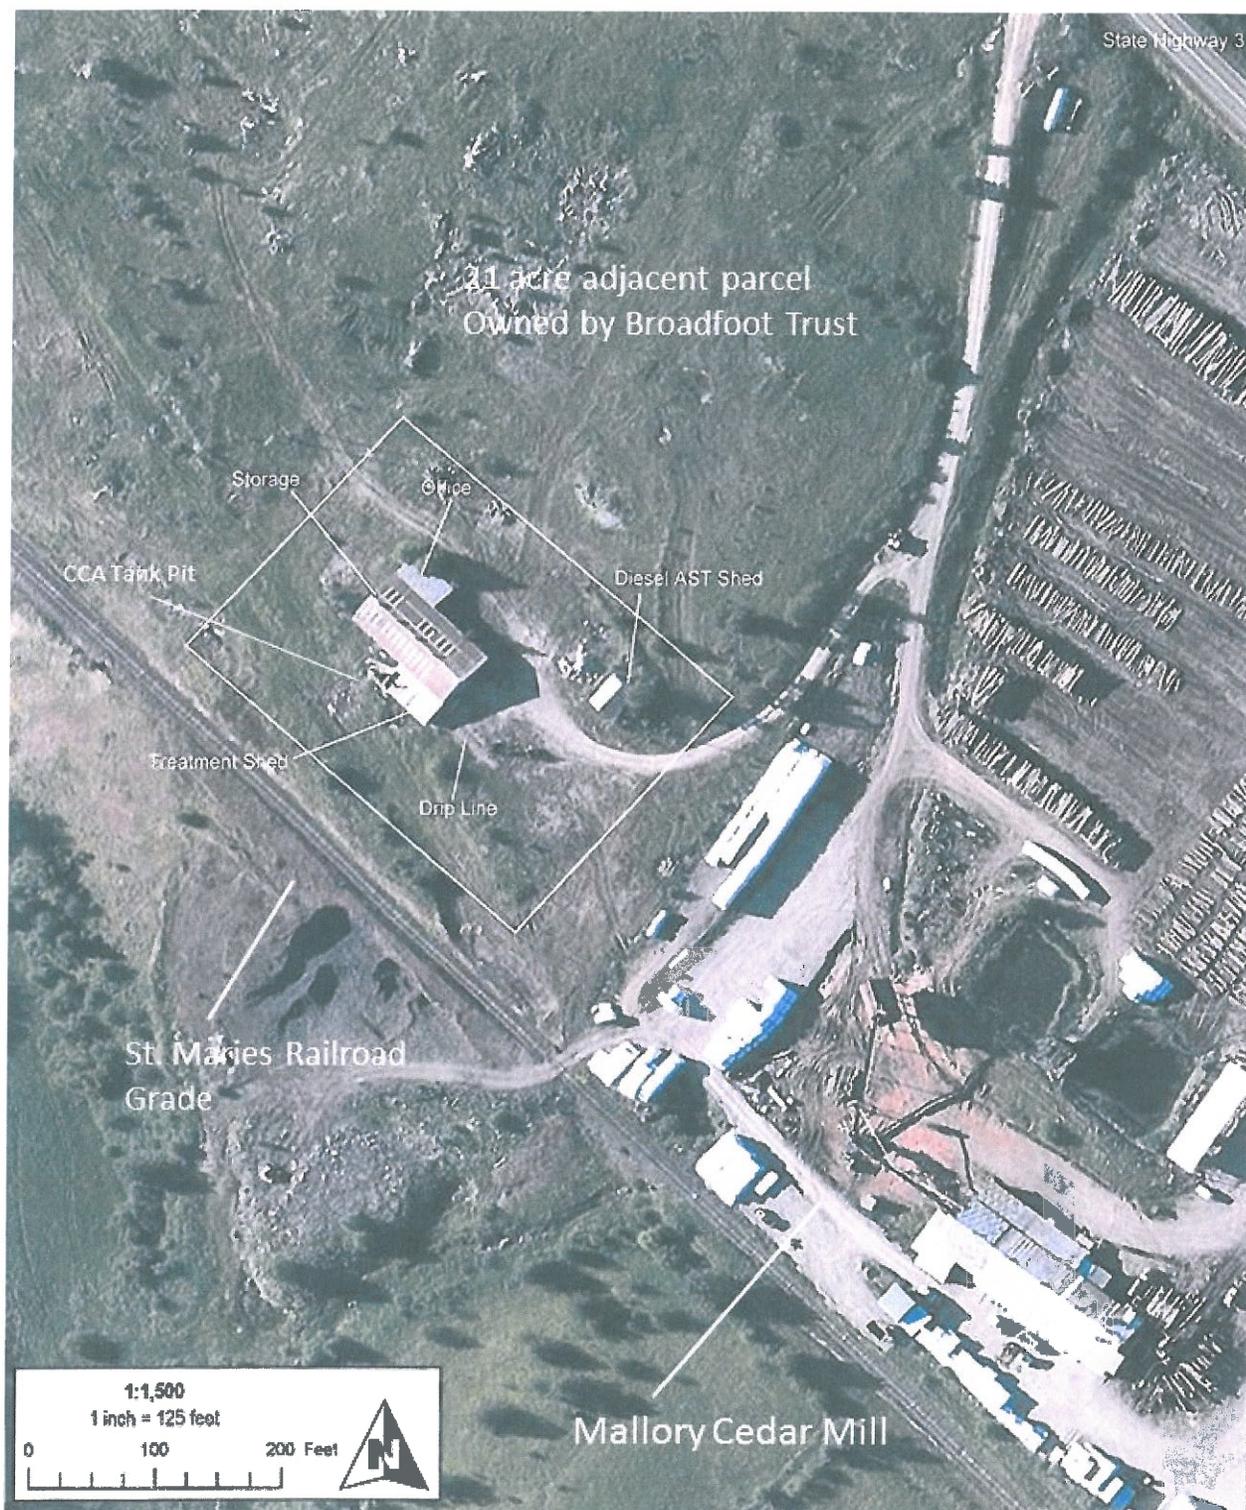
Figure 2: Timber Treat Parcel with major features and surrounding properties labeled.

The Timber Treat Products site is located just south of Santa, Idaho off of State Highway 3 (Figure 1). The site encompasses 0.6 acres (Figure 2). The site is industrial formerly housing a CCA wood treatment site, however wood treatment has not been practiced on the site for nearly twenty years. All the equipment for wood treatment has been removed as scrap metal. Current use of the site is storage and anticipated use is likely storage in support of the adjacent Mallory Cedar Mill. No surface water is located on the site. Groundwater located on the site during the site investigation appears to be a localized small area of perched groundwater. Any regional groundwater is located in the basalt bedrock well below the site.

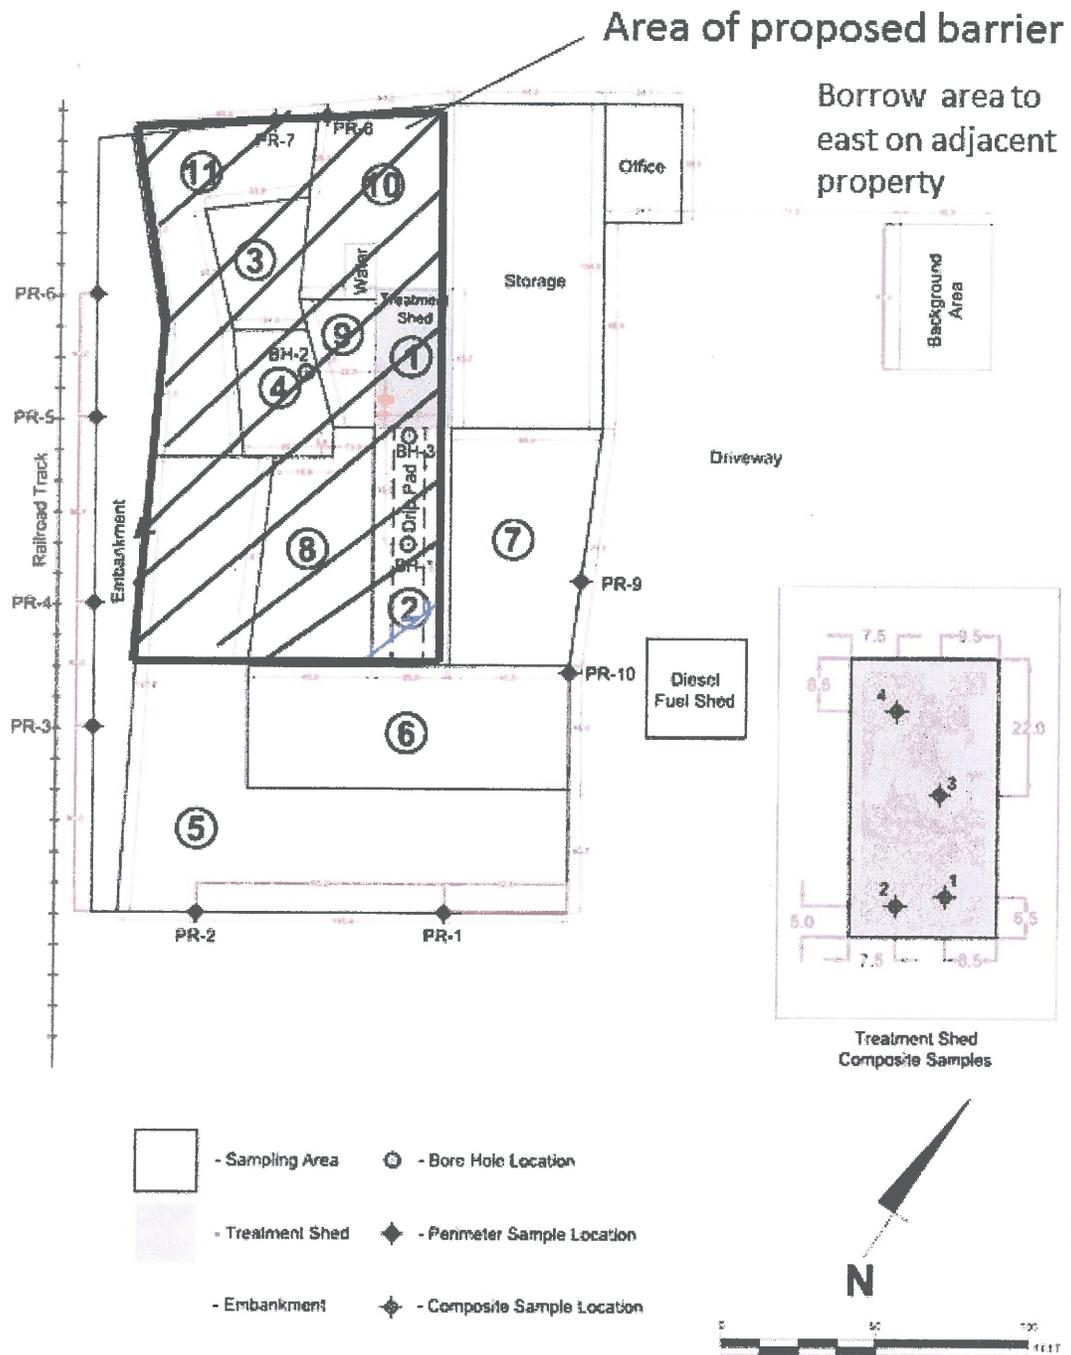
Figure 3. Location of the proposed barrier over CCA contamination at the Timber Treat Products Site

4.0.1 Cumulative Soil Samples: Two samples of background soil will be collected from the borrow area that will be used to cap the designated areas 1, 2, 3, 4, 8, 9, 10 and 11 of figure 3. Each sample will be collected into a clean, clearly labeled bag. Each sample will be collected while wearing rubber gloves, using a new clean plastic spoon to place soil in a new clean plastic bag. Samples will be cooled to 4°C and stored at 4°C until analysis.

4.1 Barrier Placement: A barrier of soil borrowed from the adjacent 21 acre property to the north east of the 0.6 acre Timber Treat Products parcel will be placed. The borrow area is owned by the Broadfoot Trust. The soil from this area is the same Reggear clay loam found on the site with same background, arsenic, copper and chrome concentrations. Areas 1, 2, 3, 4, 8, 9, 10 and 11 of figure 3 will be capped. The cap would cover approximately 53% of the parcel. The cap will consist of a layer of geotextile to mark the lower boundary of the cap material and the upper boundary of contaminated soils. Placement of geotextile will assist identification of the boundary should opening of the cap be required in further site management. One to one and a half feet of clean borrowed soil would be placed on the geotextile and re-vegetated in non-traffic use area with grasses. Areas trafficked by vehicles will be compacted and basalt shot rock added as necessary to bear vehicle weight. A cement slab may be installed over the cap inside the treatment shed. An environmental covenant would be placed on the property requiring cap maintenance and the proper re-interment of any soils excavated from beneath the cap during construction or utility placement activities.
