**Coeur d'Alene Lake Tributaries
Watershed Advisory Group
Friday May 6, 2011
U.S. Forest Service
Coeur d'Alene River Ranger District Office
10:00 – 12:00**

Coeur d'Alene Lake and River TMDL 5-Year Review (cont'd)

presented to
Coeur d'Alene Tributaries
Watershed Advisory Group
May 6, 2011

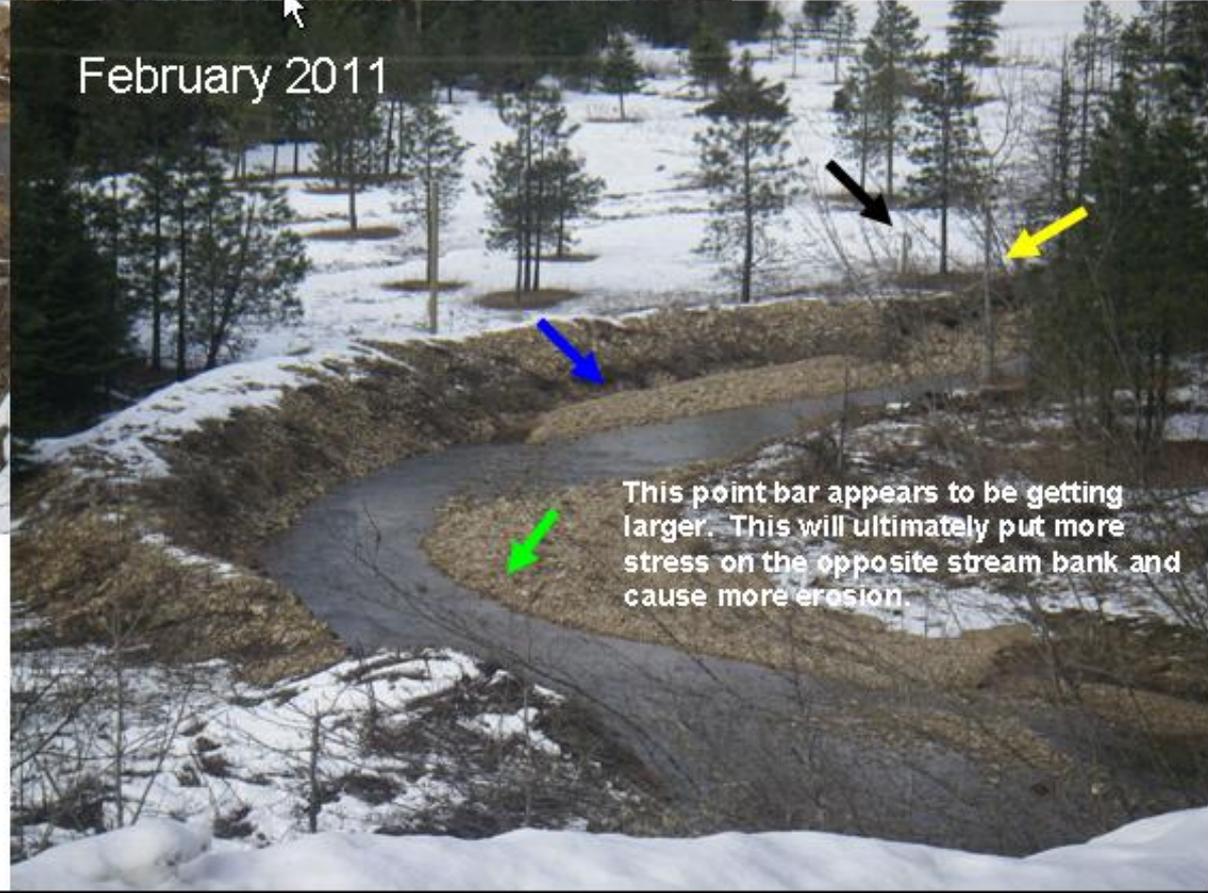
February 2011

This point bar appears to be getting larger. This will ultimately put more stress on the opposite stream bank and cause more erosion.

Black arrows – electrical box
Yellow arrow – dike
Blue arrow – newly deposited mid-channel bar.
bar material from rotational failure of dike.

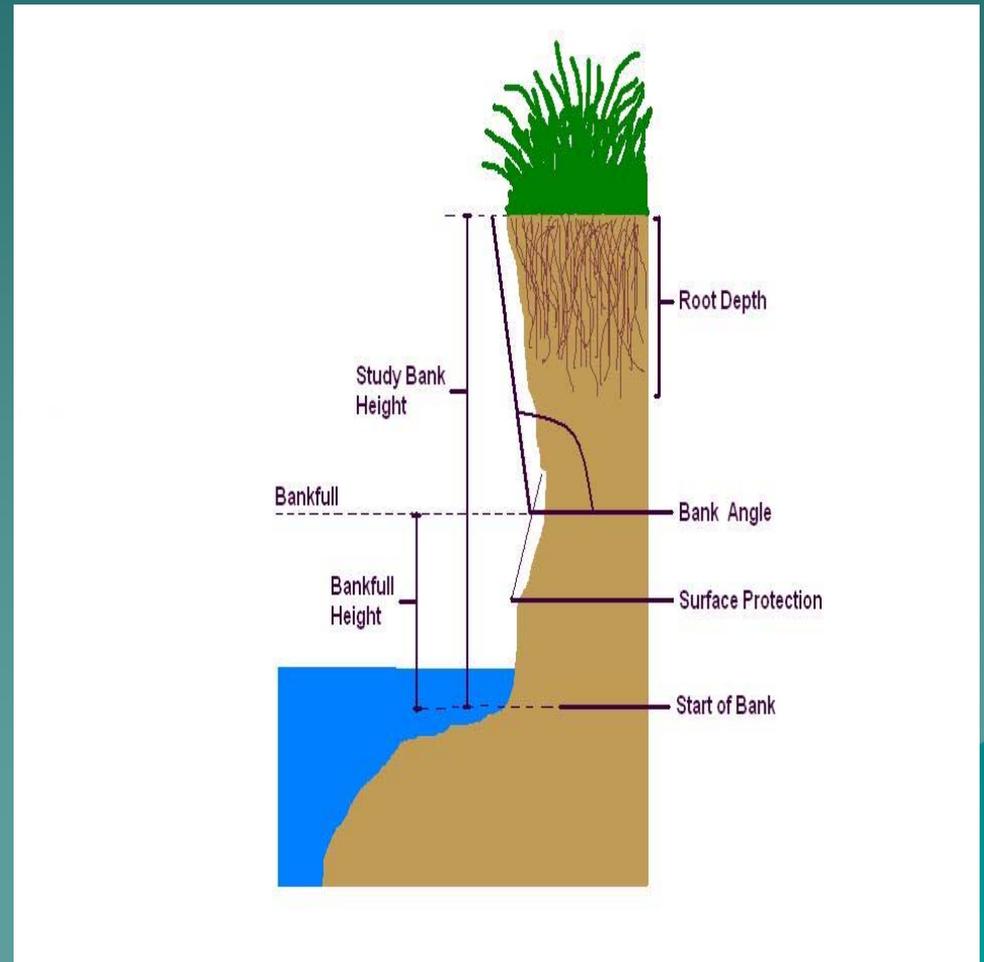
The BEHI assessment classified the riverbanks according to their susceptibility to erosion.

The Bank Erosion Hazard Index (BEHI) rated High in two reaches and Very High on one reach. Nearbank Stress rated Moderate in one reach and High in the other two.

- ◆ Three separate reaches, with intermediate erosive conditions of streambanks along Latour Creek, to conduct a stream stability survey as described in *Rosgen (2006)*.
 - 18 percent of banks unstable
 - The estimated erosion rate for the 785 ft of study reach was 0.4-0.6 ft/yr or 217 ft³/yr (10 tons/year).

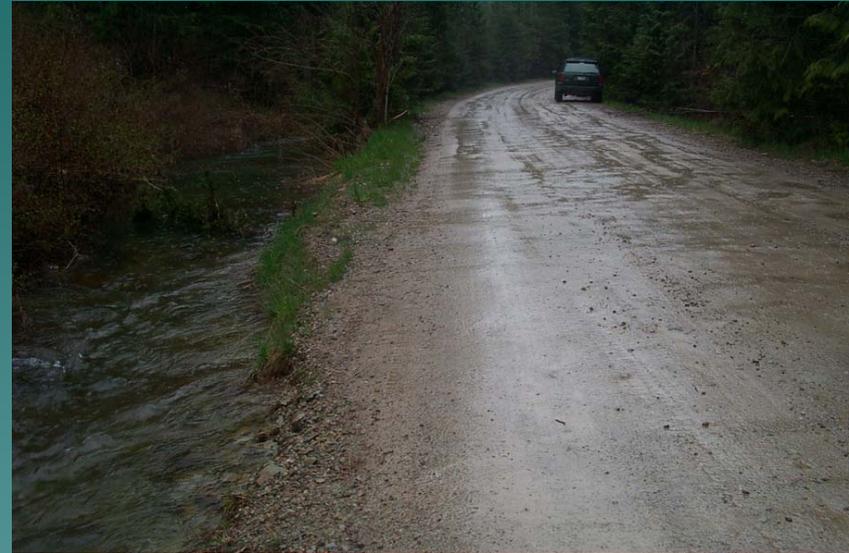
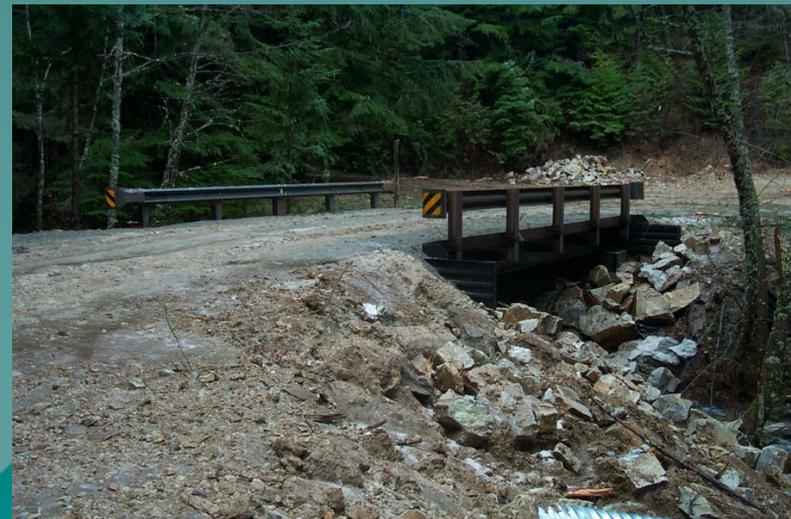
Latour Creek Implementation

- ◆ The Idaho Department of Lands improved 5.7 miles of road :
 - Bridge replacement over Lost Girl Creek and Butler Creek.
 - Work was also done on the support structures and decking on the Latour Creek Bridge.
 - Reconstruction of the 5.7 mile road.
 - 4 relief culverts, replaced 5 undersized stream crossing culverts, pulled ditches and outside shoulders, rocked ditch lines, aligned, crowned, and installed rolling dips.

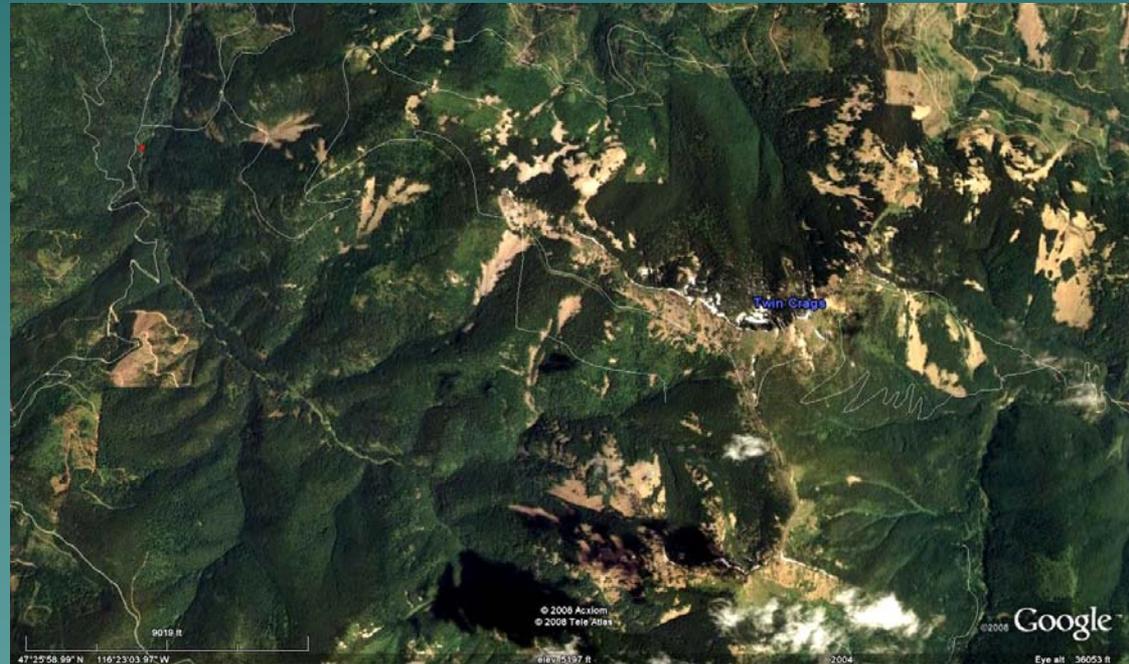
2008 Qualitative Stream Erosion Survey

- ◆ Mass wasting evident at the headwaters
- ◆ From the confluence with Butler Creek to the Mouth. Observations:
 - Road encroachment
 - Excessively high bedload.
 - Going downstream to the mouth, it became more and more evident that Latour Creek did not have enough stream energy to competently move this excessive bedload material downstream.
