Water Quality Summary Report 33

Lucas Lake, Beneficial Use Assessment and Reconnaissance Metals Monitoring

Lucas Lake, Beneficial Use Assessment and Reconnaissance Metals Monitoring Idaho County, Idaho

August 2, 2002

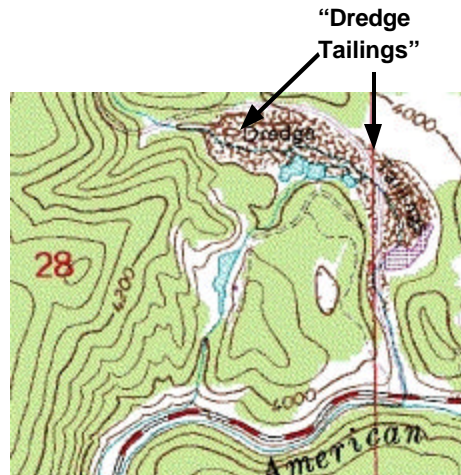
Figure 1. Lucas Lake and surrounding area

Daniel Stewart and Robert Steed visited Lucas Lake on November 13, 2001. Lucas Lake is a short walk south from neighboring dredge tailings. There is no surface water connection with these dredge tailings contrary to what is shown on the United States Geological Service (USGS) 1:24K map (see Figure 1). The outlet does function and discharges to the American River.

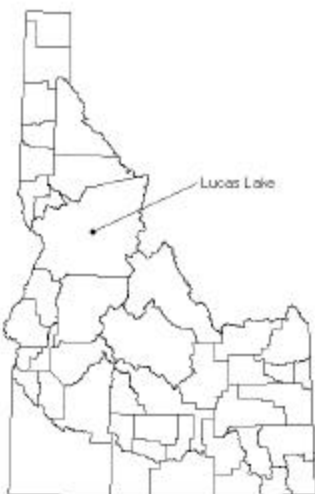
Figure 2. Location of Lucas Lake in Idaho

Lucas Lake, which is a small (less than one acre) locally-named waterbody, is in Idaho county, Idaho (45° 49' 17"N and 115° 28' 04" W). Lucas Lake outflow discharges into the American River between the town of Elk City and the South Fork Clearwater River. Lucas Lake's location is indicated on Figures 1 and 2.

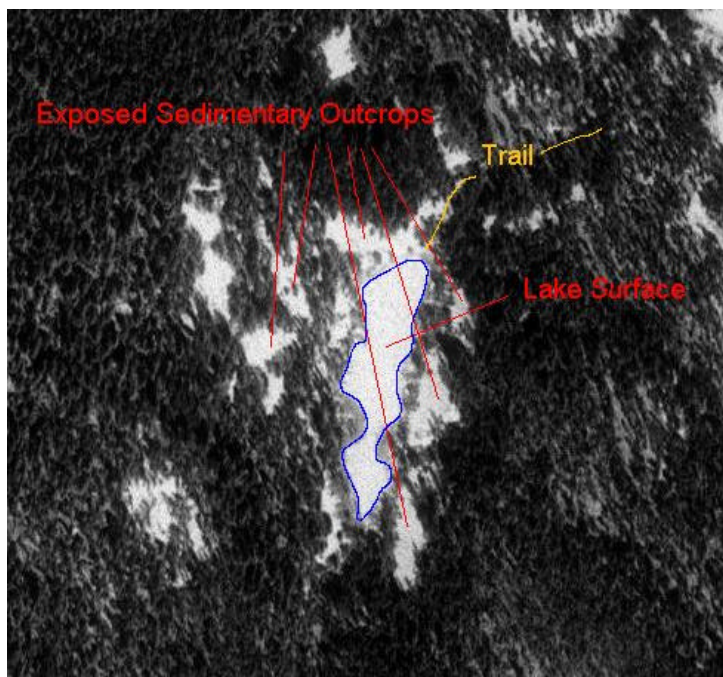
Figure 3. Aerial photo of Lucas Lake and watershed

Lucas Lake is a sink or depression, whose genesis is unknown to the author. Daniel Stewart has hypothesized that it may be an old “glory hole” (a large open pit ore is extracted from). It is also possible that it is a natural erosional feature. Lucas Lake has steep underwater banks (steeper than 45°), and appears to maintain full pool conditions throughout the year. Lucas Lake is surrounded by a very small, steep, contributing watershed, which is conifer covered and made up of small grained (1-10mm) sedimentary outcrops and clay. (In Figure 3, the outcrops are light, almost-white areas, not quite as light and white as the lake surface.) Many raw outcroppings of this erosive sedimentary parent material are visible. Lucas Lake has healthy riparian vegetation that filters sediment around approximately 95% of its perimeter. With no non-natural sediment sources identified, it is anticipated that Lucas Lake sedimentation rates reflect natural conditions. There is a distinct blue-green color to the water, probably colloidal in nature, which may have been mistaken for toxic substances in past assessments. Abundant waterboatman (*Hemiptera Corixidae*) or backswimmer (*Hemiptera Notonectidae*) insects were observed, but past observations of fish were not verified. Lucas Lake has characteristics of both a lake and a wetland.

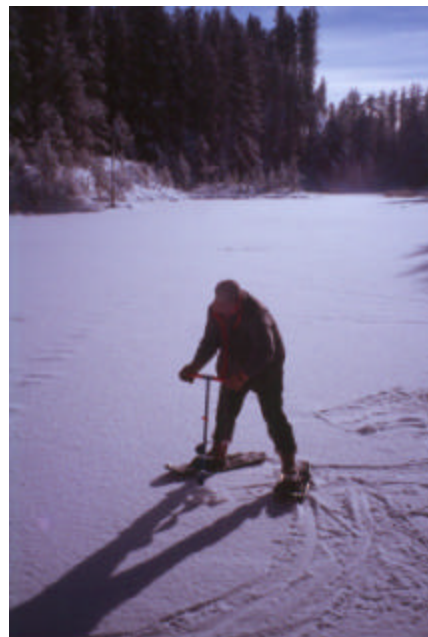
Figure 4. Using auger to drill through ice

On December 18, 2001, at 11:48 am, Robert Steed and Daniel Stewart collected water quality samples from Lucas Lake. The lake was frozen over with a slight snow cover. A hole was drilled through approximately 6 inches of ice and snow, with a steel auger (see Figure 4.). Three 500-ml samples of Lucas Lake water were taken, using new, 3-foot long disposable bailers, at a depth of 0 to 2.5 feet below lake surface. Samples were collected and transported in decontaminated or new sterilized equipment. Samples were then chilled and transported to State of Idaho Bureau of Laboratories. These samples were submitted at 8:43 am the following day (December 19, 2001) for immediate analysis.

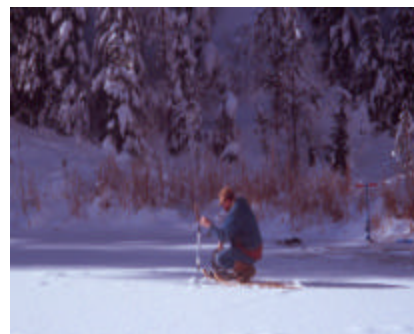
Figure 5. Measuring field parameters with a multi-meter

The following field parameters were measured immediately after samples were taken (see Figure 5):

- Water Temperature – 3.6°C
- pH – 7.46
- Dissolved Oxygen – 8.98 mg/l
- Conductivity – 31.6 µS/cm.
