# EFFECTS OF THE 1995/96 FLOODS ON STREAMS IN NORTH CENTRAL IDAHO

*Dennis T. Schult, Terrance W. Cundy, and John A. Gravelle<sup>1</sup>*

ABSTRACT: Sixteen channel and habitat parameters on 13 stream reaches in north-central Idaho were measured before and after the 1995/96 floods, which were of 25 to 100-year magnitudes. Sixteen of the 172 total comparisons possible were significant at the 10% level, and five were significant at the 5% level. Global averages of the 16 measured parameters over all study reaches showed six that were significant at the 10% level, and three that were significant at the 5% level. The only trend that could be inferred was a general decrease in width-to-depth ratios, but changes were not consistent from stream to stream. The results indicate that either the streams did not change significantly as a result of the event, or the sampling methodology used was inadequate to evaluate channel changes over time.

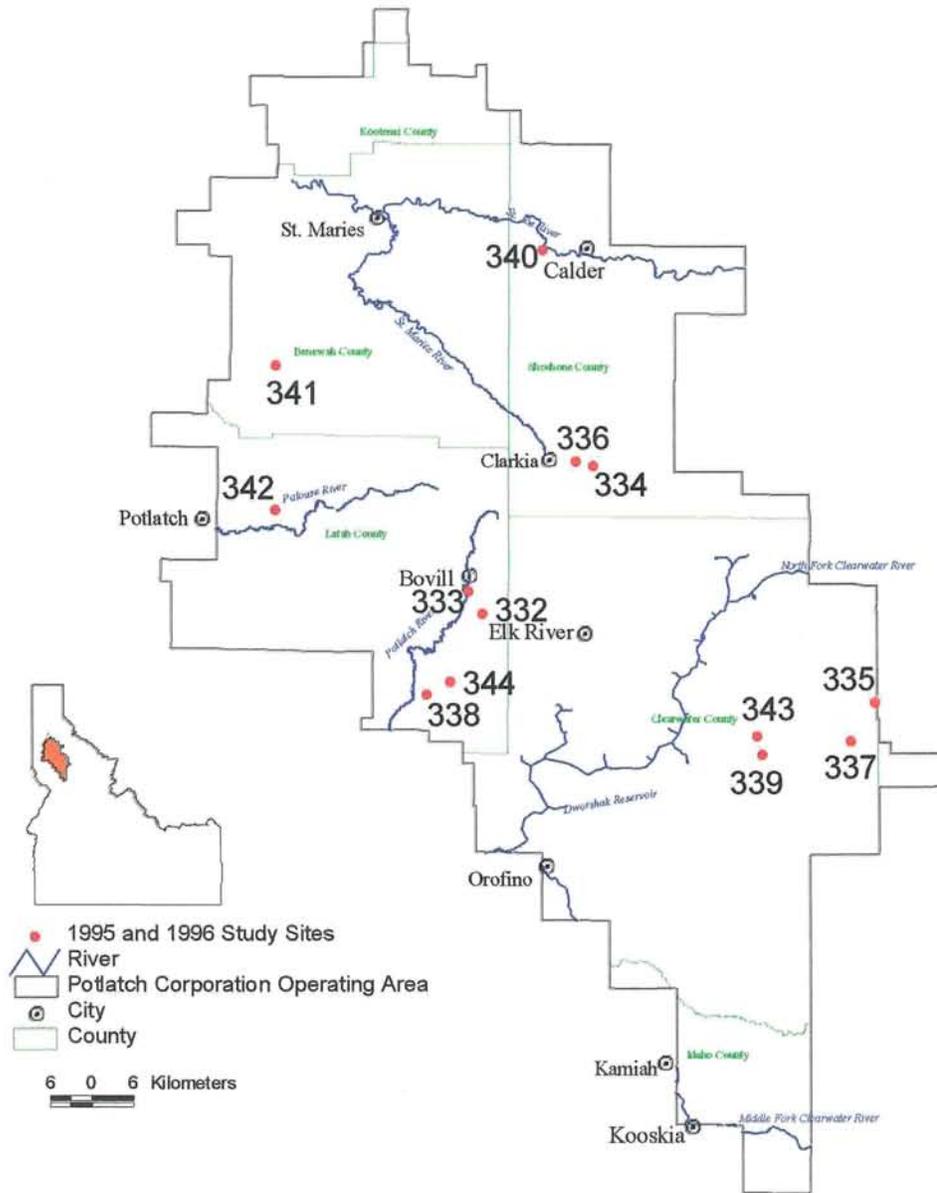
## Study Site Locations 1995 and 1996

Figure 1 shows the location of each of the 13 study reaches. Table 1 summarizes the general characteristics of each of the 13 streams sampled in this study. These reaches were located at the lower ends of watersheds, on Potlatch Corporation ownership, attempting to use “response type” reaches as defined by Montgomery and Buffington (1993). Accessibility was also a consideration.
