STATE OF IDAHO  
DEPARTMENT OF  
ENVIRONMENTAL QUALITY

RE: Site Assessment of the Deheeya Ranch Mine Claims; Ornament Mill Site (6B, 42B), Ohio North Mill Site (8B), Ohio South Mill Site (9B), Sentinel Mill Site (10B), and Trade Dollar Mill Site (7B, 43B)

## ABBREVIATED PRELIMINARY ASSESSMENT CHECKLIST

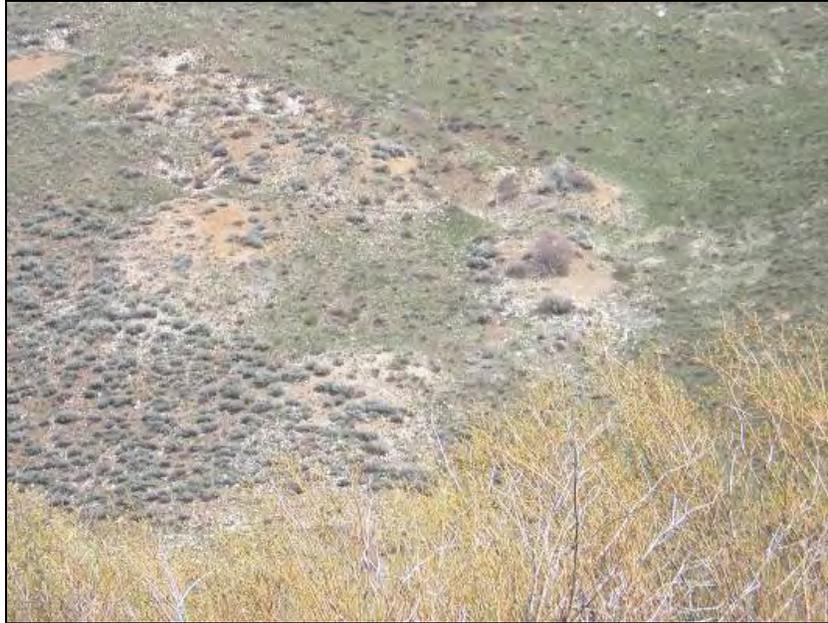
**Photo 1. Shallow pits (<100 cubic yards) on dumps, Shallow cut trends east (upper left).**

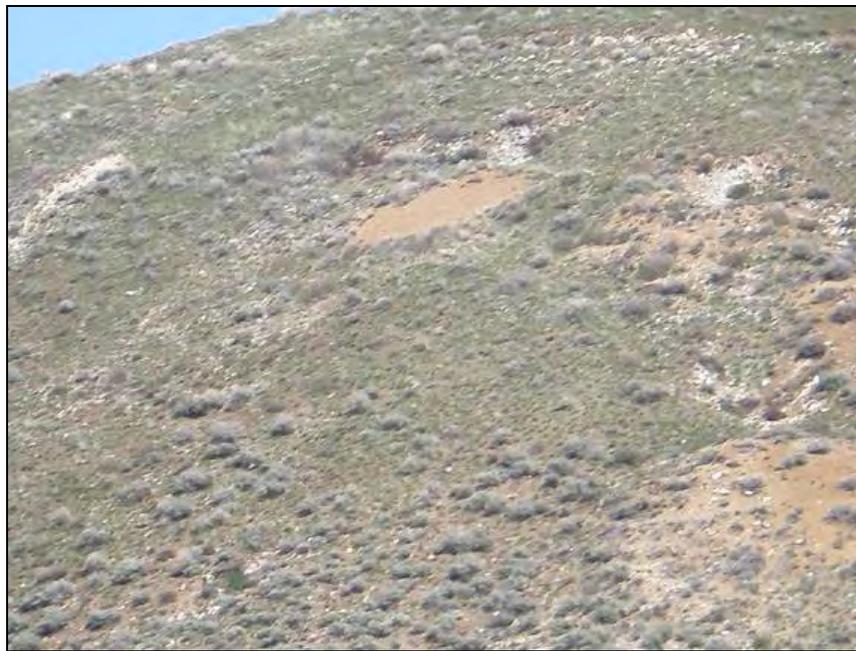
**Photo 2. Upper prospect (top center) is largest dump, shallow cut at right of dump  
All of the workings are southeast of the property fence line.**

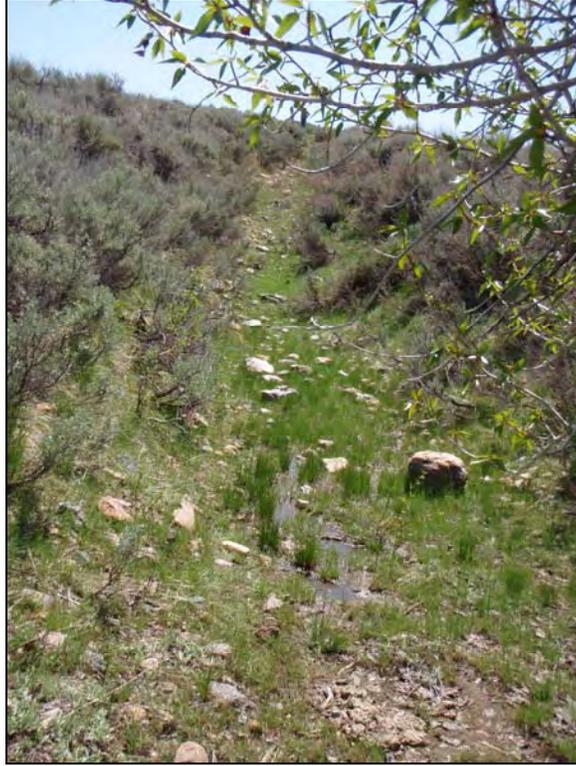
**Photo 3. Southwest view of trench with water, no evidence of adits were found.**

The area observed by DEQ staff contained one trench approximately 275' x 8' x 4' with a small pool of water, vegetation has reclaimed the disturbed areas. No adits were observed on the site.

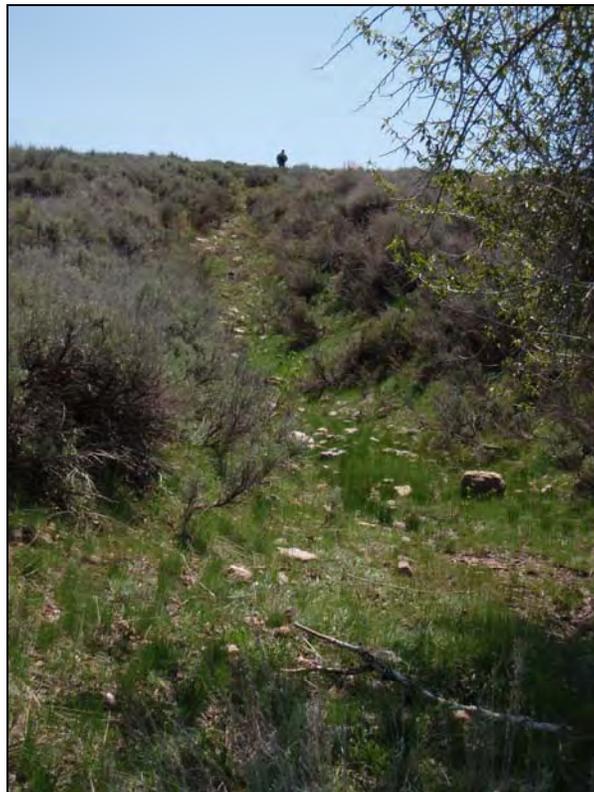
**Photo 4. Southwest view of trench, vegetation re-established, no signs of waste piles or sulfides on Deheeya Ranch property.**

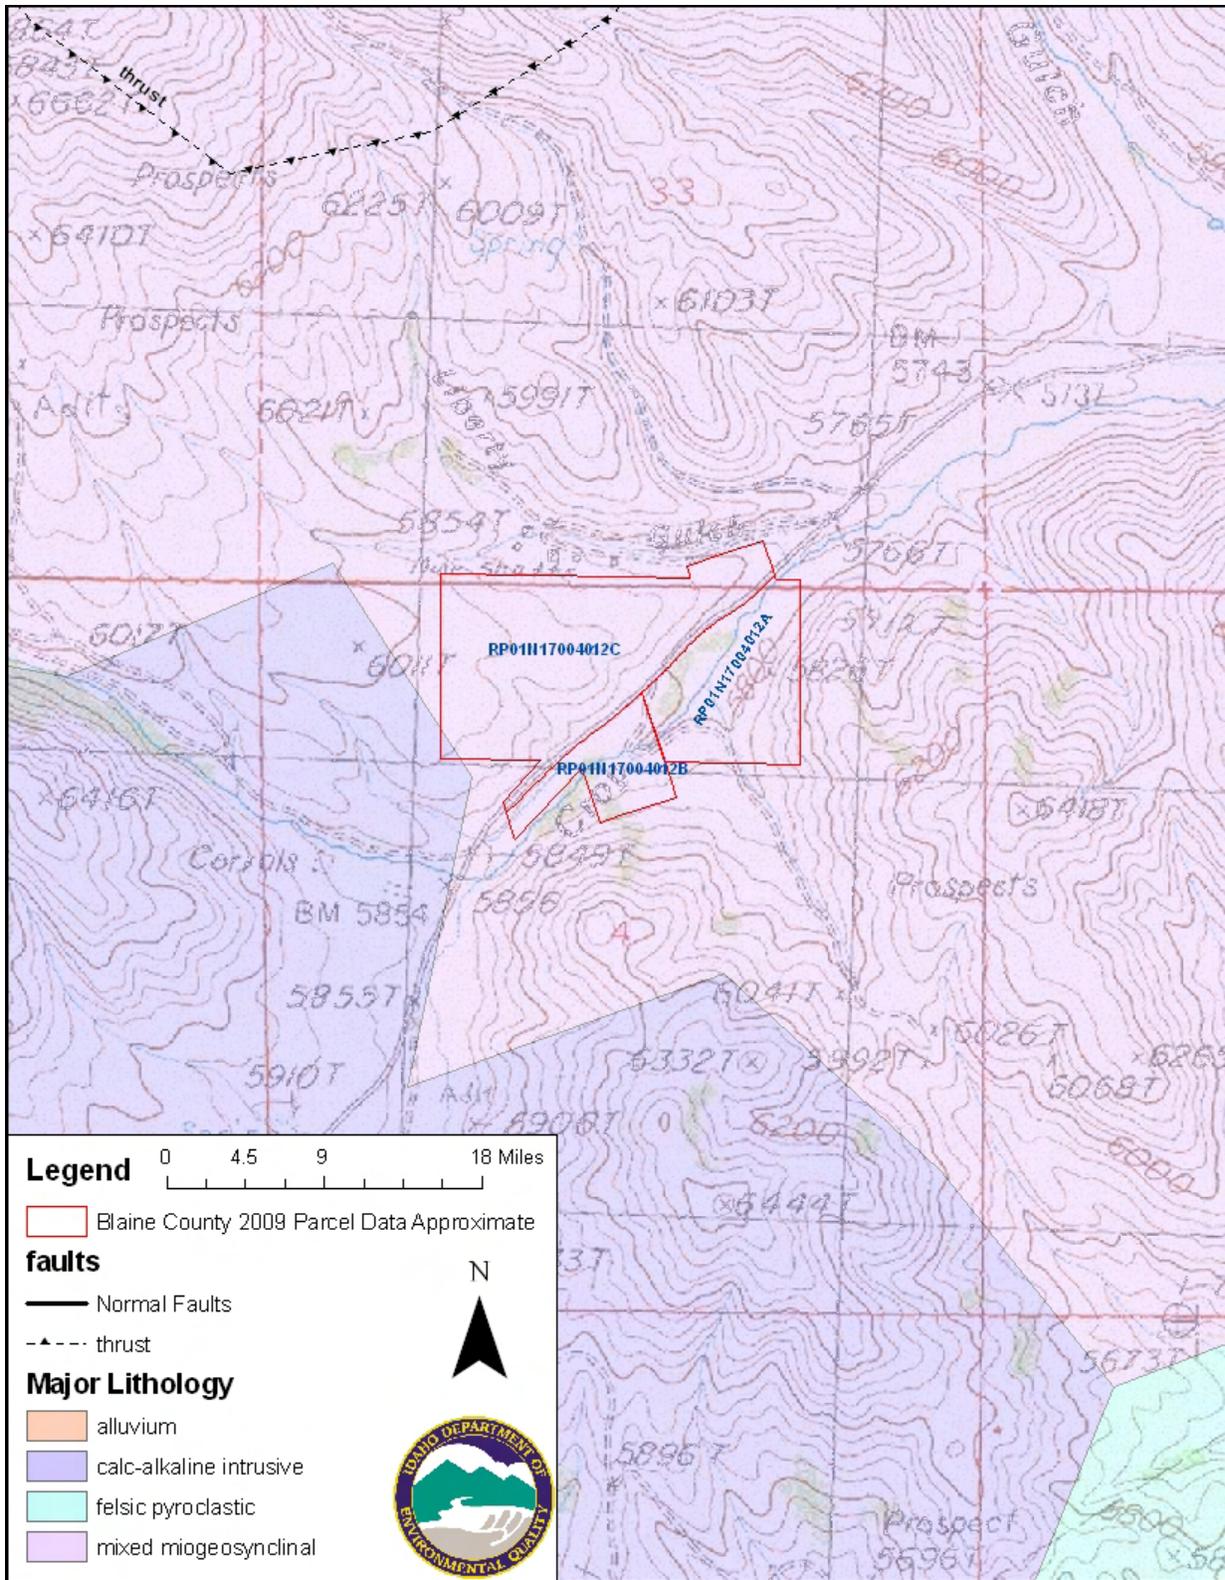
Figure 2. Geology of the Deheeya Ranch property and surrounding areas. (Map source: USGS 24k)

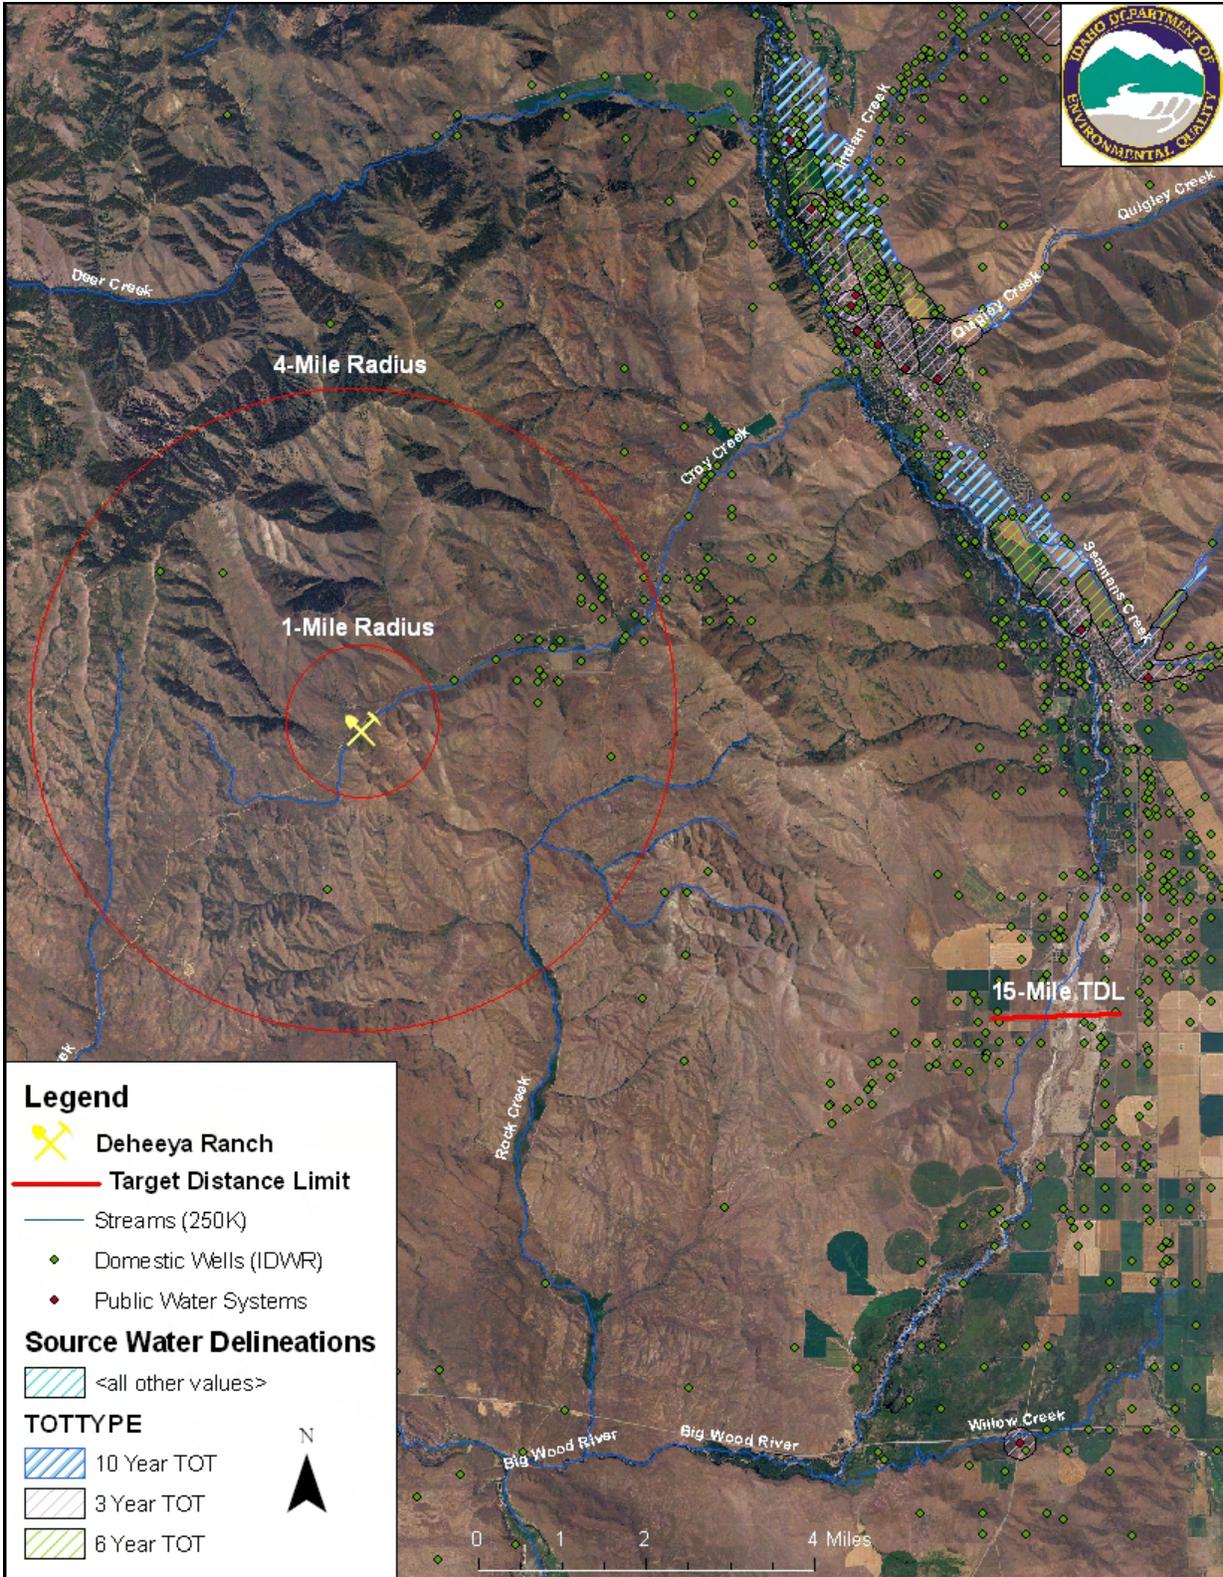
Figure 3. Drinking water well locations and source water delineations. 15-mile Target Distance Limit (TDL). (Map source: Blaine County NAIP)
