Drinking Water State Revolving Fund Green Project Reserve - Interim -

City of Lava Hot Springs Drinking Water Project SRF Loan #DW1604 (pop. 410) \$4,400,000

Interim Green Project Reserve Justification Categorical GPR Documentation

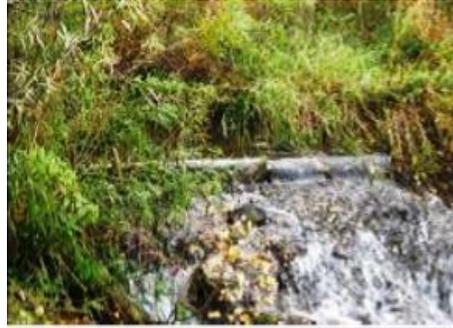
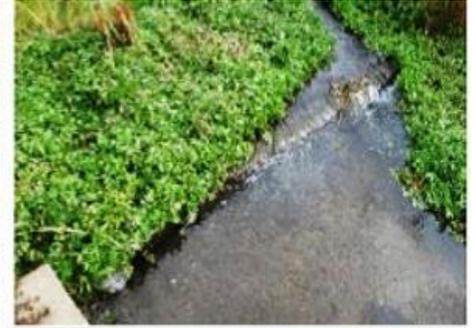
- In 2014 the City repaired 10 or more leaks in the transmission line. The soft lead joints fail on a regular basis. The pipe alignment crosses a creek three times and a canal, where there is potential for contamination.

Exposed Transmission Line

- A Water Facilities Planning Study recommended the replacement of the 8" diameter cast iron transmission line from the spring to the storage tank with 8" diameter PVC pipe.
- The new pipe will eliminate water leaks in the transmission line, prevent entry of contaminated water, and provide a more secure water supply.
